# A STUDY ON ECONOMIC LOSSES CAUSED BY EARTHQUAKE

Ercan IŞIK<sup>1</sup>, Muhammed Hamidullah ÖZLÜK<sup>2</sup>, Ercan DEMİR<sup>3</sup>

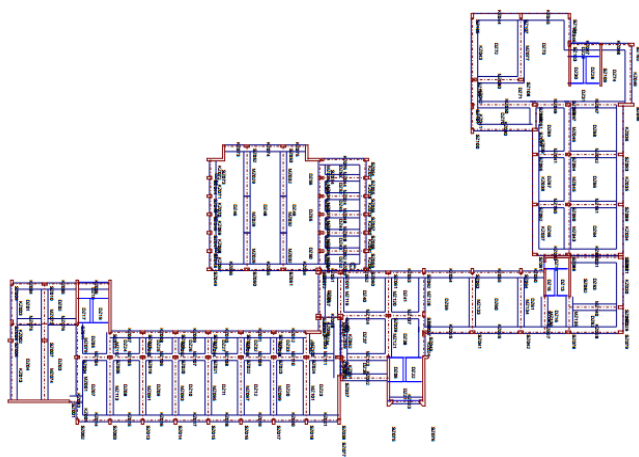
Fig.-3. The blueprint of ground story

Tatvan Vocational High School was investigated in this study which was located in Tatvan province in Bitlis. The building was built in 1993. Building was formed one basement, one ground and one normal storey. It is totally 3 stories. The dimensions of the building are 76.55m x 48.45m. Building was formed RC frame and RC walls. Total height of building is 10.80m. The blueprint of ground story was given in Figure 3.

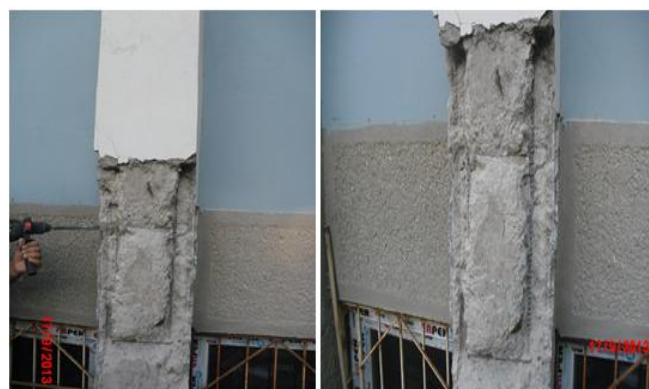
Fig.-4. Status of the columns

Required experiments for performance analysis were carried out of the building, which is designed as an educational institution. Determine the existing concrete strength is one of these. The concrete strength was calculated by taking the required number of core samples in the studied building. The concrete class is determined as C3.5 from experiment results [8]. In experiments conducted at the construction site, corrosion measurement and reinforcement mat is scraped visual control of diameter and made of corrosion was observed in this case the equipment. It also has been found to be specified in regulations stirrup densification process (Fig. 4).

The structure is modelled as three stories for performance based assessment. Bearing capacity of the beams and the columns were observed to be minimal. There is a certain need to strengthen the structure as to the windings in columns. This plurality of columns (at least 90%) will need to be strengthened. This information is made within the framework of the strengthening of the columns and beams of 90%, the concrete in the basement curtains and strengthening the basic structure of the basement because of poor pitch will make it necessary to be strengthened [8]. This calculation probability of exceedance 10% in 50 years, which now use of the seismic forces and the possibility of exceeding 2% in 50 years were found to be not provided the level of safety performance. So strengthening of building is unsuitable.

Many factors must be considered in strengthening the damaged structures. The strengthening of the non-rational to be immediately demolished, it will be more economical.
