A SYSTEMATIC APPROACH TOWARDS RESTORATION OF HERITAGE BUILDINGS- A CASE STUDY

4. CASE STUDY

To study the way in which typical rehabilitation work in India is carried out, study of rehabilitation of main building, University of Pune has been carried out. The building is indexed as a Grade I structure [http://www.urbanindia.nic.in/publicinfo/byelaws.htm], which was constructed in 1871 by the British. Designed by the then architect James Trubshawe, the building is a G+1 structure with 60,000 sqft area having shallow foundation resting on black cotton soil. The typical features include sloping pitch roof, jack arch slab, typical wooden flooring, un coursed rubble masonry in an Italian gothic architecture.

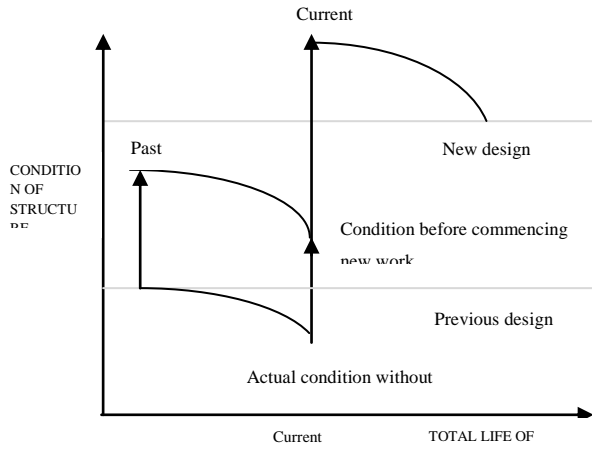
strength level as seen from graph in Figure 1. It is necessary to follow a precise methodology, whose main steps are survey, diagnosis, safety evaluation, the choice of criteria and techniques of interventions, and finally the controls [Crocic G.,2009].

Fig -1: Need for restoration

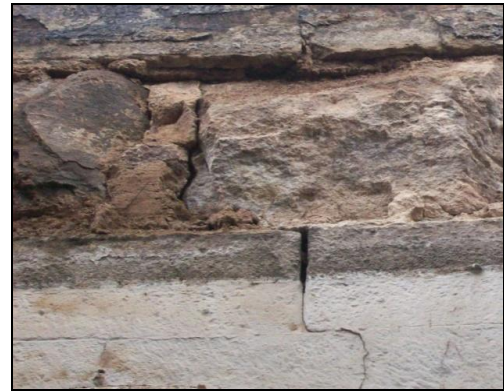
Poor load distribution, poor water proofing causing bulging of structural members had caused the members to crack with cracks of varying magnitudes. The cracks observed on site

were not only superficial but also extended to the core of the masonry. The entire north side of the structure along with northwest and northeast corners was covered with very thick creepers. The roots had penetrated in the wall through the joints in masonry. Thus the gaps in the joints had increased (Figure 3). The creepers had pulled out the upper portion of the corner. Hence the upper portion of the wall was leaning out of plumb. Masonry damage was the result of aging of the structure and materials, poor water proofing, wrong loading conditions etc. The destabilization of older walls due to the deterioration of the inner core rubble between the exterior and interior faces of masonry needed proper attention.

Fig -3: increased gap in joints due to growth of creepers

Epoxy grouting for strengthening weakened and cracked masonry, jacketing of disturbed wall surfaces by means of applying a mesh of non-ferrous steel reinforcement to both sides of the wall, bonded to the wall with a mortar matrix, metal straps with bolted connections are some of the measures to repair & avoid any further cracking of masonry. The gaps in the joints of the masonry can be filled up with lime mortar. Also stitching can be done to avoid further damage. In the case study, the repair of masonry cracks was taken care by filling all the cracks by epoxy grout with the help of inserted nipples and grouting gun. After the grouting was completed, plinth beam was casted and steel C sections were placed on both the sides of the wall bolted with each other through the wall cross section as shown in Figure 4. A mesh of 8mm

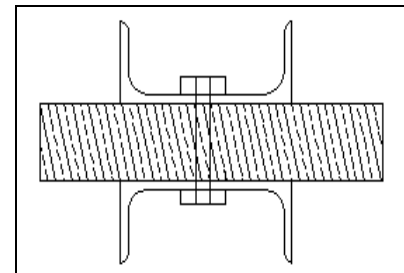
Fig -4: Reinforcement details of the wall face

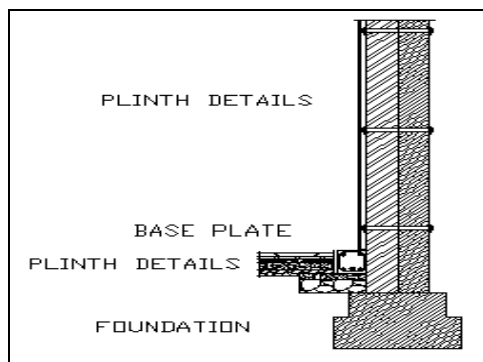
Fig -5: Details of plinth and reinforcement

reinforcement bars was placed on the wall as shown in Figure 6 and then the face was shotcreted with suitable mix of concrete and plastered with the conventional material mix lime mortar 1:3. Details of the reinforcement of damaged masonry walls are given in Figure 5.

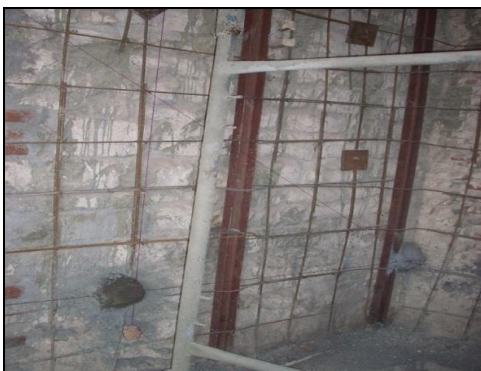
Fig -6: C/s of wall and plinth details

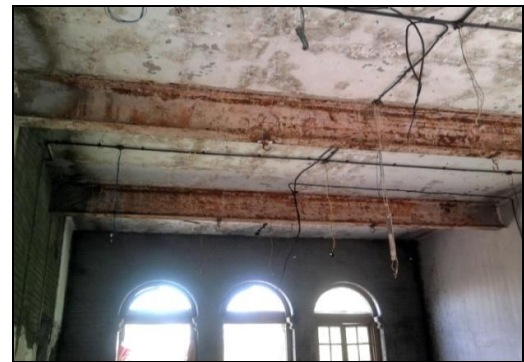
Thick creepers were allowed to grow on the masonry. The creepers had its only support from the wall thus causing the roots to grow in the masonry joints. The slab consisted of steel sections supporting lime concrete. Ceiling tiles in terracotta were laid below the lime concrete and were visible from below. The Rolled Steel Joists (450 mm deep) did not have any binding or bracing at the outer face of the porch to prevent

it from moving outwards. This allowed the upper portion of the wall to be pulled out by the heavy creepers. The absence of fixity either using nut-bolts or welding had further allowed the walls of the porch to lean out of plumb by 25-30 mm. After opening up the waterproofing on the slab, 20-25 mm wide cracks were observed in the lime concrete slab towards southern side running in east-west direction. It was also observed that the T-sections at the outer face had corroded due to the water seepage in presence of lime concrete, considerably reducing the cross-section area of the steel members (Figure 7). This had made the slab structurally instable that could have collapsed without any warning.

Fig -7: Corroded steel members due to leakage

Part of the porch was dismantled and the wall was reconstructed in plumb. Damaged stones were replaced. Steel members were fixed by welding and damaged steel sections were replaced. Also bracing at the joist level was added. Old slab was replaced with similar slab structure as shown in Figure 8 which consisted of stack of two I sections one above the other supporting inverted T section. Concreting of suitable grade was done over the inverted T-section. Proper care was taken to provide brick bat coba type of water proofing so as to reduce future deterioration.

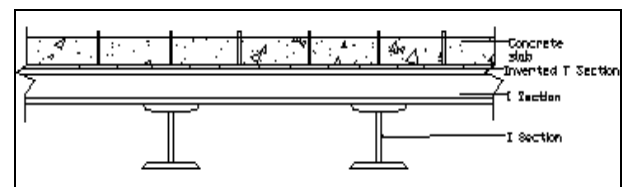
Fig -8: Details of reconstructed porch slab

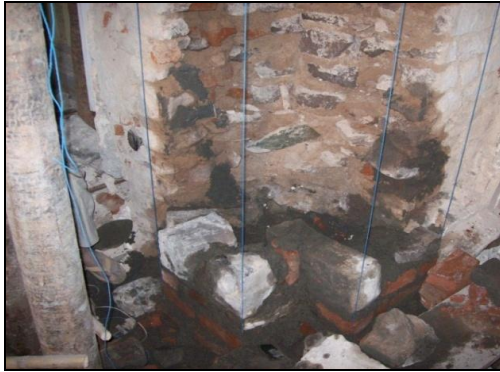
The column which was supporting overhead beams showing major signs of bulging due to water seepage collapsed partially which initiated the urgency to rehabilitate the structure. The intact portion of the column showed loose bonding of the mortar as well as cracks in the core which needed special attention (Figure 9).

Fig -9: Reconstruction of partially collapsed column

The collapsed portion was removed and reconstruction of that portion was carried out using the same type of stone and mortar. During the reconstruction, steel rods were inserted into the old masonry so as to establish a proper bond between the old and the new masonry. After the reconstruction, the cracks in the core of the column were taken care by the epoxy grouting carried out through the inserted nipples (Figure 10).

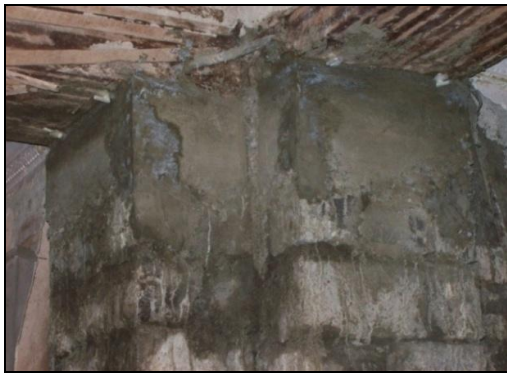
Fig -10: Grouting nipples at the top to fill voids

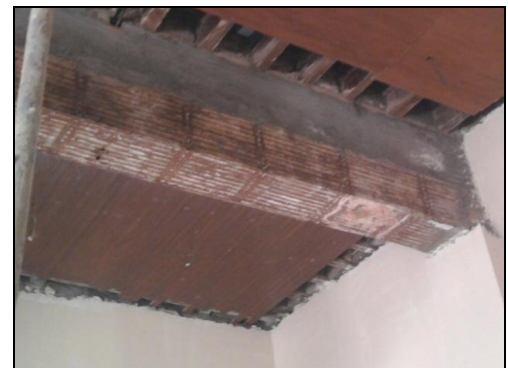
The internal wall on eastern side was found showing signs of bulging. The rainwater gutter on the terrace, which is above this wall, was sagged due to water seepage observed in the first floor wall as seen from Figure 11. The wall was bulged at this location on first floor and also some cracks had appeared in the plaster of the wall on ground floor at same location.

Bulged wall resting above the beam caused the beam to have sag at the centre leading to a structural crack. This major longitudinal crack posed a major problem and required flitching of the beam with steel plates on the exposed sides after the wall resting on it is removed. The steel plates were then bolted to the beam by anchor and through bolts as shown in Figure 12. After restoring the beam, the wall above was reconstructed.

Fig -11: Longitudinally cracked beam with visible sag

The reason for the bulging of this wall was found to be a corroded gutter above the wall, which allowed the water to seep in the wall thus the gutter needed to be replaced and laid with proper slopes. The bulge in the wall also needed to be

checked for its stability and also it was necessary to ensure if the cracks in the wall could be rectified by stitching or the required part of the wall could be dismantled and replaced with minimal disturbance to the rest of the structure to ensure proper transfer of loads through the walls.

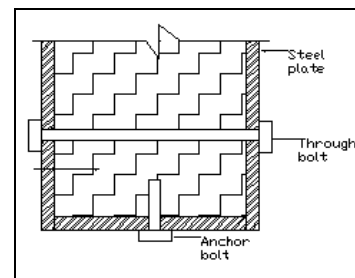
Fig -12: Flitching details of beam

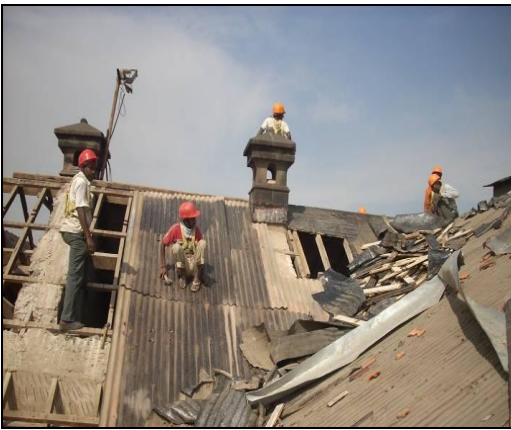
The roof is constructed in lime concrete slab using chicken-mesh. This slab is covered with mangalore tiles laid above corrugated G.I. sheets (Figure 13). The mangalore tile roofing did not have a proper slope for storm water drainage. Thus water logging at the corners was observed which allowed growth of trees. Seepage through roofs and down-take pipes had resulted in the bulging of stone masonry and severe cracking of the brick masonry below on the ground floor. There were several places where the storm water from roof did not reach the ground and seeped in the structure due to improper laying of storm water drains or inadequate maintenance.

Fig -13: Dismantling of deteriorated roof members

The repair technique comprised of restoring proper slopes, replacing corroded members, using lead flashing wherever necessary. The down take pipes that travel through inaccessible panelling through the centre of the building were taken through more accessible positions with strict schedules of periodic maintenance. The bulged and cracked masonry was taken care of as per the requirements. State of the art devices for detection and alarm in case of fire were installed in the roof voids and other infrequently accessed spaces of the building. Several changes in the profiles of roofs were done to ensure better performance of roofs. The repaired roof was then covered with panels coated by multiplas sheets for water proofing (Figure 14).

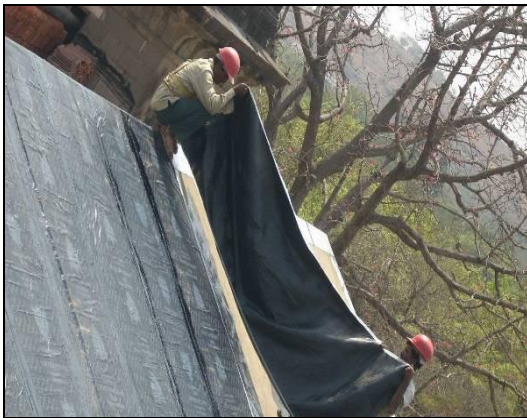
Fig -14: Laying of Multiplas sheet for waterproofing
