# STUDY ON RUTTING AND SURFACE BEHAVIOUR OF URBAN FLEXIBLE PAVEMENT

KumKum Bhattacharya<sup>1</sup>, Sagar Deshmukh<sup>2</sup>

<sup>1</sup>M.Tech Scholar Department Of Civil Engineering, Gujarat Technological University

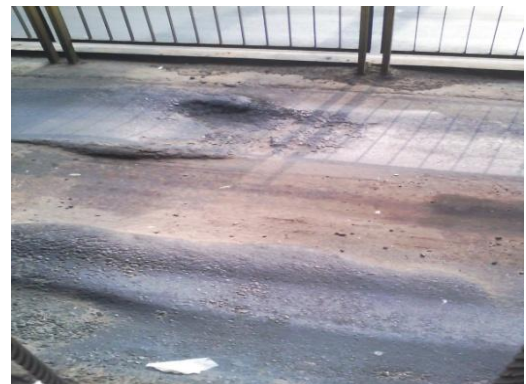
(a) Valinath chowk

- After the completion of phase-1, the pavement was found to breaking up fast, leading to bumpy rides for the commuters.
- The pavement was uneven near the bus shelters where repeated application of brakes are resulted the distress.
- The overall cost has spurred as the risen cost of bitumen is a petroleum product.
- Maintenance of BRTS route is also a problem because maintenance works requires the regular traffic to be stopped which creates disturbances during the transport of daily goods to the commodity and also the regular maintenance work is very inadequate.

**Fig: 1** Rutting on the BRT Bus shelter [(a) & (b)]

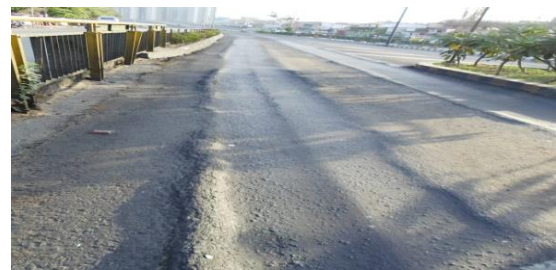
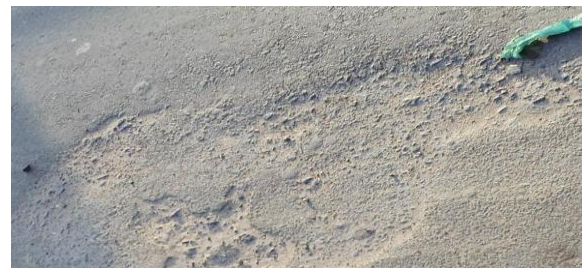
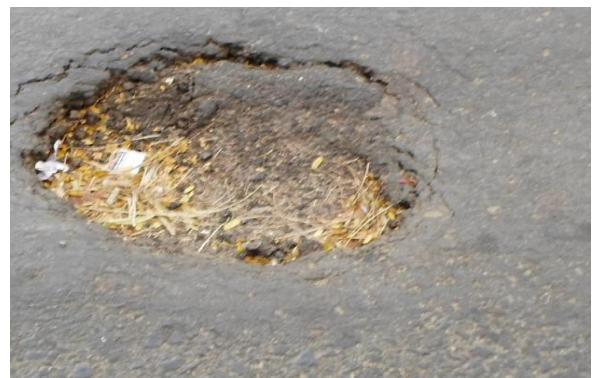
Fig-2: Distress photos of the above stretch [(a), (b), &(c)]

From this table after pavement condition survey we had observed that raveling and patch deterioration is in high extent condition which is more shown up in the Akbarnagar Area where as other condition are not high.

From this table after pavement condition survey in this area we had observed that there is no high extent distress type condition.

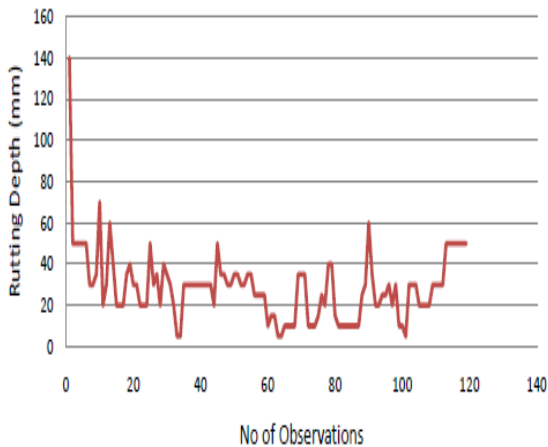
**Fig: 3** Bar- Graph of Rutting Depth vs. No of observations

From the above fig. we can noticed that rutting depth decreases initially with respect to no. of observations and as no of observations progresses it varies abruptly.

The rutting is generally measured in depth. As per IRC: 37-2012, permissible rutting depth is 20 mm. Looking at the case study rutting depth is found as high as 90 mm (at Bhavsar hostel Shelter). The average rutting depth over the entire stretch comes out to be 65 mm. This means that the pavement has failed completely.

1. Stone Matrix Asphalt (SMA)
2. Flexible Pavement with Mastic Asphalt
3. Flexible Pavement reinforced with Glass Fibre Grid
4. Paver Blocks
5. Rigid Pavement (PQC)

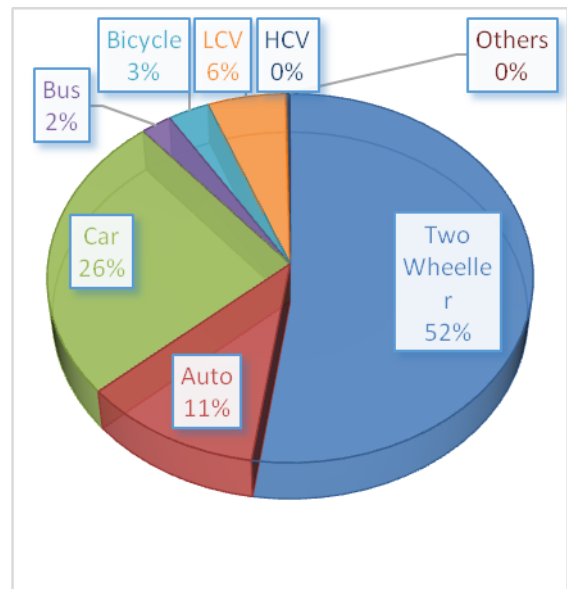
**Fig4: a.** Morning vehicle composition

The above figures show the traffic composition in PCU/hr in the midblock section of peak hours on the day. The method adopted was videography method and was calculated for one hour. Here two-wheeler loads in high percentage where as bus load percentage is less in number except others.
