# WATER AND SOIL QUALITY ASPECTS OF NELLIGUDDE RESERVOIR CATCHMENT AND COMMAND AREAS; MAGADI TALUK, RAMANAGAR DISTRICT: A CRITICAL STUDY

## Abstract

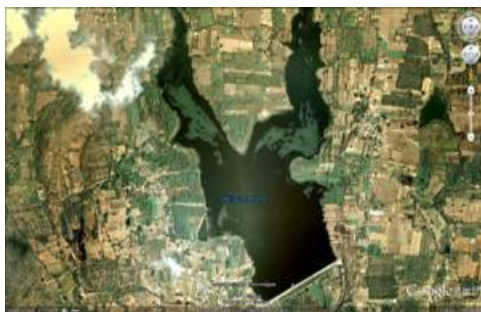
**Fig 2** Satellite Image of Nelligudde reservoir
