DEVISING A NEW TECHNIQUE TO REDUCE HIGHWAY BARRIER ACCIDENTS

G.Udayakumar¹, S.Chandralekha²

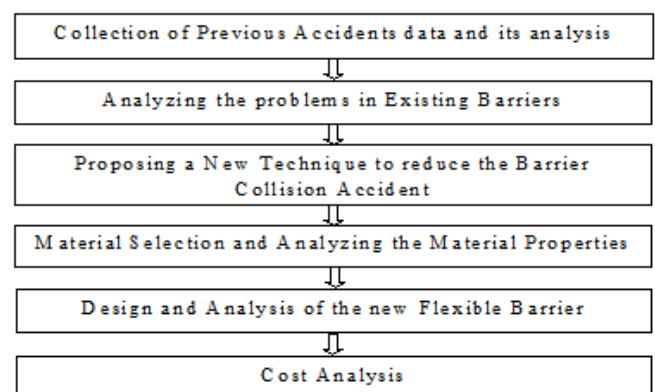
Fig -2.1.: Methodology Chart

The above chart involves the collection of previous accident data, analysis of problems in existing barriers, analysis of selected material properties, design and analysis of the new flexible barrier using ANSYS software, proposing a new technique to reduce barrier collision accident and cost analysis of the new barrier.

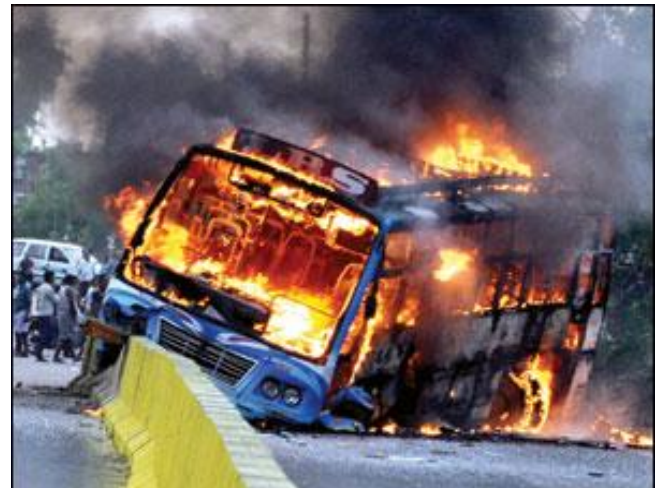
Fig -2.2: Barrier Collision Accident happened at Ammapet, Salem

This accident is happened on 09.04.2014 at 4.00hrs near Ammapet (Military Road), Salem. In this accident to avoid accident on pedestrian, the private bus driver (aged 32) rammmed against the median barrier. Then the front wheels of the bus detached and the diesel tank of the bus hit the median and got fire. About 90% of bus destroyed in the fire, 3 passengers were suffered burns during accident and about 52 passengers were escaped from fire. The newspaper report says that the fault of driver is the cause of this accident.

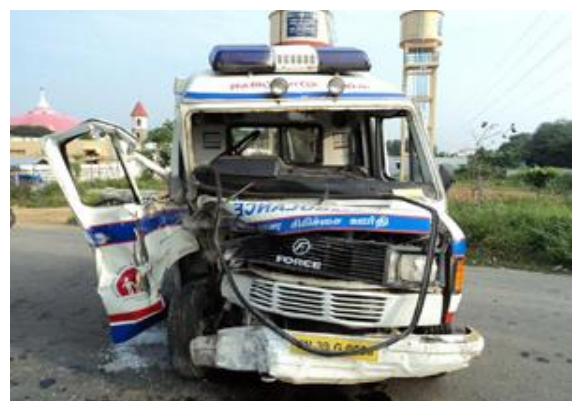
Fig -2.3: Barrier Collision Accident happened near Govt. Hospital, Harur

This accident is happened on 05.12.2013 near Harur Govt. Hospital. In this accident the ambulance driver (aged 34) drives vehicle and rammmed against the median barrier placed in front of the Harur, Govt. Hospital.

The news paper report says that, during this accident the person accompanied with the patient got died and patient got injured during accident.

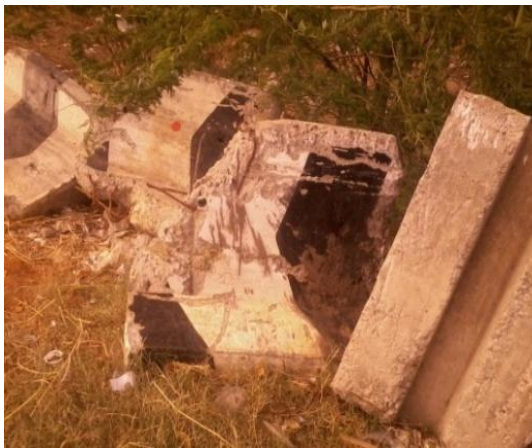
Fig -2.4: RCC Jersey Barriers

The RCC Jersey barriers and Flexible PU barriers are mostly used in the medians of road to reduce the accident. But there are some problems in these types of barriers. The various problems found in the existing type of Barriers are shown in below Fig -2.4 and Fig 2.5.

- RCC barrier get damaged during collision with vehicles
- And also RCC barrier damage the vehicle which hit on the barrier
- We cannot re-use the damaged RCC barriers
- Flexible PU Barriers get damaged during collision with vehicles
- The PU Barriers cannot withstands the vehicle load during collision

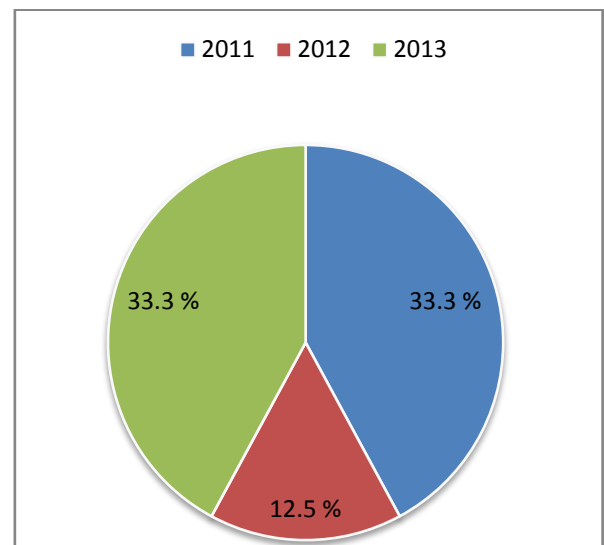
Chart -3.1: Total Accident Severity: 2011-2013

The severity of road accidents, measured in terms of persons killed per 100 accidents, is shown the below Chart- 3.1.

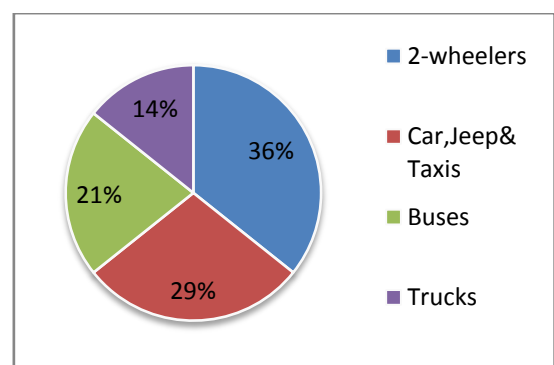
Chart -3.2: Share of various categories of vehicle in total accidents 2012-2013

The share of various categories of vehicle in total number of Road Accidents from 2011 to 2013 is given in Chart- 3.2.

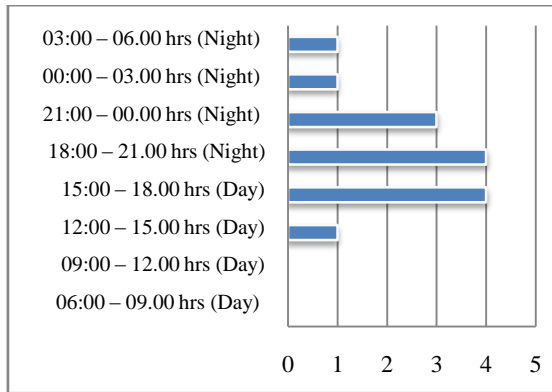
Chart -3.3: Distribution of Total Number of Road Accidents as per time of occurrence: 2011-2013

The share of various distribution of total number of Road Accidents as per time of occurrence from 2011 to 2013 is given in Chart- 3.3.

The above accident reports shows that the barrier collision accident rate is increased more than double times and these accidents mostly happened at night time.

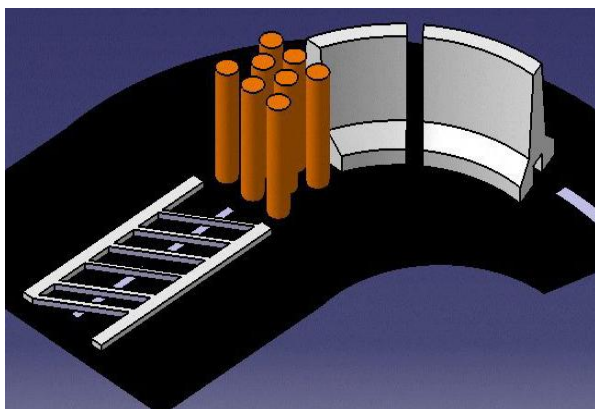
Fig -3.1: Arrangement of Flexible Barriers

- Fixing the FLEXIBLE BARRIER in Zigzag manner in front of the Jersey Barrier (Fig- 3.1)
- Constructing the small Speed Breakers (Rumble Strips) over the Restricted Path (White Marking) made in front of the Flexible Barrier (Fig- 3.1)

The Rumble strip arrangement is made to reduce the speed of the vehicle and also to alert driver about the hazard. The Zigzag arrangement of the flexible barrier will be suitable for both 2-wheeler and 4-wheeler accidents. When 2-wheeler hits the barrier it will get in between the gap provided in the barrier arrangement. And when 4-wheeler hits the barrier then the barrier will get flexed and accident effect will be reduced.

Rumble strip arrangement is made to reduce the speed of the vehicle and also to alert driver about the hazard. The Zigzag arrangement of the flexible barrier will be suitable for both 2-wheeler and 4-wheeler accidents. When 2-wheeler hits the barrier it will get in between the gap provided in the barrier arrangement. And when 4-wheeler hits the barrier then the barrier will get flexed and accident effect will be reduced.

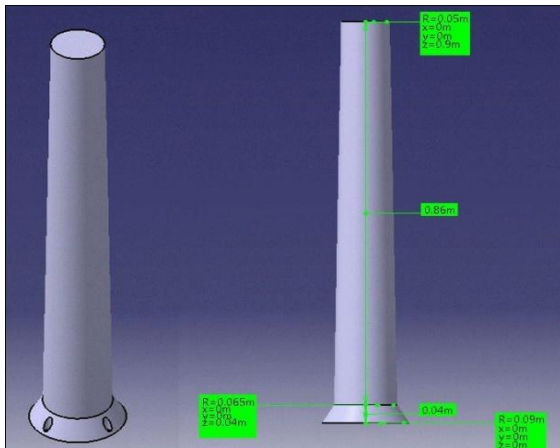
Fig -3.2: Design details of Flexible Barrier

The size and shape of the Flexible barrier is designed after analyzing the vehicle properties and previous type of barriers and its performances. The Flexible barrier is provided with nail hole at bottom for fixing the flexible barrier to the road. And also it can be fixed below the ground using concrete. The new flexible barrier is provided with base diameter 0.18m, height 0.85m and weight is 12.5kg. And the post bottom diameter is 0.13m and top diameter is 0.1m (see Fig – 3.2).

(i) Volume of Frustum of Cone (V) = $[\pi h/12]*[d^2+Dd+D^2]$
 (h= height of cone, D= bottom diameter, d= top diameter)
