# THE EFFECT OF WATER/CEMENT RATIO ON THE SULFATE CORROSION OF FINE GRAINED CONCRETE

Martin Vyšvařil<sup>1</sup>, Markéta Rovnaníková<sup>2</sup>, Patrik Bayer<sup>3</sup>

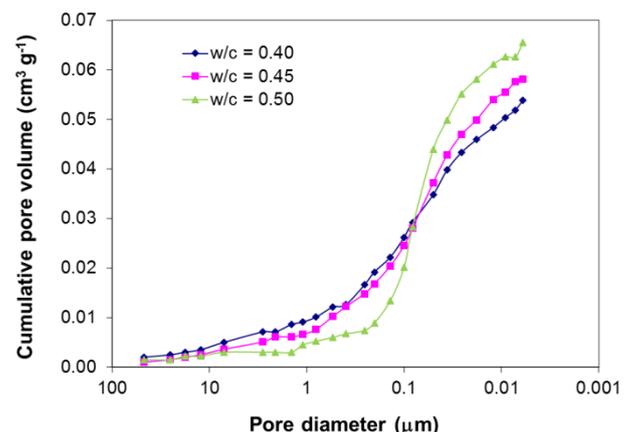
**Fig. 1:** Pore size distribution of concrete samples

All of the manufactured specimens were unmoulded 24 hours after casting under laboratory conditions ( $t = (22 \pm 2)$  °C, R.H. =  $(55 \pm 5)$  %) and placed into water bath for another 27 days. Afterwards, the specimens were air-dried for 24 hours and then the bulk density ( $\rho_v$ ), flexural strength ( $R_f$ ) and compressive strength ( $R_c$ ) of the samples were determined according to CSN EN 196-1 [17] (see Table 2). The pore structures of the samples included determination of total porosity ( $P_t$ ; Table 2) and pore size distribution (Figure 1) were studied by high pressure mercury intrusion porosimetry using a Micromeritics PoreSizer 9310 porosimeter. The microstructure of samples was observed by scanning electron microscope MIRA3 (TESCAN).

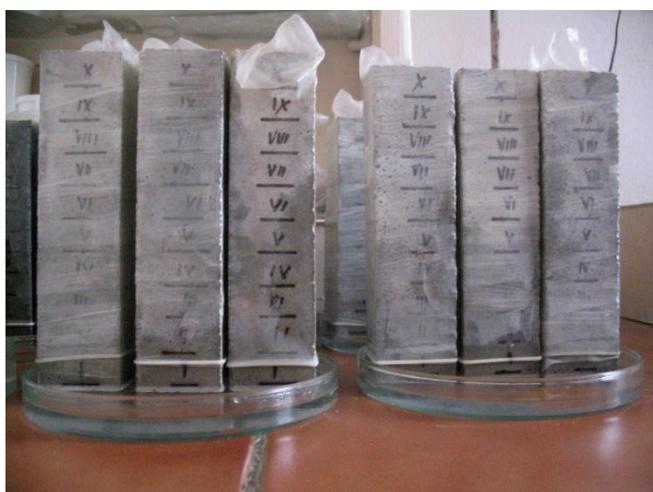
Fig. 2: Concrete samples placed in 0.5% H<sub>2</sub>SO<sub>4</sub>

Subsequently, the test samples were graphically segmented on 10 layers of 15 mm (I - X) and one layer of 5 mm (P). The specimens were covered by a protective coat as a drying prevention, and by the whole layer P. They were stand into solution of 0.5%  $H_2SO_4$  or solution simulating waste water (see Figure 2). The concentration of sulfuric acid was chosen in accordance with the literature [19]. Chemical composition of solution simulating waste water is mentioned

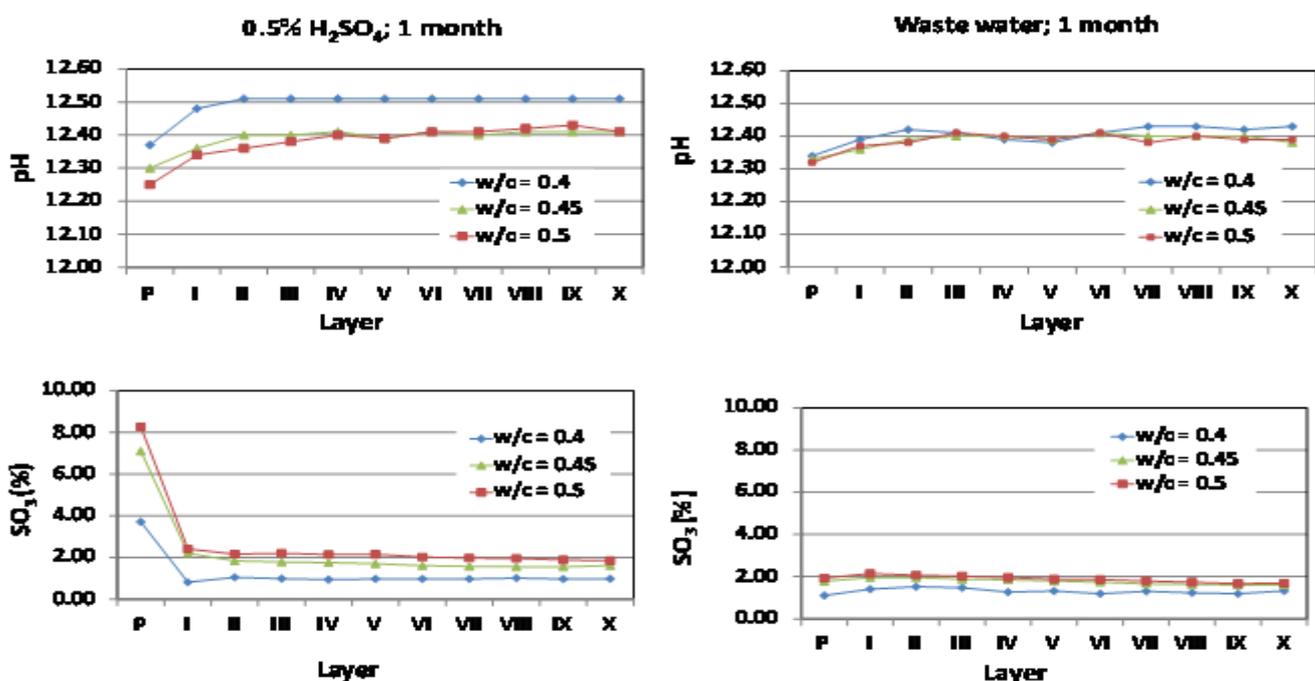
Fig. 3: Content of sulfates and pH of aqueous leaches of particular layers of concrete samples made with different water to cement ratio after 1 month standing in 0.5% H<sub>2</sub>SO<sub>4</sub> and waste water

After one month standing of concrete in a solution of 0.5% sulfuric acid, the pH reduction of aqueous leaches of layers P and I was observed for w/c = 0.4 and 0.45. Layers II – X showed the constant pH of aqueous leaches of 12.51 for w/c = 0.4 and 12.41 for w/c = 0.45. A slight decrease in pH of layers P – III was detected for sample prepared with w/c = 0.5. This small decrease in pH of layers II and III, unobserved in previous samples, may be caused by larger porosity and thus easier penetration of sulfates into the higher layers of the sample. The decrease in pH of layers P is logical due to the contact of the layer directly with the acid. Layers I showed a very slight decrease in pH by approx. 0.03 units. It can be concluded that after 1 month contacting of concrete sample with sulfuric acid to a concentration of 0.5%, no significant changes occurred in pH of concrete. The content of sulfate in particular layers of the samples is graphically compared in Figure 3. Increased concentration of sulfates was observed only in the layer P. In other layers content of sulfates remained almost unchanged in all samples. Sulfate ions thus do not penetrate after 1 month standing of concrete samples in 0.5% H<sub>2</sub>SO<sub>4</sub> into a greater depth than 5 mm regardless of the w/c.

The changes at pH of aqueous leaches of particular layers of concrete samples standing in the waste water were lesser perceptible and sulfate content was not dramatically changed for all tested w/c. It was confirmed that the waste water itself does not cause significant corrosive effect on concrete and that microbiologically induced sulfate corrosion of concrete, which takes place above the water line in sewer systems, is much more damaged.

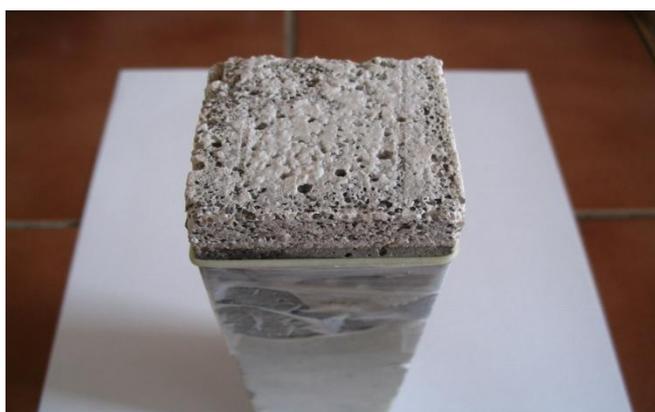
Fig. 4: The view on the immersed part of the layer P (w/c = 0.45) after 1 month standing in 0.5% H<sub>2</sub>SO<sub>4</sub>.

Figure 4 illustrates the effect of 0.5% sulfuric acid on the concrete sample with w/c = 0.45 for 1 month. There is well recognizable white precipitate of CaSO<sub>4</sub>·2H<sub>2</sub>O on the surface. Electron microscopy equipped with EDX probe showed a high content of gypsum and ettringite in the structure of layer P (see Figure 5).

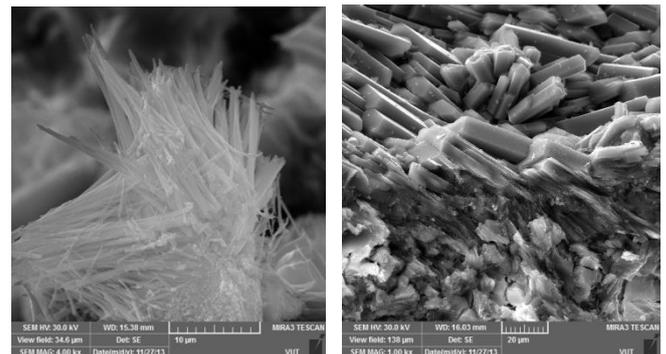
Fig. 5: SEM images of ettringite (left) and gypsum (right) identified in the structure of the layer P (w/c = 0.45).

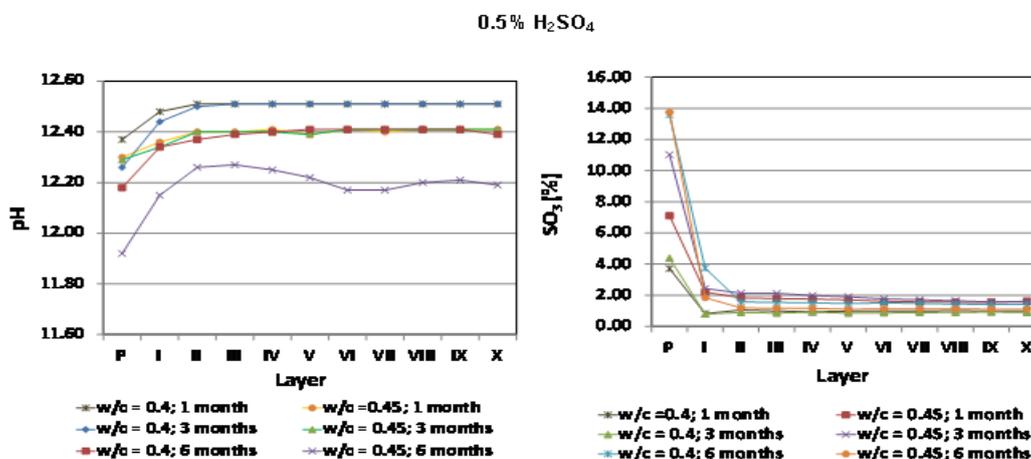
Fig. 6: Changes in pH of aqueous leaches of particular layers of concrete samples with w/c = 0.4 and 0.45 and sulfate content depending on the time period of placing the samples in 0.5% H<sub>2</sub>SO<sub>4</sub>

The six-month treatment of concrete samples in 0.5% sulfuric acid has already led to slight changes in pH of aqueous leaches (see Figure 6). The leach of layer P sample with w/c = 0.4 reach a pH by 0.2 unit lower than after 1 month, for layer I pH was determined lower by 0.15 unit and the other layers showed pH lower by 0.1 unit. Greater differences were obtained for samples with w/c = 0.45 (layer P – a reduction of 0.4 unit, the other layers – pH lower approx. by 0.2 unit). The changes of pH of aqueous leaches of layers P corresponded with increased sulfate content in these layers. The content of sulfate in layers P increased with increasing duration of sulfuric acid treatment. The slight increase of sulfate concentration can be observed also in layers I. In the other layers, the concentration of sulfates was not increased, although it was found lower pH of these layers. Sulfate ions penetrate after 6 months standing of concrete samples in 0.5% H<sub>2</sub>SO<sub>4</sub> into maximum depth of 20 mm.

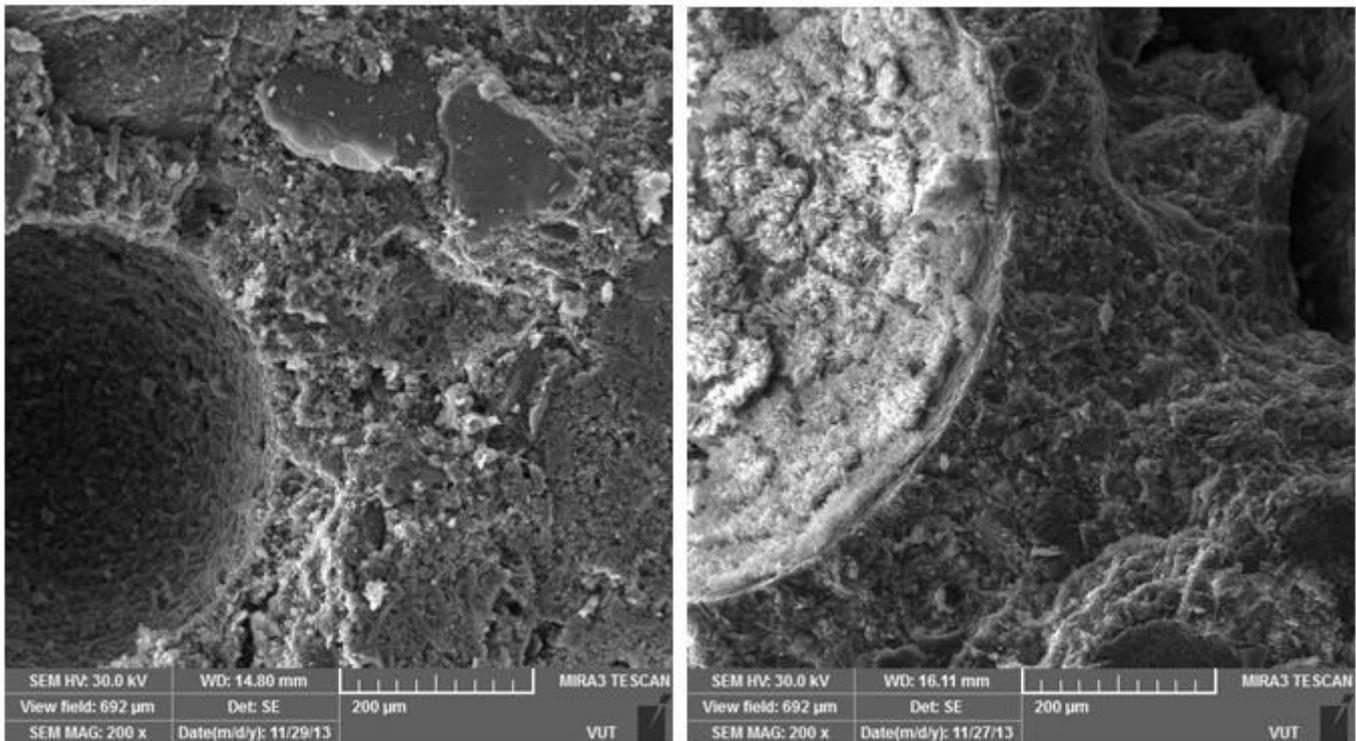
**Fig. 7:** SEM images of top layer of the sample  $w/c = 0.45$  before (left) and after (right) six months standing in 0.5%  $H_2SO_4$

Despite the unchanging content of sulfates in the upper layers of the samples even after 6 months treatment in sulfuric acid a relatively significant content of ettringite was observed by electron microscope in the structure of the top layer of the  $w/c = 0.45$  sample. Comparison with the

structure of the same layer before placing the sample in sulfuric acid is shown in Figure 7. Ettringite is present on the surface of the pore in typical needle crystals.
