WIND DAMAGE TO BUILDINGS, INFRASTRUCTURE AND LANDSCAPE ELEMENTS ALONG THE BEACH ROAD AT VISAKHAPATNAM

Mohan Kotamrazu¹

¹Senior Professor, Gitam School of Architecture, Gitam University, Visakhapatnam, Andhra Pradesh, India

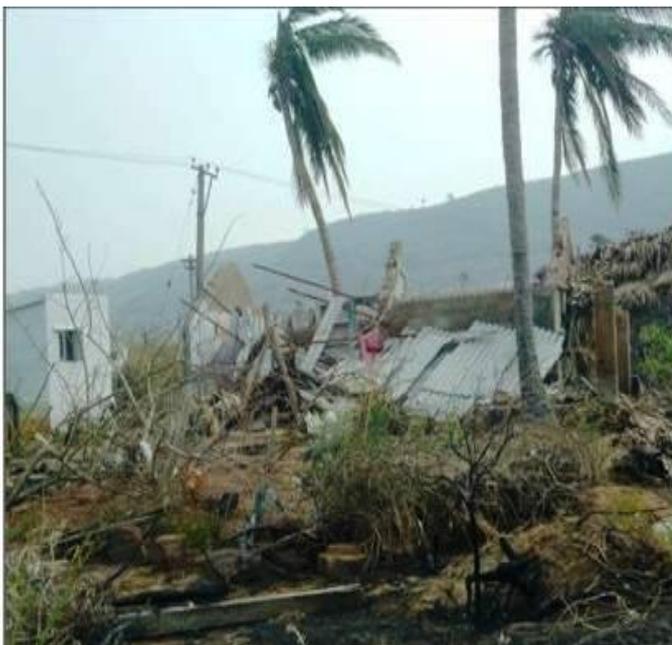
Fig 1 (a) A house with collapsed roof at Bheemunipatnam (b) Damage to the Non-Teaching staff quarters of Andhra University.

Many residences built with semi- permanent materials and roofs with A.C. sheets suffered extensive wind damage. Figure 1 (a) shows a building with a collapsed roof located along the Visakha-Bhimli Beach Road near Bheemunipatnam. The badly battered quarters Non-Teaching staff quarters of the Andhra University are shown in Figure 1(b). Several houses in Sagar Nagar, Visalakshi Nagar and on the base of the Kailasha Hill got badly bruised with broken porticoes, parapets and balcony railings. Figure 2 (a) shows the damaged portico in a residence exposed to

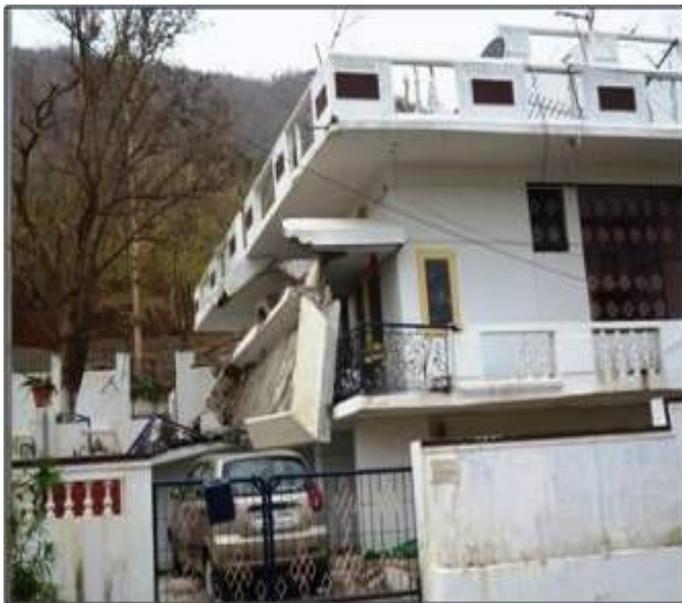
the direct assault of wind at the base of the Kailasha hill. All the other buildings in the wake of this building were unaffected.

Fig 2 (a) Damage to the portico in a residence at the base of Kailashgiri (b) Damage to windows, glass screens and balcony parapets in Arihant Apartments on the Beach Road

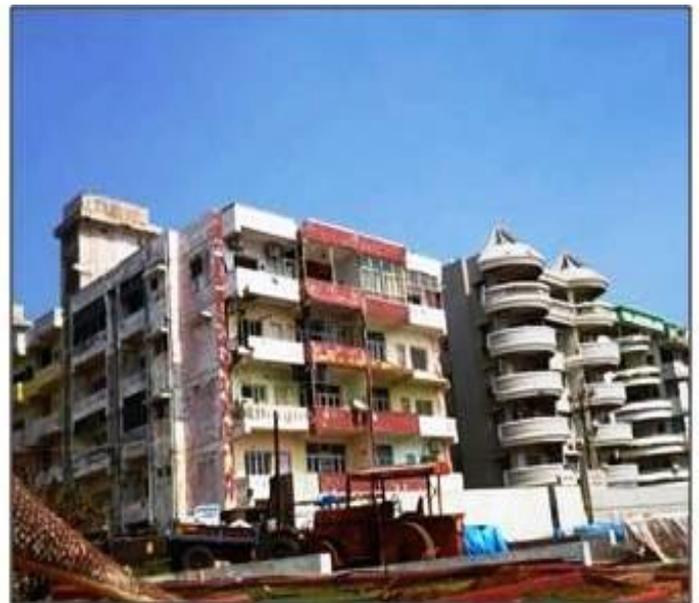
(b)

The facades of several apartments have incurred damage and the compound walls in two apartments have been damaged substantially. Several balconies, parapets of the bluff bodied Arihant Apartments have been damaged by strong winds whereas the streamlined balconies of the adjacent Sunrise Apartments were unaffected 2(b).

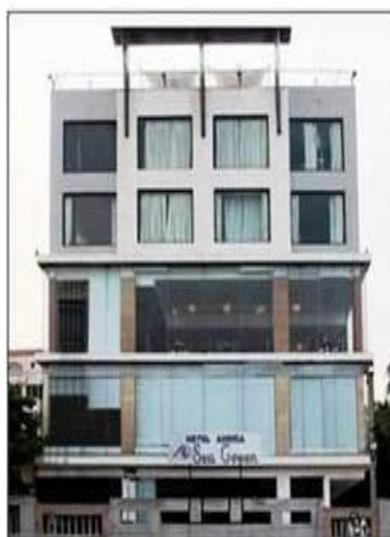
Fig 3 (a) View of the Hotel Ambica Sea Green at Kirlampudi Layout before the cyclone. (b) Shattered glass panels in second and third floor of Ambica Sea Green post Hudhud.(c) Wind damage to glass windows and roof cladding of Vihar restaurant on Rushikonda Hill.

Several hotels and restaurants that have recently sprung up along the Beach Road such as the Novotel Hotel near Ramakrishna Beach and Rushikonda Hill sport large glass facades to capture the sea view. While Novotel Hotel was only slightly affected, Hotel Ambica Sea Green and Vihar restaurant suffered appreciable damage (View of the Hotel Ambica Sea Green is shown in Figure 3(a)). The damaged glass wall panels in the banquet hall and the restaurant in the first and second floors respectively is shown in Figure 3(b). Figure 3(c) gives a view of the damaged roofing sheets and glass panels in the façade of the Vihar restaurant on the Rushikonda hill.

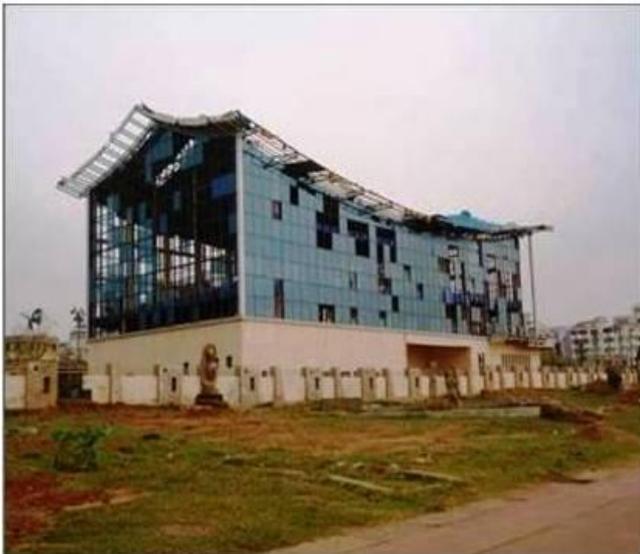
Damage to the glass facades and false ceilings has been observed not only in buildings in the vicinity of the Beach Road but also in many other car showrooms elsewhere in the city. One such building where the entire false ceiling got ripped off is the Visakhapatnam airport. Figure 3(a) shows the damage to the glass walling and roof cladding in the Rajiv Smruti Bhavan, an exhibition hall located along the Beach Road. View of the Indoor Sports stadium in the Gitam University campus showing damage to roof cladding is shown in Figure 3(b)

Fig 3 (a) View of the damaged glass wall panels and roof cladding in the Rajiv Smruti Bhavan, on the Beach Road. (b) Damage to the Indoor sports stadium at Gitam University.

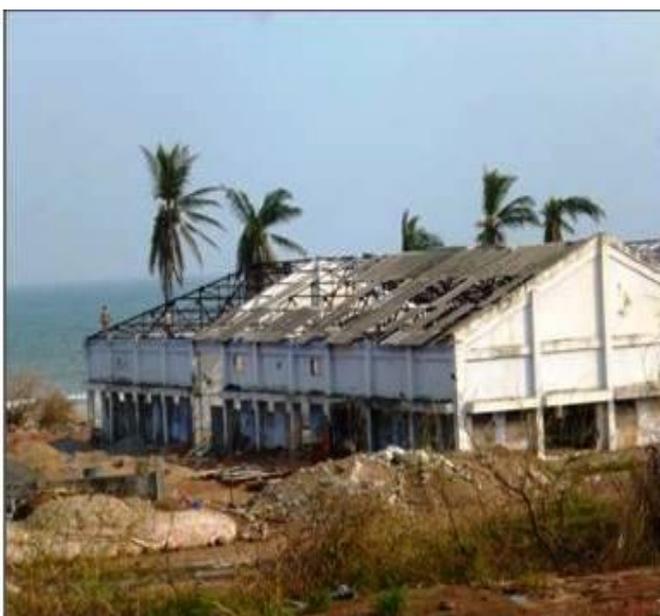
Fig 4 (a) A damaged hatchery building near Thotlakonda. (b) A collapsed water tank in front of a Hatchery building near Thotlakonda.

A large number of hatcheries located along the Beach Road beyond Thotlakonda bore the full impact of the cyclonic winds. Most of the roof cladding materials has been extensively damaged and in some cases the roofs have been completely blown away. Figure 4 (a) shows a hatchery building with damaged roof cladding. Figure 4(b) shows a grounded water tank in front of another hatchery building near Thotlakonda.

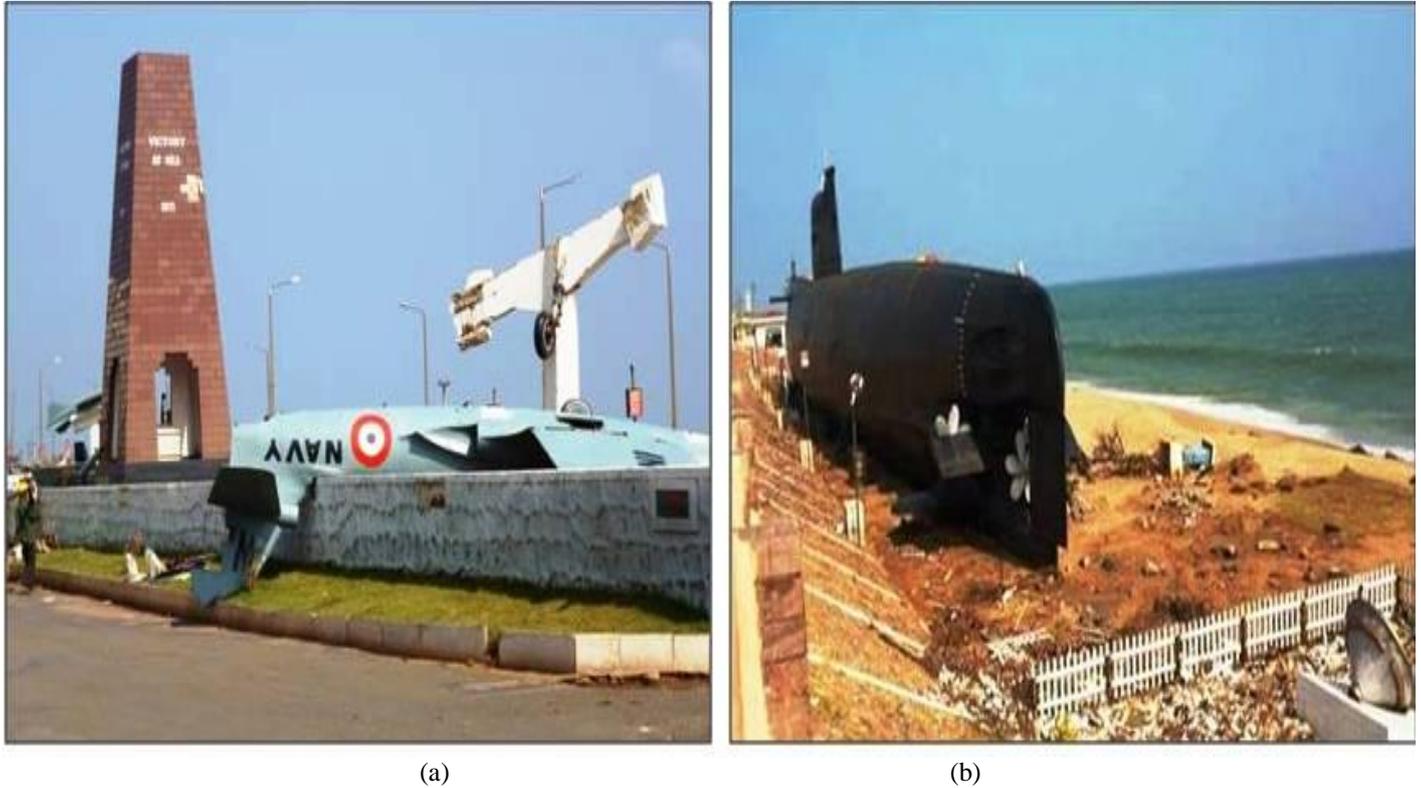
Fig 5 View of a fallen warplane replica in the landmark war memorial park at Kirlampudi Layout. (b) View of the submarine museum Kursura after the cyclone.

In the aftermath of Cyclone Hudhud, erosion is being witnessed all along the coast, including behind Vuda Park, near the Lighthouse at East Point Colony and also along the beach at Bheemunipatnam. According to oceanography experts the beach around Kursura, the only submarine museum in South Asia may experience further erosion. Figure 5(b) shows the damage to the park in front of the submarine museum. Earlier a protection wall and a belt of casurina trees served as a defence for the submarine, which got wiped out by the cyclone. The area in front and behind Kursura is witnessing more erosion. The sea side stretch is now open and has become inaccessible to visitors. The museum is now temporarily closed.

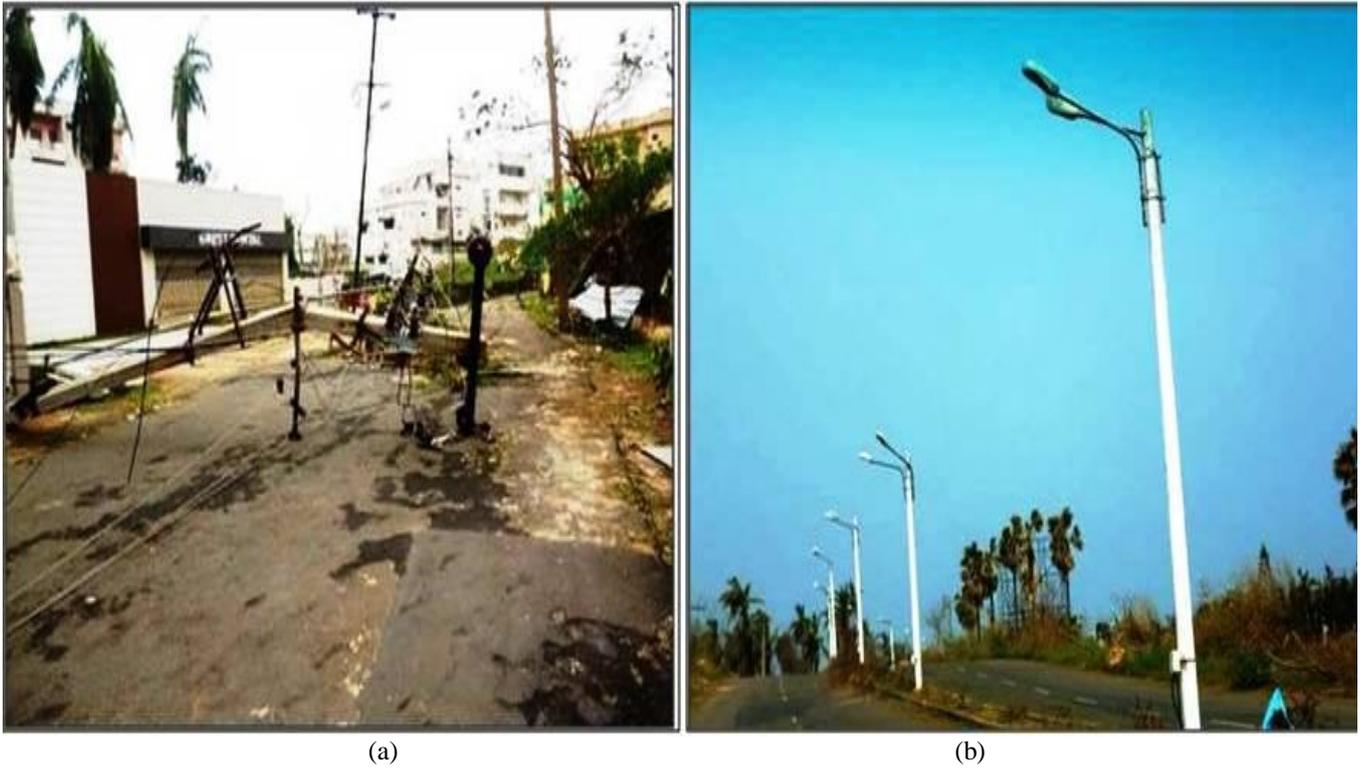
Visakhapatnam. Figure 6(a) shows a fallen electric pole blocking the road in the residential area of Kirlampudi Layout. Figure 6 (b) shows the twisted streetlights on the Beach road beyond Rushikonda. Though the poles remained intact the luminaires on all the poles have been twisted to the other side due to the torque effect exerted by the cyclonic winds. Figure 7(a) shows a damaged pavement along the Beach road near Coastal Battery and 7(b) shows a pavement damaged by an uprooted Terminalia catappa tree at Vuda Park. Views of damaged bus shelters are shown in Figure 8.

Fig 6 (a) Grounded electric poles block the road at Kirlampudi Layout (b) View of the wind twisted street lights along the Beach Road beyond Rushikonda.

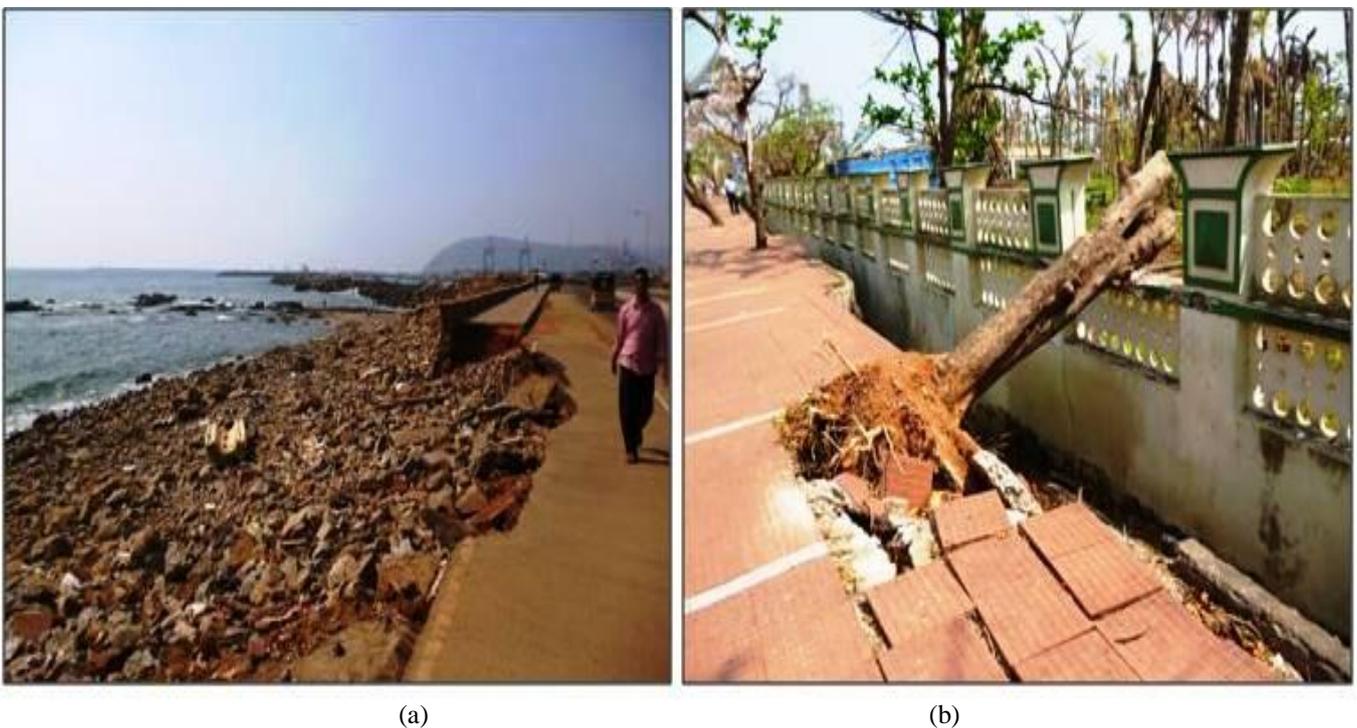
Fig 7 (a) Damaged pavement along the Beach road near Coastal Battery. (b) Pavement damaged by an uprooted Terminalia catappa tree at Vuda Park.

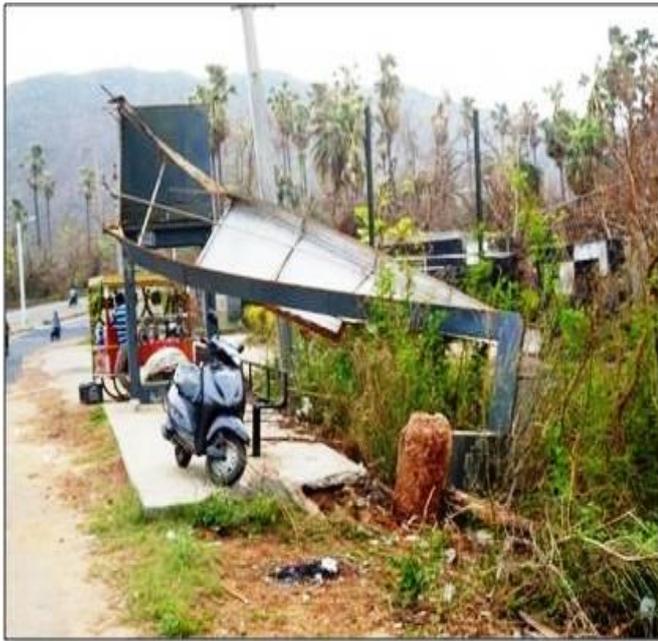
Fig 8 (a) A damaged bus shelter in front of the Indira Gandhi Zoological Park near Rushikonda. (b) A bus shelter with damaged roof and seats opposite Tenneti Park along the Beach Road.

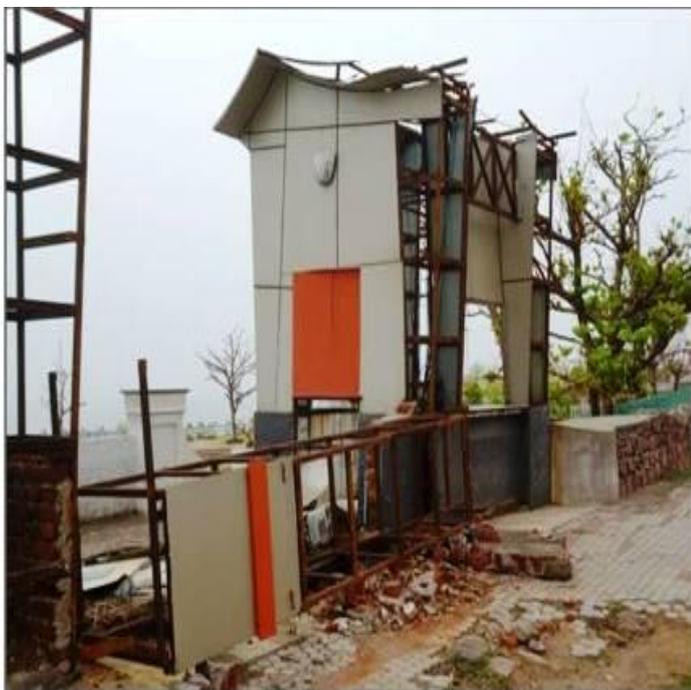
Hardscape elements comprise of the non- living elements in the landscape such as rocks, paving materials, street furniture, lighting fixtures and other utility elements. Damage to the hardscape elements in Tenneti Park, Shivaji Park and a park in Bheemunipatnam are shown Figures 9, 10, and 11 respectively.

Fig 9 (a) A damaged ticketing counter at the entrance of Tenneti Park (b) Damaged amphitheatre in Tenneti Park.

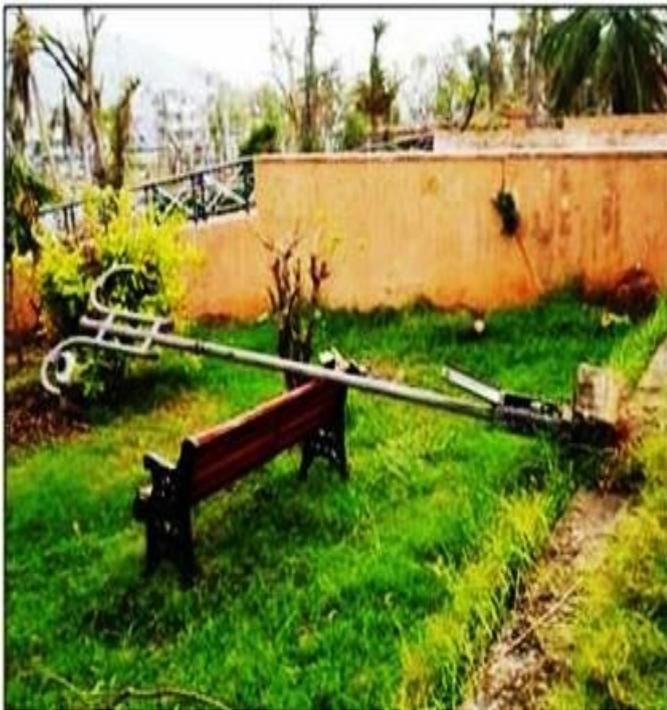
Fig 10 (a) Fallen lamp post in Shivaji Park (b) Damaged bench in Tenneti Park

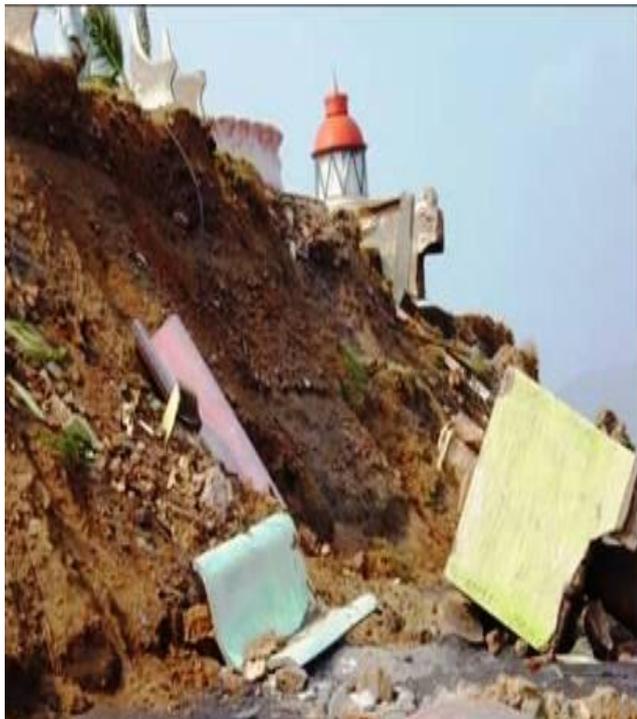
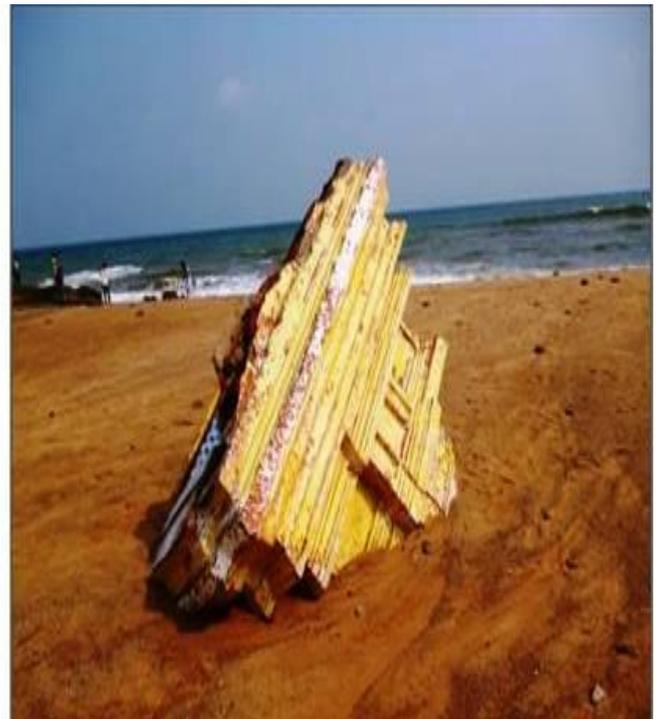
Fig 11 Damaged hardscape elements in a park at Bheemunipatnam.

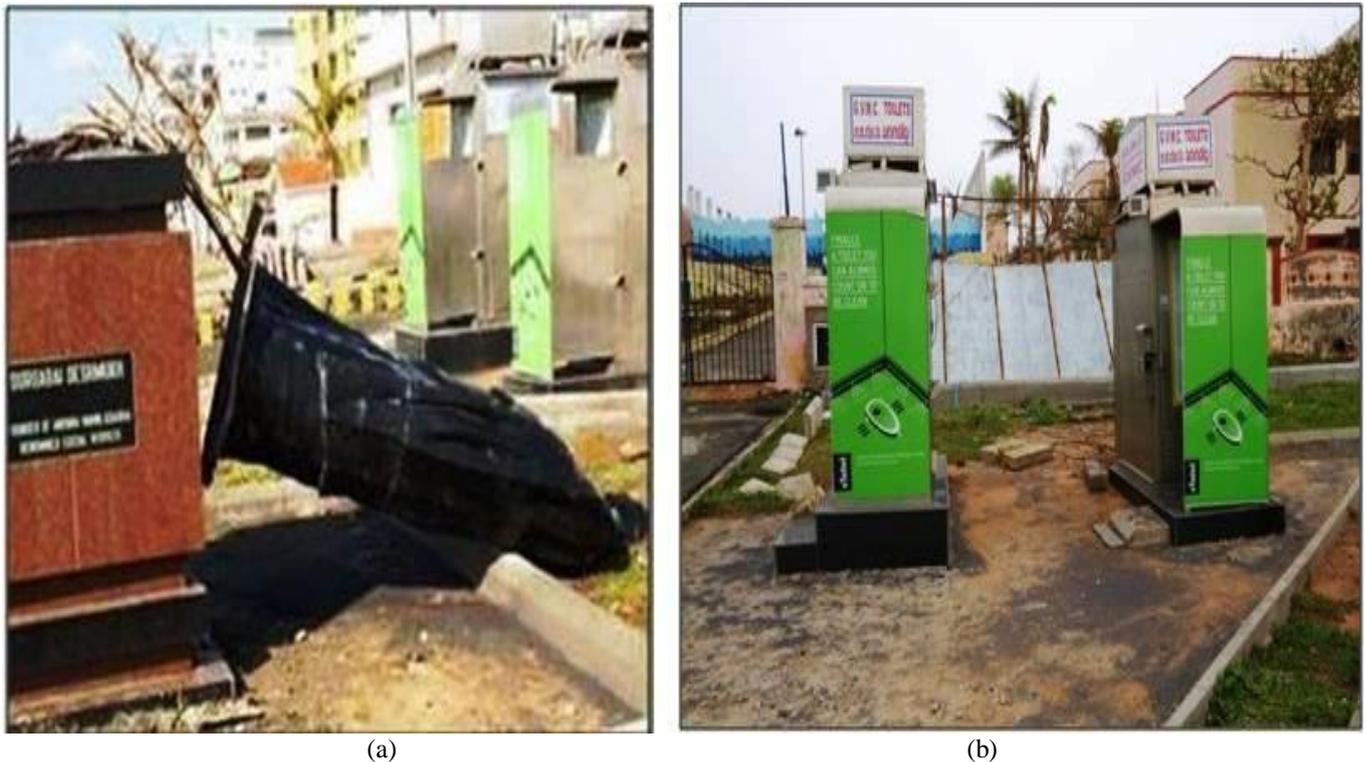
Fig 12 (a) View of a statue that fell on the Beach Road. (b) View of two E-toilets on the beach road adjacent to the fallen statue, that stood up to the fury of the cyclone.

A view of a collapsed statue along the Beach Road is seen in Figure 10 (a). Figure (b) shows two E-toilets set up as public conveniences by the Greater Visakhapatnam Municipal Corporation and designed to withstand extreme winds. These toilets, designed by a Kerala based company stood up to the fury of the cyclone without getting damaged, while the hoardings in the rear of the toilets collapsed. Made of steel these toilets have been designed to provide pre-flushing prior to entry and sensors for water. Several such toilets are proposed to be set up in the Vuda Park.

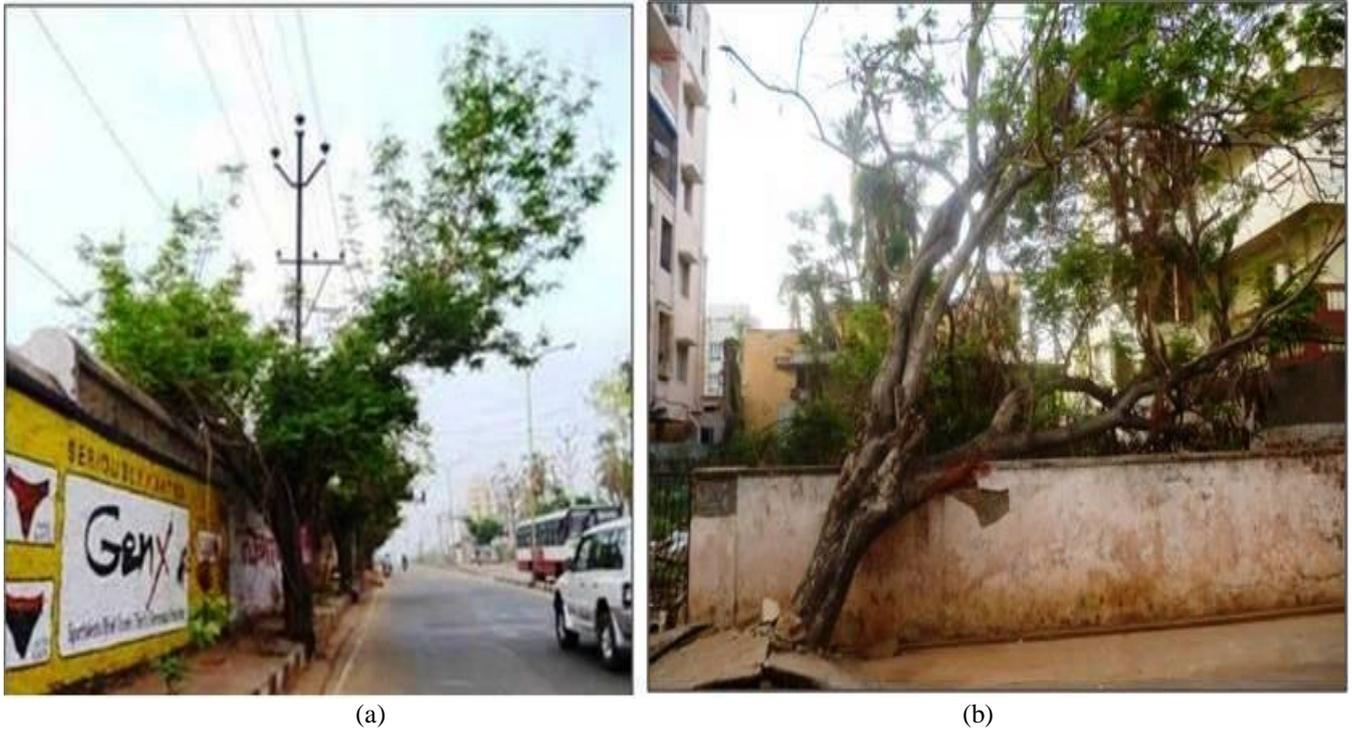
lines. Removal of the central part of the canopy or one side of the canopy damages the tree structure, affecting its structure and stability, making it vulnerable to storm damage. Figure 13. (a) shows an indiscriminately pruned roadside *Peltophorum* tree and Figure 13.(b) shows a collapsed *Peltophorum* tree striking the compound wall of a residence in Lawson's Bay colony.

Fig 13 (a) A roadside Peltophorum tree indiscriminately pruned to prevent damage to power lines. (b) A leaning Peltophorum tree in Lawson's Bay colony.

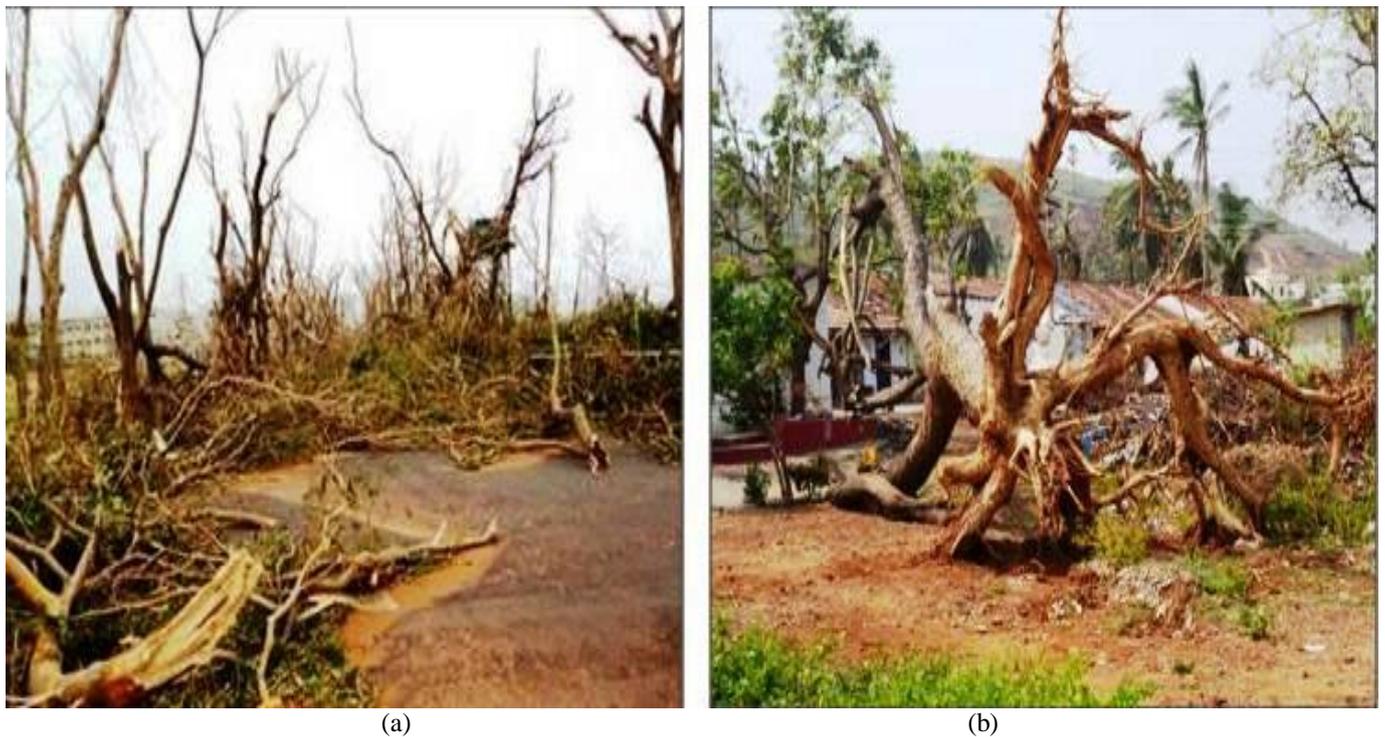
Many massive *Eucalyptus*, *Peltophorum* and *Ficus religiosa* trees have been uprooted in the Andhra University campus. Several mature uprooted *Eucalyptus* trees have fallen on top of buildings and in some cases even crushing them (Figure 14(a). Extensive damage has also occurred to the green cover at the Gitam University campus in Visakhapatnam. Figure14 (b) shows salt spray damage to the *Callophyllum ionophyllum* trees (left) and the *Tecoma castinifolia* and *Azadrachta indica* (Neem) trees (right) in the Gitam University Campus at Visakhapatnam.

Fig 14 (a) Damaged Peltophorum trees in the Gitam University campus. (b) An uprooted Peltophorum tree in a village near Bheemunipatnam.

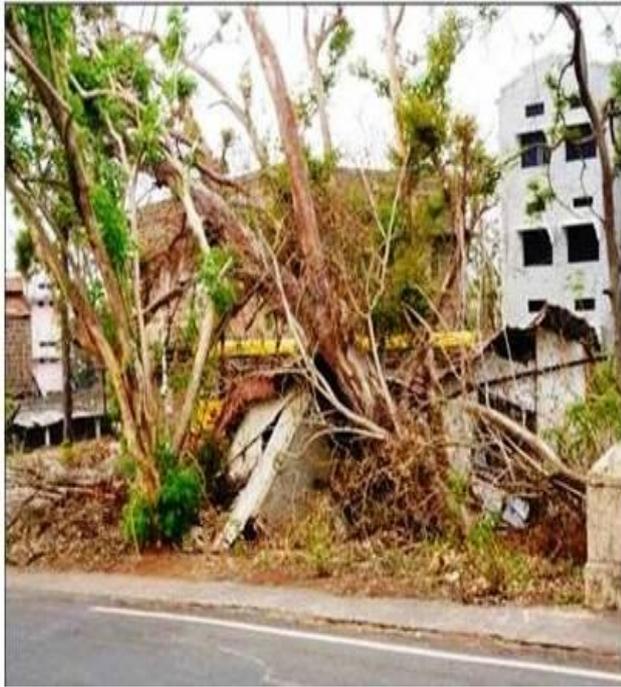
Fig 15 (a) A building crushed by uprooted Eucalyptus trees in front of the Advances Sciences Bhawan in the Andhra University campus (b) Salt spray damage to trees in the Gitam University campus.
