REVIEW STUDY ON PERFORMANCE OF SEISMICALLY TESTED REPAIRED SHEAR WALLS

Abstract

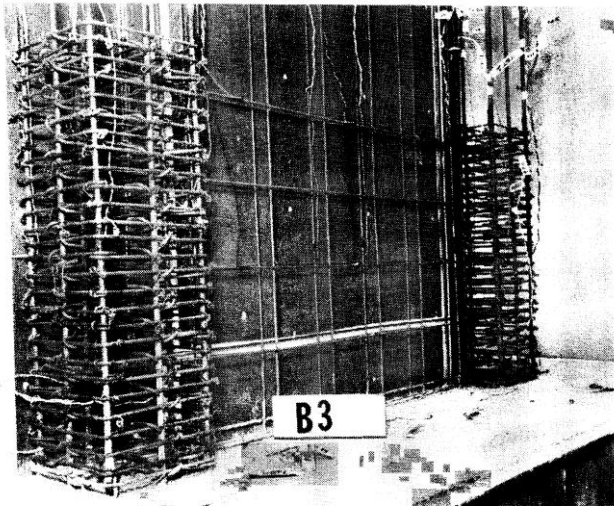
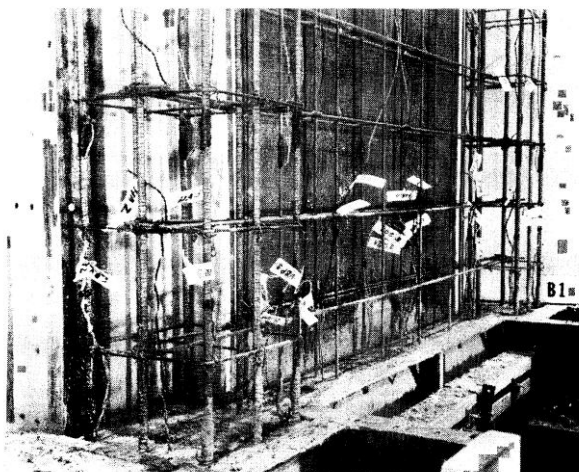
Ordinary column tie reinforcement

Special transverse reinforcement

Fig. 1. Confinement reinforcement in boundary wall provided (Oesterle et al. 1980)

Oesterle et al. (1980) highlighted the importance of transverse reinforcement and also the anchorage of wall reinforcement into the boundary elements. The dimensions of hoop and spacing serve four primary functions: i) lateral confinement to increase limiting strain capacity of concrete core. ii) support vertical reinforcement in resisting inelastic buckling. iii) retain concrete within the core along with vertical bars iv) improves shear capacity and stiffness for dowel action of boundary elements. Four isolated RC walls with one-third scale factor were cast and tested under seismic loading. The wall with normal column tie spacing failed due to inelastic buckling of vertical reinforcement. The wall with special transverse reinforcement exhibited sufficient shear capacity for the formation of hinge at the

base of boundary element. The anchorage of wall horizontal reinforcement plays an important role in the formation of horizontal cracks in the tension boundary element which subsequently propagated into web as diagonal crack. The horizontal web reinforcement need to be extended across the boundary element and terminated with standard 90° bend for low shear walls and 135° hook for high shear walls.

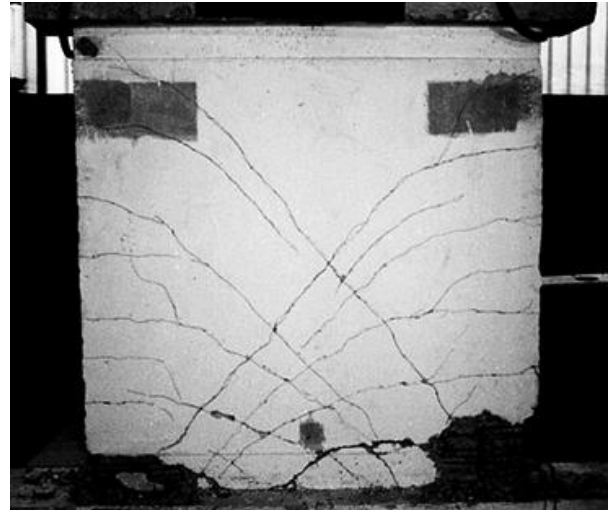
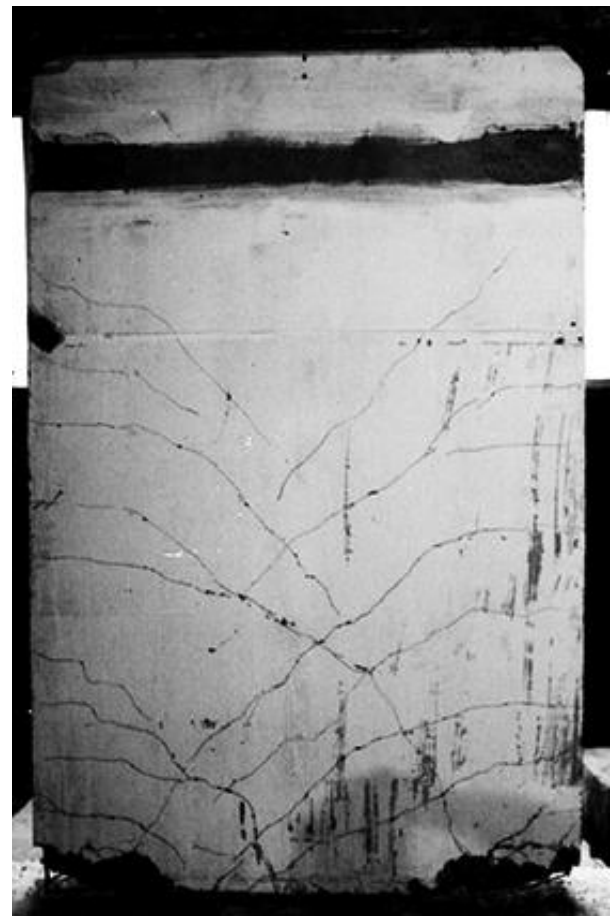
Aspect ratio 1.5

Fig.2. Failure pattern in RC wall with lateral and axial load (Salonikios et al. 1999).

Salonikios et al. (1999) tested eleven reinforced concrete walls designed according to Eurocode 8. The code provides different design equations for diagonal tension, diagonal compression and sliding shear modes of failure. The aspect ratios of the walls coincide with the shear ratio $a_s = M/Vl_w$ since they are cantilever shear walls. Five walls have the aspect ratio of 1.0 and six with 1.5. The test parameters are aspect ratio, use of bidiagonal bars with and without distance at the intersection point at base, web reinforcement ratio, longitudinal reinforcement ratio, with and without axial loading, and presence of construction joints in one specimen with aspect ratio of 1.5. The walls were tested under three loading cycles at each ductility level. The walls

failed predominantly in flexure mode, with intersection of flexural cracks originating from opposite edges. Concrete crushing and reinforcement buckling at the confined edges was observed. Pinching of hysteresis loop was observed in walls without diagonal bars due to horizontal sliding and bond-slip of vertical reinforcement. Sliding was controlled in walls with bidiagonal bars.

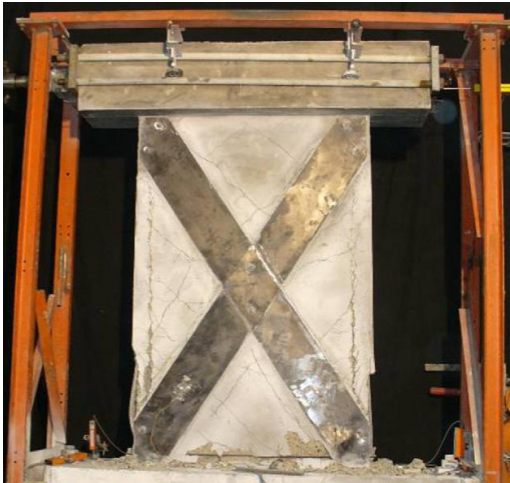
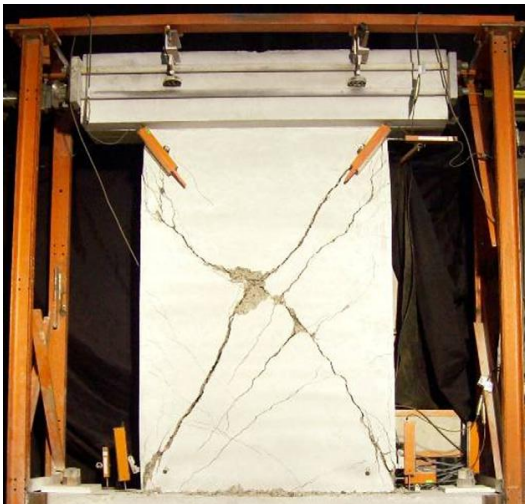
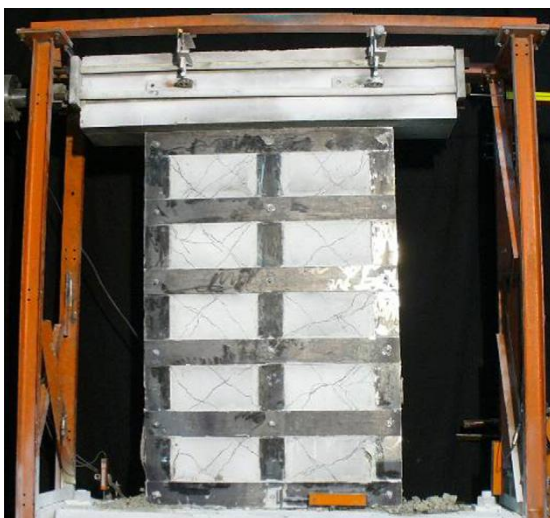
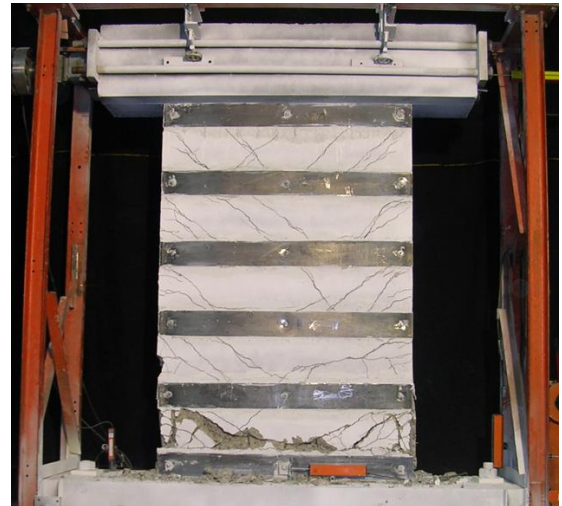
Control specimen

Diagonal steel strips

Lateral steel strips

combination of lateral and vertical steel strips

Fig. 3. Control and strengthened specimens with steel strips (Altin et al. 2013)

Elnashai et al. (1998) brought out selective techniques for repairing damaged walls. Use of external bonded steel plates was recommended for increasing the stiffness without altering the strength. The plates were bonded to the wall with epoxy mortars. The addition of external unbonded reinforcement bars increased the strength without affecting stiffness of the walls. Ductility can be increased by adding U-shaped external confinement steel plates. The shear strength can be enhanced by providing steel plates in horizontal bands. Strengthening of RC structural members with externally bonding steel strips is an effective technique for improving the seismic resistance. Considerable research has been performed on columns and beams, low masonry walls to increase the shear capacity of these members. **Altin et al. (2013)** extended this technique to RC walls subjected to earthquake loading. Four walls deficient in shear strength were cast; one controlled wall and three were strengthened with steel strips. A scale factor of 2 and a slenderness ratio (the ratio of length-to-width) of 1.5 was used. A head beam for transfer of lateral load and a foundation for anchoring the walls to the floor are cast integrally with the wall panel (shear wall). The wall was provided with 6mm diameter horizontal and vertical reinforcement in two layers and a concentrated vertical reinforcement of 16mm at end regions. Concrete of 18MPa compressive strength was used. The three walls vary in the alignment of steel strips such as diagonal, lateral and a combination of lateral and vertical. Steel strips were bonded to the walls after 28 days of curing and then walls were tested after 15 days. All the walls were

subjected to lateral load. Application of epoxy adhesive to surface of the wall and insertion of anchor rods prevented debonding of steel strips and delayed premature buckling of steel strips.

The reference walls failed in diagonal tension shear. Such failure was prevented in strengthened walls due to shear strength of bonded steel strips. The maximum base shear was controlled by flexure. The anchors enabled in limiting the opening of shear cracks thereby increasing the lateral load, drift energy dissipation capacities of the strengthened walls. Shear sliding displacements were observed once the strengthened walls attained their flexural capacities. The strengthened walls exhibited 65% higher ultimate strength, improved initial stiffness and ductility than the controlled walls.

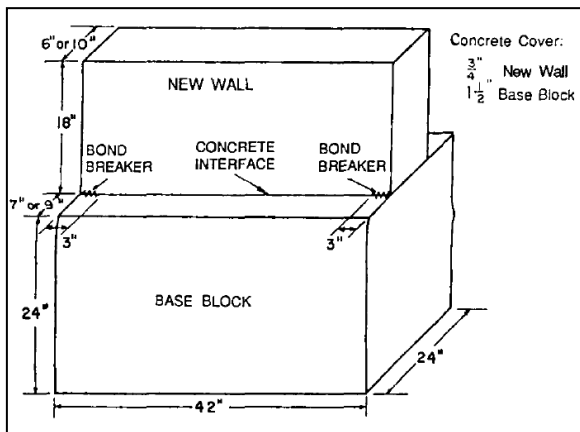
Fig. 4. Typical push-off specimen (Bass et al. 1989)

Concrete jacketing is one of the measures to be used in seismic strengthening where new concrete is cast against an existing surface. The two materials vary in age and hence it is necessary to study the shear transfer capacity at the interface. **Bass et al. (1989)** tested thirty-three push off specimens to determine shear force at the interface. The specimen consists of column referred as "base block" and the infill wall constructed above the base block referred as "new wall". Specimens were cast in vertical, horizontal overhead positions. Different interface characteristics were adopted, which include; untreated, heavily sand blasted, chipped to achieve surface roughness, provided with shear key and coated with epoxy agent before pouring new concrete. It has been concluded that increase in embedment depth, amount of reinforcement, and use of deep surface preparation techniques at the interface results in high shear strength at higher slip levels.

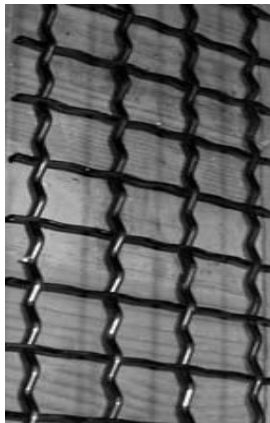
Fig. 5. High Strength steel mesh used in specimens (Marini et al. 2008)

Marini et al. (2008) assessed the effectiveness of seismic strengthening of RC shear walls with thin high performance jackets. One-third scaled shear walls were designed only for gravity load, strengthened with high performance jackets and tested under cyclic loading. High performance jacket includes a steel mesh with tensile strength of 1200MPa covered with a thin layer of concrete of compressive strength greater than 140MPa. The steel mesh consisted of bent weaved wires of 2mm diameter and 20mm spacing. A uniform crack pattern with limited opening extended from the wall base to the critical zone of failure. The failure was governed by bending moment upto collapse. The failure of strengthening walls occurred due to crushing of concrete jacket at the base, exhibiting high ultimate strength, structure deformation capacity and ductility.

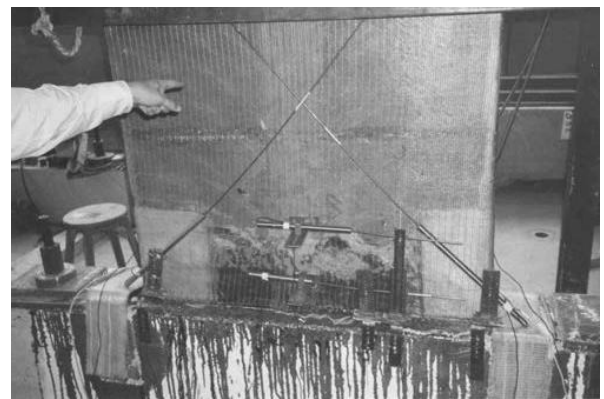
Fig. 6. Failure pattern in FRP strengthened wall (Antoniades et al. 2003)

Antoniades et al. (2003) retrofitted squat RC shear walls with FRP jackets in combination with FRP strips in order to increase the strength of heavily damaged during earthquake. The original walls were designed according to Eurocode 8 provisions. The spacing of web reinforcement and arrangement of bidiagonal reinforcement were varied. One wall was repaired conventionally by replacing damaged concrete with non shrink mortar, and welding of fractured reinforcement. Remaining damaged walls were strengthened with FRP. Repaired wall could achieve original strength but showed less initial stiffness and energy dissipation capacity when compared to original wall. The hysteresis behaviour and initial stiffness of FRP strengthened wall was more than the conventionally repaired wall but less than that of the original wall. The propagation of existing shear cracks was prevented by FRP jackets.

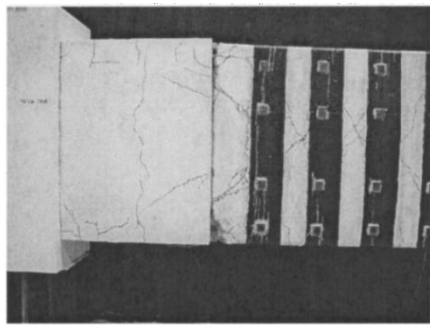
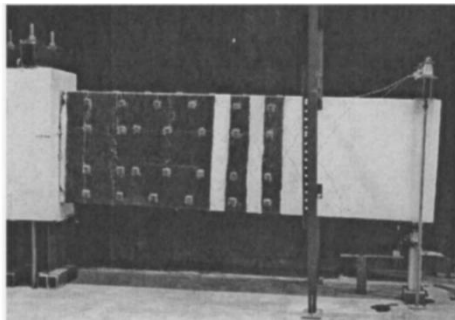
Wall with reinforced collar and CFRP

Wall with headed reinforcement and CFRP

Fig.7. Failure pattern in strengthened walls by Paterson et al. (2003)

Paterson et al. (2003) performed tests on strengthened RC shear walls with poor detailing. The detailing deficiencies include lap splicing of the longitudinal reinforcement in the plastic hinge region, poor confinement of boundary elements and anchorage of transverse reinforcement, and insufficient shear strength to develop hinging. The walls cantilevering from a heavily reinforced foundation block were anchored to the strong floor and tested in horizontal position. The first control specimen was provided with lap splice at the base and failed due to failure of lap splice. The lap splice was provided in the region of flexural hinging in the second control wall and it exhibited more ductile capacity than the first control wall. One wall was retrofitted with provision of reinforced collar and wrapping it with carbon fibre to increase the shear strength. Another wall was retrofitted with additional confinement reinforcement over the lap splice region along with headed bars and CFRP wrapping. The retrofitted walls exhibited good displacement ductility, energy absorption and flexural hinging. The combination of headed reinforcement with CFRP reduced the shear distress and was effective in confining the boundary elements.

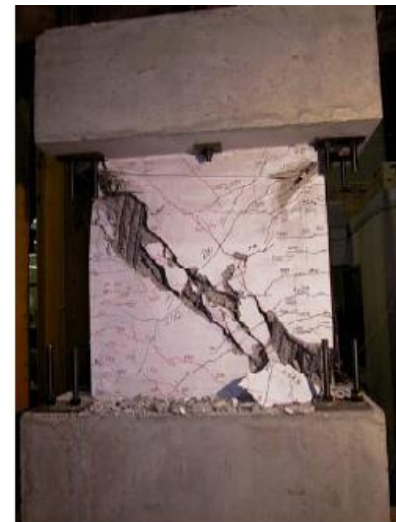
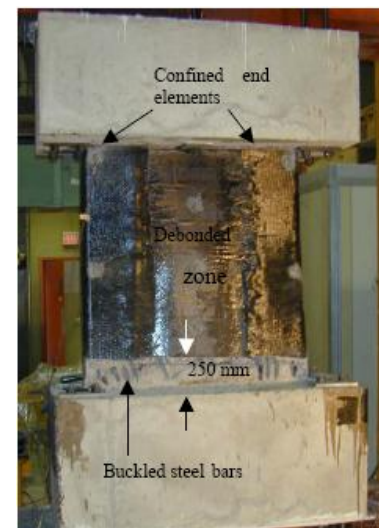
Control wall

Rehabilitated wall

Fig. 8. Failure mode in walls (Ghobarah et al. 2004)

Ghobarah et al. (2004) rehabilitated RC walls with fibre composites to enhance the wall capacity to earthquake loads and also ductility. Three walls were tested; control wall, upgraded with bi-directional fibre-reinforced sheets and bidirectional sheets anchored with additional steel bolts. The control wall was deficient in shear and ductility. The rehabilitated walls were wrapped with bi-directional sheets in the wall region and uni-directional sheets on the boundary elements. The boundary elements were also provided with FRP anchors in the upgraded walls. The control wall developed tension cracks at the bottom and midheight of the wall. Diagonal cracks were formed in both the directions increased in size leading to complete shear and sudden failure of the wall. Crushing of concrete was observed at the toe of the wall on the compression side and the vertical steel in the boundary elements buckled. The horizontal bars yielded and the tensile strains were recorded both in pushing and pulling direction. In the first rehabilitated wall delamination of CFRP sheets occurred at ductility level 1.5 in the wall region but they were intact in the boundary elements. FRP anchors failed at the bottom region of the wall and as a result concrete crushing and buckling of steel lead to failure of the specimen. In the second rehabilitated wall debonding of CFRP sheets was controlled by the steel anchors which resulted in less reduction in stiffness and more energy dissipation capacity. The rehabilitated walls recorded more strain in concrete, less strain in horizontal bars, higher displacement ductility than the control wall. The alignment of fibres at 45 degrees prevented shear mode of failure. FRP anchors failed in shear but steel anchors failed due to yielding. The confinement of the boundary elements with CFRP sheets delayed concrete crushing and also enabled in developing full tension in longitudinal bars.
