# ASSESSMENT, ANALYSIS AND STUDY OF ENCROACHMENTS AND CHANGE IN NATURAL WATER FLOW IN INTERIORS OF WORLD FAMOUS DAL LAKE DURING 2003 -2015.

<sup>1</sup>Student, Department of Civil Engineering, DIT University, Dehradun, Uttarakhand, India

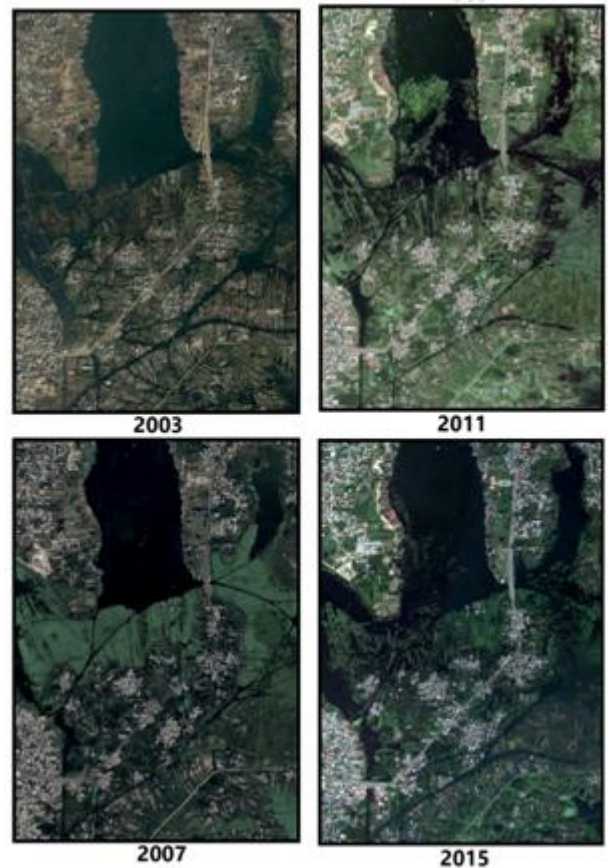
Fig-6: ZONE- C - Lake degradation comparison

This zone is the worst encroached region of the lake and parts of this region are no longer considered as lake area due to high influence of inhabitants for socio-political reasons that are adamant and claim property rights to the land which actually forms part of Lake Interior on north-west side. Roads have been constructed connecting to schools and colonies developed locally and illegally. This region separates the Nagin (or Nigeen) with main Lake. While the water depth and quality of Nagin is remarkable due to many underwater springs still present; water quality of adjoining Dal is pathetic and largely neglected by lake conservation authorities. Floating markets, guest houses, slums etc. have been developed in this region which is having devastating effect on lake ecology of lake. This region also comprises of many old floating gardens that exist even today and are a major source of fresh vegetables. However, most of the erstwhile gardens have been converted into plots by practicing earth filling and wastage dumping followed by construction of buildings.

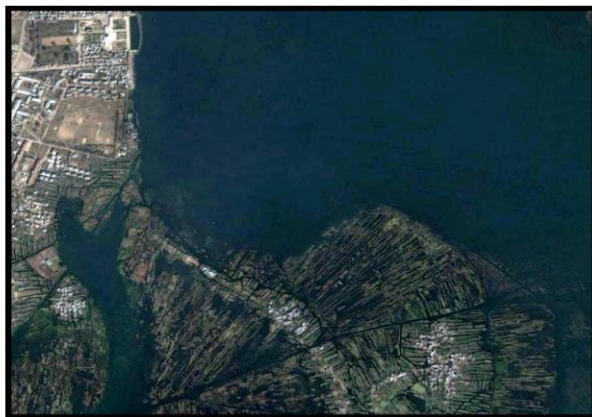
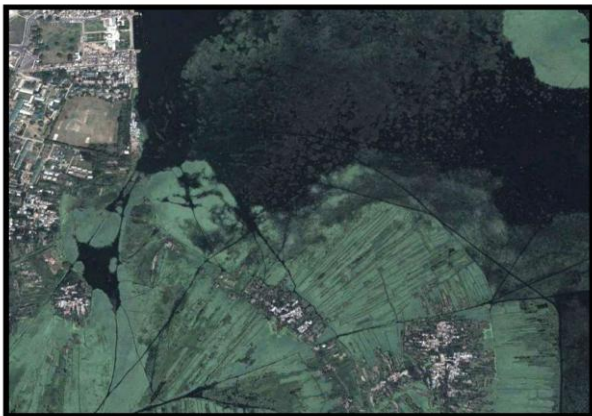
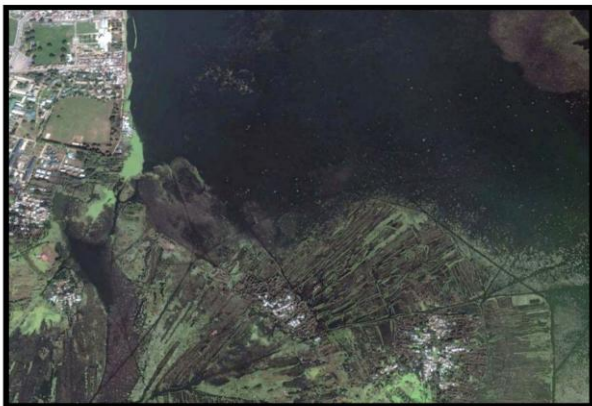
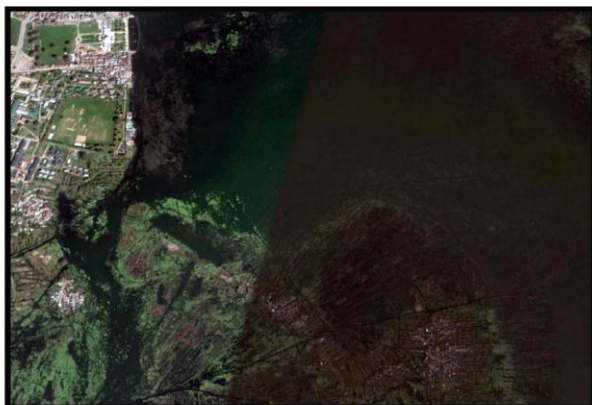
Fig-8: ZONE- D - Lake degradation comparison

This is the most vulnerable region present in Dal Lake with very small scale encroachments at present from the left end only. This zone is currently being preserved by authorities to its full capability. Though there have been some changes on southern side but nature of such changes is largely negligible. Figure 8 can be referred further to understand the nature of lake in this zone. This zone can thus be considered as best region at the moment existing in lake in terms of water parameters (compared to other zones) and tourism related activities. This is importantly that part of lake which is noticeable from the Srinagar Boulevard.

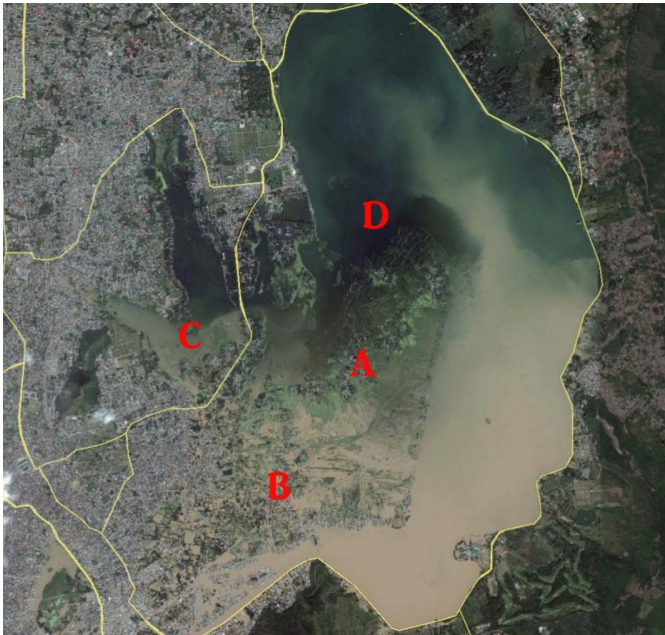
Fig-10: Floods- 6<sup>th</sup> September 2014 (DAL LAKE)

Srinagar city witnessed worst flood in hundred years on 6th September 2014. More than half of capital city of Srinagar was inundated for weeks as most of the rivers and lakes of Kashmir valley were overflowing due to continuous rains and few cloud bursts in hilly areas. The flood data of Dal Lake collected explains complete stagnation in free flow of water in lake due to human interference and uncontrolled exploitation. As explained by Figure 10 Zone A & B have been completely submerged by flood waters while some portions of Zone C and almost no part of Zone D has been effected. The interior flow of water is thus at present expected to be largely inhibited by uncontrolled land filling and unplanned urbanization in lake interior. Due to this immobility of water movement inside the lake famous road along Zone A & B remained completely submerged for nearly one week due to flood waters which continued to remain stagnant and had to be ultimately pumped out manually.
