STIFFNESS DEGRADATION BEHAVIOR OF RETROFITTED RC INFILLED FRAME UNDER CYCLIC LOADING

The present study was to evaluate the load carrying capacity of retrofitted 3-bay 4-storey brick infill R.C frame using Ferro cement under cyclic loading. Generally bricks will not be considered as a structural element, but by an effective strengthening technique infill walls and RC frame elements can be kept together and forcing them to work as a whole until the end of the ground motion. The effectiveness of the retrofitted frame under cyclic load was investigated in terms of displacement, stiffness and load carrying capacity.

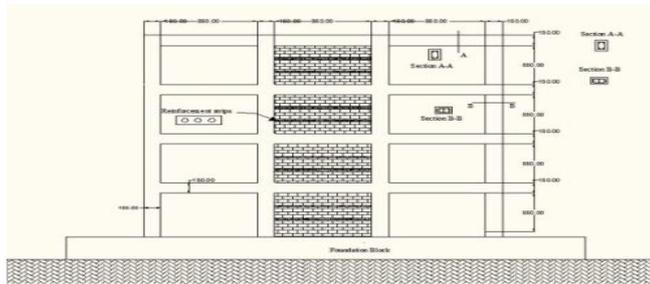
The cross section of the beam and column in the frame is taken as 150x100 mm.

Frame along X axis	: 3m
Frame along Y axis	: 2.8m
No of storey	: 4

Height of each storey : 0.7m
 No of bays : 3
 Width of each bay : 1m
 Mix ratio : 1:1.7:2.72

Figure- 1: Schematic diagram of Frame

The schematic diagram of frame was shown in Fig.1.

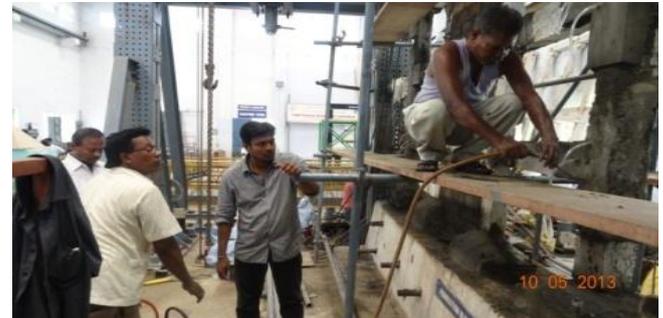
Figure- 2: Grouting of retrofitted frame

The performance of grouting depended on the mechanical, physical, and chemical properties of the mix and its interactions with the frame to be retrofitted. In this study, expansive cement and epoxy resin were mixed and injected for minor cracks of less than 2 mm [Fig 2].

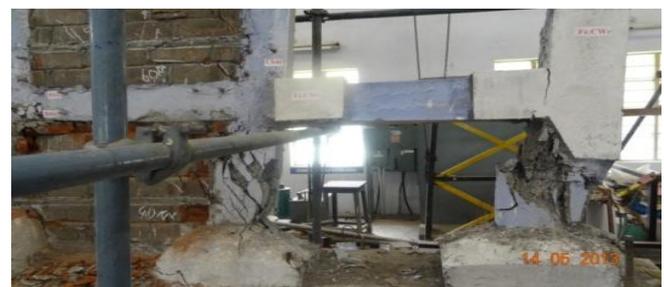
The retrofitted frame was tested in the loading frame under cyclic load. Cyclic loading was applied on the frame with the help of load cells till the frame got failed. For each loading the readings were noted in LVDTs and dial gauges and strain readings were also taken on both concrete and steel. Concrete strains were noted till the initial failure of concrete and steel strains were noted for the zero reading and up to ultimate load. The failure of the retrofitted frame was shown in fig 3.

Figure- 3: Failure of retrofitted frame

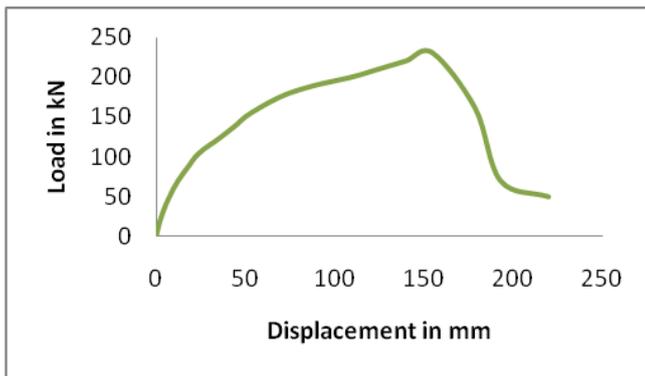
The load – displacement behavior of the frame was as shown in fig 4. It was observed that until 180kN the displacement was proportional and increased to 155mm at the collapse load of 230kN. Attempt of three post cycle was possible and at the end of 230mm displacement, load was 50kN and the structure did not regain any displacement. This showed that the retrofitted frame was having good ductility property. Further more because of the proper interfacing, the spalling of infill did not occur and hence the adverse effect of infill was nullified. The load Vs deflection curve was shown in fig 4.

Figure- 4: Load vs Displacement

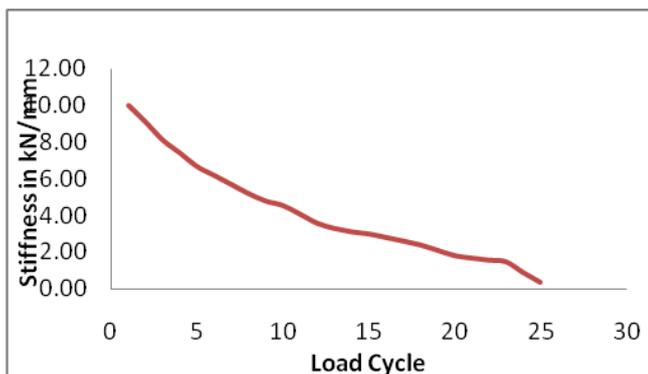
The stiffness degradation at the initial stage was steep and after 18th cycle, the stiffness degradation was gradual. It was attributed to the transfer of load to frame and the RC strip after the bond failure in brick layers and yielding of reinforcement. The stiffness Vs load cycle curve was shown in fig 5.

Figure- 8: Load Cycle vs Stiffness
