# SEISMIC BEHAVIOUR OF BEAM-COLUMN SUB-ASSEMBLAGES DESIGNED FOR TWO LEVELS OF GRAVITY LOADS

An exterior joint of a typical three storied three bay reinforced concrete (RC) Framed building is considered for the study. The frame is designed for the combination of dead load and live loads. Depending on the load level, there is a possibility of providing either singly reinforced (SP1) or doubly reinforced (SP1-D) section for beams at the joint. For gravity load designed specimens which require singly reinforced section for beams, bottom reinforcement bars are curtailed as required. For higher gravity designed specimens which require doubly reinforced section for beam, bottom reinforcement bars are to be provided with required anchorage beyond the face of the column. The beam-column sub-assemblages designed for two levels (normal and higher) are subjected to seismic type of loading and load-displacement hysteresis, energy dissipation, strength and stiffness degradation of the specimens are compared. The cumulative energy dissipation of specimen SP1-D is 37% higher than that of SP1. The specimens SP1-D and SP1 have shown almost same level of stiffness degradation in negative cycles. In

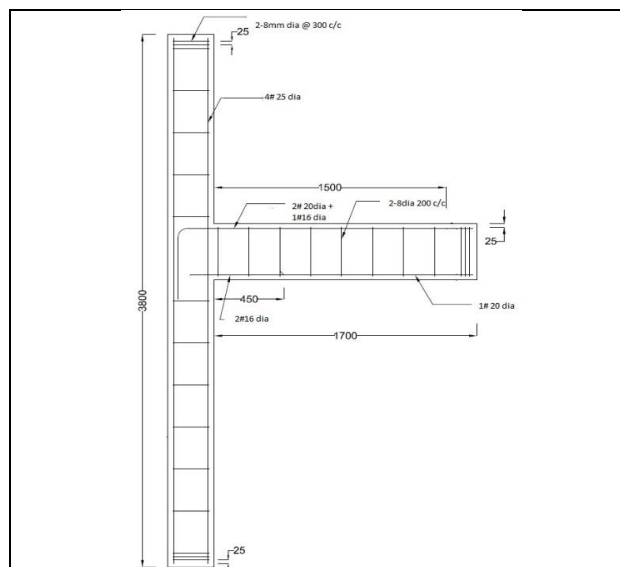
**Fig 1.** Details of gravity load specimen (SP1)

A typical three storied RC Framed building with 6m span and 3.5m each floor height is taken up for the study. A 3D model of the building is created using standard software package. The support conditions are assigned as fixed at the bottom of the column. The linear elastic analysis is performed. An exterior joint without transverse beams of a typical three storied RC is chosen for investigation. Beams and columns are designed for the combination of dead load and live loads but the higher load demands are considered for higher gravity load designed specimens. For gravity load designed specimens beam bottom bars project straight into the joint region and for higher gravity designed specimens beam bottom bars are provided with compression anchorages. The cross section dimensions of 300mmx400mm and 300mmx300mm are adopted for beam and column respectively for all the specimens and the reinforcement details of the specimen are as shown Figs 1 and 2. The general dimensions of beam-column sub-assemblage are as follows: height of column is 3800mm and length of beam is 1700 mm.

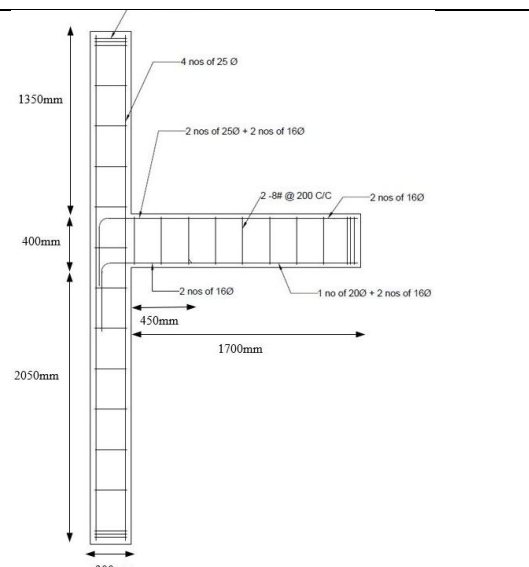
**Fig 2.** Details of higher gravity load specimen (SP1-D)

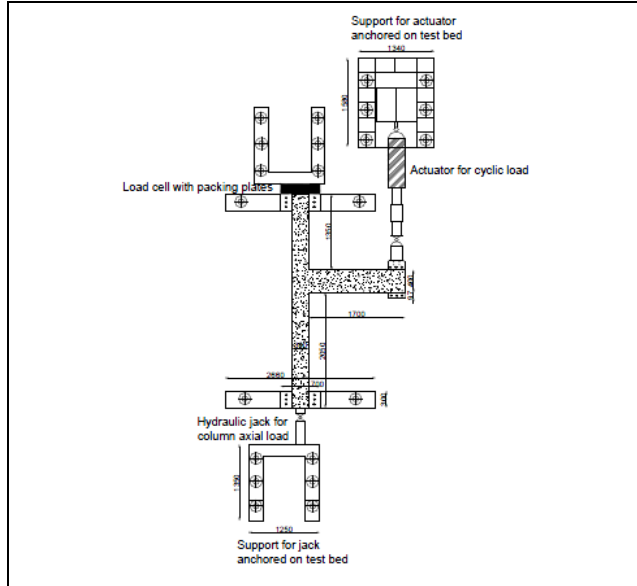
**Fig 3a** Schematic test setup

The test setup is arranged on the test floor so that the beam-column joint is positioned horizontally parallel to the floor and the cyclic load is applied in the plane of the test floor. The schematic diagram of test set-up and positioning of test specimen is shown in Fig.3. An axial load of 300kN is applied to the column by hydraulic jack at one end of the column against the reaction block at the other end. The level of axial load in column was arrived by analysis of the global system of the three storey four bay building. The lateral load

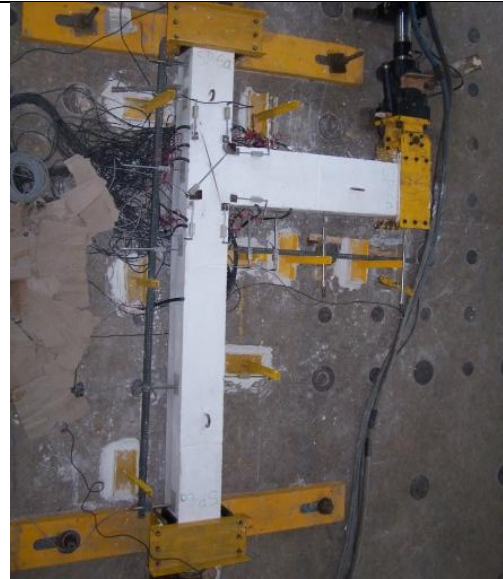
**Fig 3b** Actual test setup

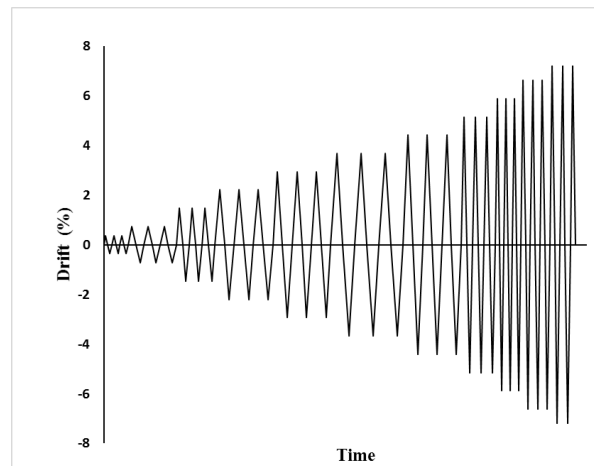
**Figure 4.** Reverse cyclic loading history

was applied on the beam tip in displacement control mode using 25t actuator, according to the load history shown in Fig. 4. Reverse cyclic load is applied in terms of drift ratio (%) of the component where the drift is calculated as per equation (1).

Where,  $\Delta l$  and  $l_b$  are the applied displacement at the beam tip and the length of the beam from column face to the application point of the displacement respectively. Three complete cycles are applied for each drift ratio. Reverse cyclic displacements of equal magnitude are applied on all the specimens, where positive drift produces tension in the beam bottom and negative drift produces tension in beam top. The test was stopped when the load dropped either in the positive or negative drift ratio by 50% of that maximum load.

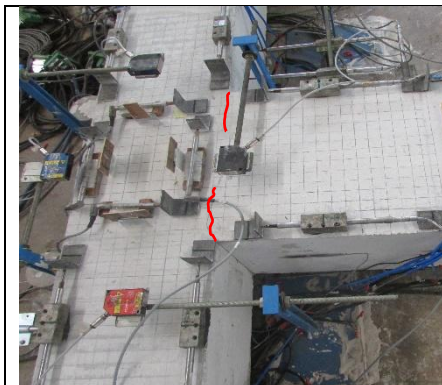
**Fig 5a** Flexural crack at 0.367% drift ratio-SP1

Reverse cyclic displacements of equal magnitude are applied on all the specimens, where positive drift produces tension in the beam bottom and negative drift produces tension in beam top. During first cycle of  $\pm 0.367\%$  drift ratio in SP1, flexural cracks appeared at face of joint in the beam bottom and beam top as soon as tensile stresses exceeded cracking stresses in specimen SP1 as shown in Fig 5a. With further increase in drift, the flexural cracks spread along the length of the beam at both positive and negative cycles. At drift ratio of  $\pm 1.47\%$ , joint shear cracks appeared along both diagonals of the joint. At drift ratio of  $+1.47\%$ , a prominent crack appeared at the joint face propagated to the complete depth of beam with a crack width of 3mm due to loss of bond between bottom reinforcement and concrete which is evident from the drop in strain of the bottom reinforcement. Upon further drift increment, the crack at joint face widened during positive cycles, at a drift ratio of 2.94% the crack width measured is 3mm. The joint shear cracks along the diagonal connecting beam bottom and column outer got widened and propagated into the column D-region of the column during the negative cycles. The joint shear cracks developed and propagated during negative cycle rather than positive cycle as shown in Fig 5b.

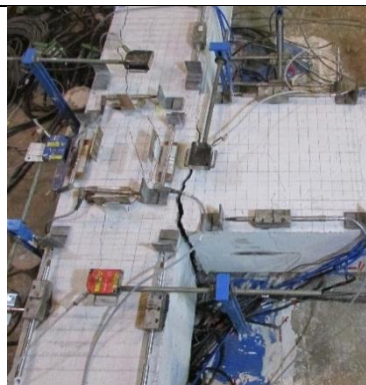
**Fig 5b** Crack pattern at +2.94%(left) and -2.94%(right) drift ratio –SP1

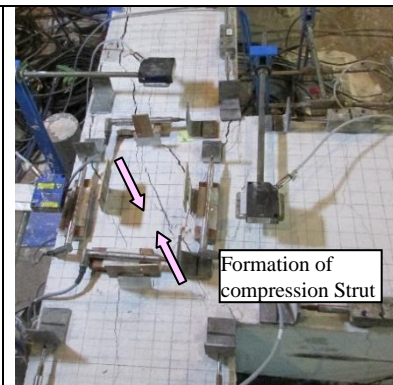
Formation of compression Strut

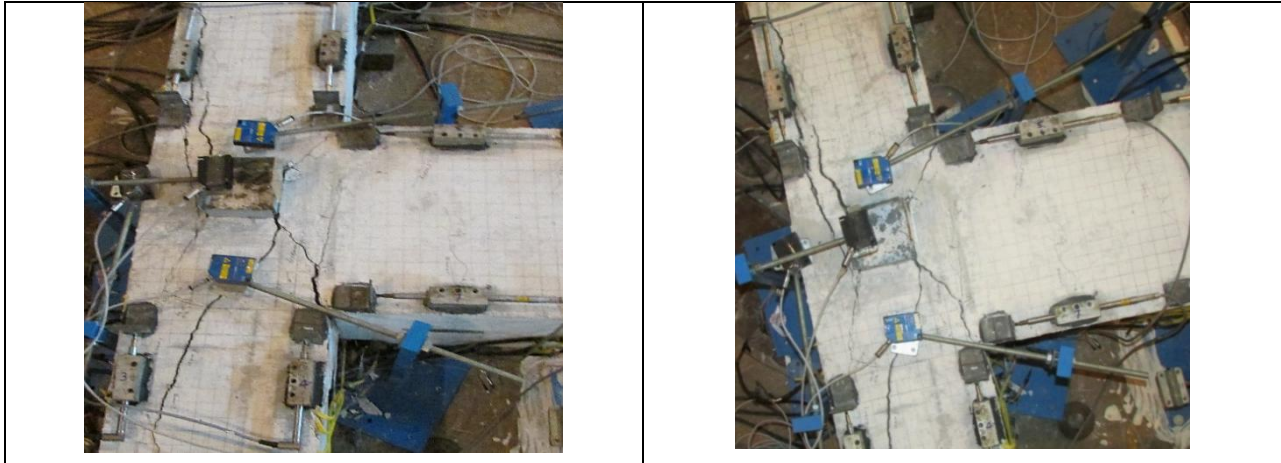
Fig 6 Crack pattern at +3.67%(left) and -3.67%(right) drift ratio –SP1-D

For specimen SP1-D during the positive drift ratio of 0.367(%), flexure cracks appeared in the beam bottom whereas the flexural cracks are formed on top face of the beam at drift ratio of 0.735(%). With the further drift increment shear cracks are appeared along both diagonals of the joint at drift ratio of 1.47%. As soon as the yielding of reinforcement commences, the damages got shifted towards the joint as the joint does not possess enough shear resistance to cater for the huge shear demand imposed on the joint due to seismic type of loading. At drift ratio of 2.2(%), fine flexural cracks are observed on the outer face of column and with further increase in drift the existing cracks in the joints got widened. The maximum crack width of 10mm is observed at the final stage

of loading. The crack pattern observed during positive and negative cycles at drift ratio of 3.67% is as shown in Fig 6.

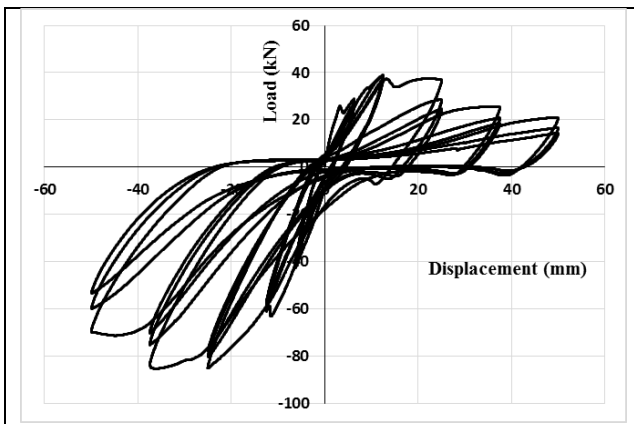
Fig. 7 Load Displacement hysteresis of SP1

The load versus displacement curves obtained from reverse cyclic test on specimens SP1, and SP1-D are depicted in Figs 7 and 8 respectively. From the load displacement hysteresis curve, it is evident that Specimen SP1 which was designed only for gravity loads exhibited poor seismic performance when compared to SP1-D, which was due to lack of anchorage and inadequate reinforcement at beam bottom. The maximum load carried by Specimen SP1 during the positive cycle is 54% of maximum load of the negative cycle. In the positive cycle of specimen SP1, the load dropped at the displacement cycle of 25mm due to the slippage of beam bottom reinforcement. In the negative cycle of specimen SP1, the load increases with the displacement until the yielding of beam top reinforcement. Beyond which global strength degradation behavior is observed due to extensive damage of joint region with drift increment. Specimen SP1-D showed better performance compared to that of SP1 as the yielding of beam reinforcement occurred in both positive and negative cycles. Specimen SP1-D sustained up to the displacement level of 62.5mm whereas the SP-1 sustained up to 50mm displacement at the beam tip. Further, sudden bond failure is not observed in the SP1-D in contrast to that observed in SP1. The specimen SP1-D showed uniform strength degradation behaviour in both positive and negative cycles whereas specimen SP1 showed sudden drop in load during positive cycles.

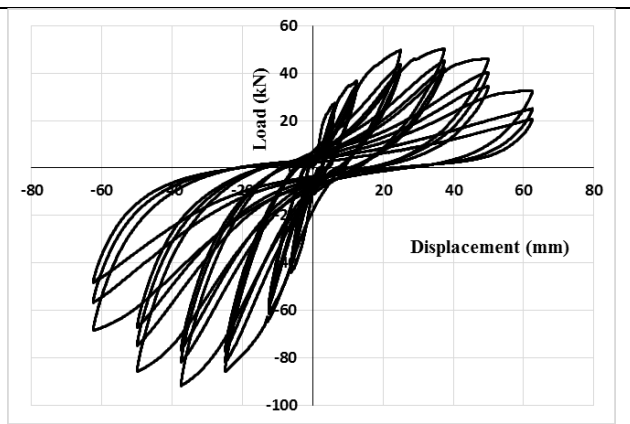
Fig 8 Load Displacement hysteresis of SP1-D

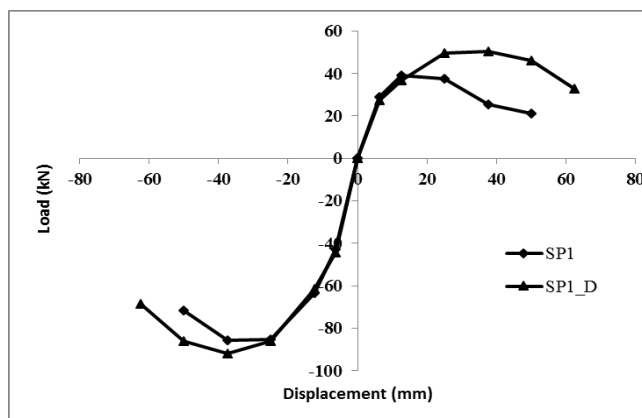
Fig. 9 Load Envelope of specimens SP1 and SP1-D

The load-displacement envelope curves obtained for specimens SP1 and SP1-D are compared in Fig 9. During positive cycles up to the displacement of +12.5 mm, maximum load carried by SP1 and SP-D are almost same. Beyond the displacement level of 12.5mm SP-1 incurred huge strength degradation this could be witnessed from Fig 9. During negative cycles, both specimens carried same load up to a displacement of 25mm and after that SP1-D carried higher load than the SP1 and also undergone larger displacements. The maximum loads carried by SP1-D are 22% and 7% higher than SP1 in positive and negative cycles. SP1-D showcased better performance compared to SP1.

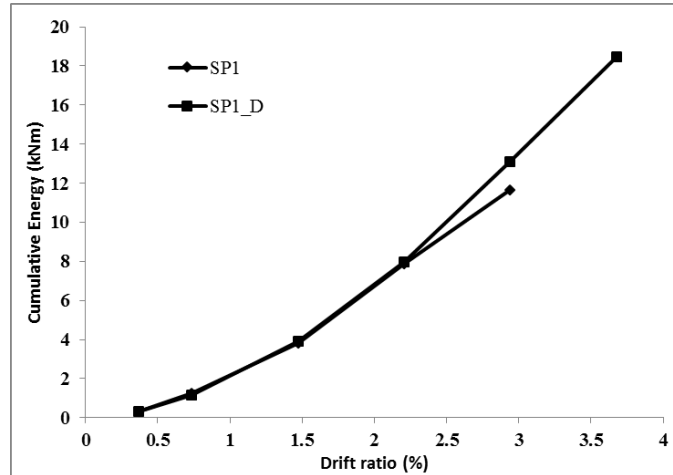
Fig 10 Cumulative energy dissipation

The energy dissipation is the crucial performance parameter as the energy imparted to system during earthquake has to be dissipated by the system. The cumulative energy dissipation capacity of specimen is shown in Fig 10. The specimen SP1 and SP1-D dissipated almost same energy till the drift ratio of 2.2%. At the drift ratio of 2.94% cumulative energy dissipated by SP1 is 11% lower than SP1-D. The cumulative energy dissipated by specimen SP1-D is 37% higher than that of SP1. Thus, doubly reinforced gravity load designed specimens

showed remarkable improvement the energy dissipation compared to the singly reinforced section.

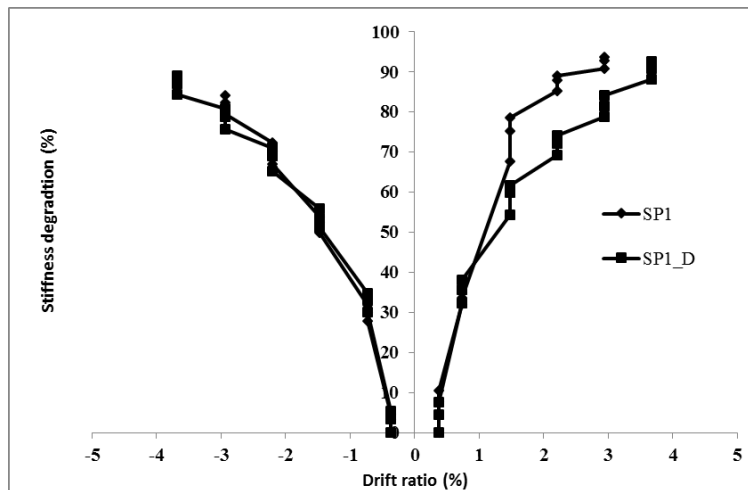
Figure 11 Stiffness Degradation of specimens

The stiffness degradation of the specimens are reported as percentage degradation of the positive / negative cycle with respect to the corresponding first cycle and stiffness of each cycle is calculated as the slope corresponding to the maximum displacement. The stiffness degradation of the specimens is shown in Fig 11. Both specimens have undergone more than 90% of stiffness degradation before failure in both positive and negative cycles. The specimens SP1-D and SP1 have undergone almost same stiffness degradation in the negative cycle. In positive cycle SP1 have undergone more stiffness degradation than SP1-D due to separation of joint. At drift ratio of +1.47%, the stiffness of the SP1 is 25% lesser than that of the SP1-D. It is also observed that stiffness degradation in the positive cycles is more than the stiffness degradation in the negative cycle for both the specimens. At drift ratio of 2.2%, stiffness degradation of first positive cycle is 10% and 21% lower than corresponding negative cycle in SP1-D and SP1 respectively.

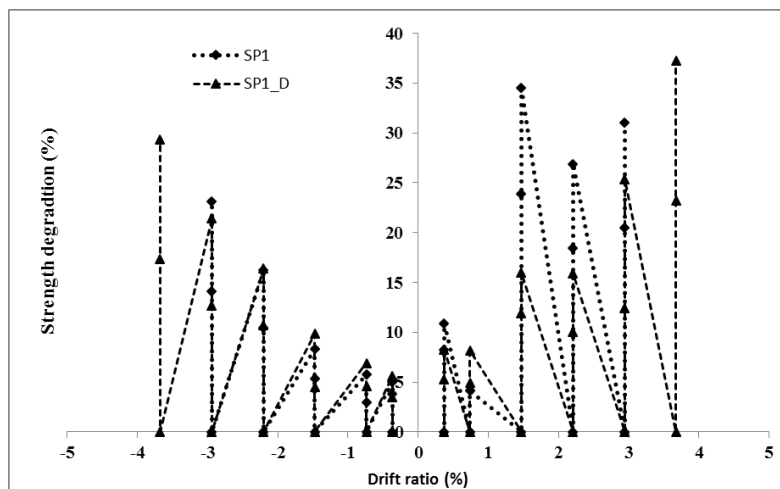
Figure 12 Strength Degradation of specimens SP1 and SP1-D

The strength degradation in second and third cycles with respect to the first cycle of each drift ratio is as shown in Fig 12. From Fig 12, it is observed that the strength degradation in the positive cycles is larger than that in the negative cycles for both the specimens. The strength degradation between second and third cycles is smaller compared to that of strength degradation between first and second cycles for both the specimens. The strength degradation of SP1 is more in both positive and negative cycles compared to that of SP1-D. Maximum strength degradation of SP1-D is larger than SP1 in both positive and negative cycles. The maximum strength degradation of SP1-D and SP1 in positive cycles is 37% and 34% respectively and in negative cycles are 29%, and 23% respectively. Even though the maximum strength degradation of both specimens is nearly same the maximum strength degradation of SP1-D occurred at drift ratio of  $\pm 3.67\%$  whereas in SP1 it occurred at +1.47% and -2.94% in positive and negative cycle respectively.
