SEISMIC PERFORMANCE OF DUCTILE AND NON-DUCTILE DETAILED BEAM-COLUMN SUB-ASSEMBLAGES

A.Kanchana Devi¹, Saptarshi Sasmal², K.Ramanjaneyulu³

Abstract

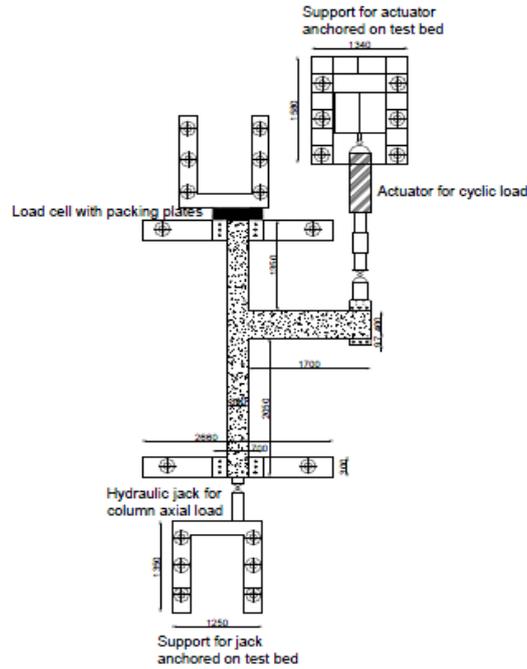
Fig 3a Set up for experimental investigation

The test specimens are also instrumented with LVDTs (linear variable displacement transducers), which are mounted on the joint surface as well as attached to the beam and the column segments to measure deflections along the length of beam and column segments and to calculate the rotation of the joint. The test setup is arranged on the test floor so that the beam-column joint is positioned horizontally parallel to the floor and the cyclic load is applied in the plane of the test floor. The schematic diagram of test set-up and positioning of test specimen is shown in the Fig.3a. An axial load of 300kN is applied to the column by hydraulic jack at one end of the column against the reaction block at the other end. The level of axial load in column was arrived by analysis of the global system of the

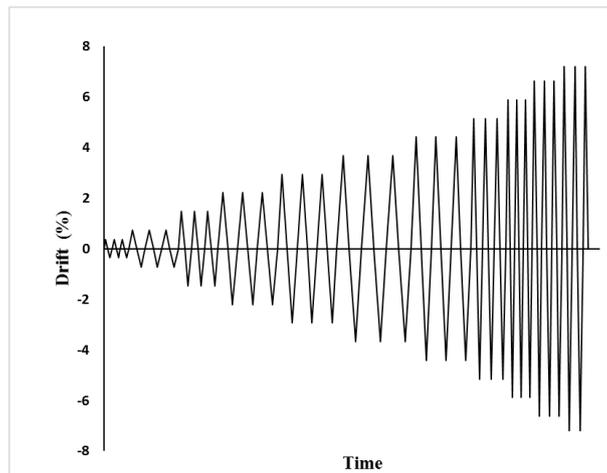
Fig 3b Reverse cyclic loading history

three storey four bay building. The lateral load was applied on the beam tip in displacement control mode using 25t actuator, according to the load history shown in Fig. 3b. Reverse cyclic load is applied in terms of drift ratio (%) of the component where the drift is calculated as per equation (1).

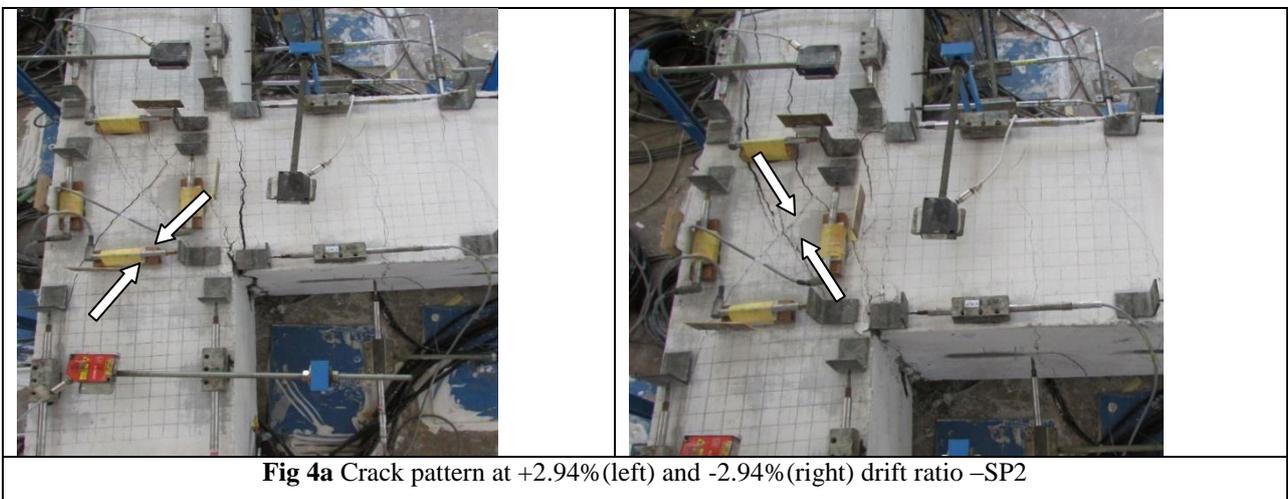
Fig 4a Crack pattern at +2.94% (left) and -2.94% (right) drift ratio –SP2

For specimen SP2, the first flexural cracks are developed at the face of the joint in beam top and bottom at the drift ratio of 0.367%. The flexural cracks spread throughout the twice the depth of the beam till the drift ratio of 1.47%. At the drift ratio of -0.735%, the diagonal shear cracks appeared along diagonal connecting beam bottom and column outer face. At drift ratio of 1.47%, the shear cracks appeared along the diagonal connecting beam top and column outer face. At the drift ratio of 2.2%, flexural cracks appeared at the outer face of column. As the joint is provided with horizontal ties and the beam bottom as well as top bars are anchored, the diagonal cracks widened in both directions with the further increment of drift ratio. The diagonal strut mechanism could be mobilized along both diagonals of the joint which is evident from Fig.4a. After the yielding of beam reinforcement, the damage is shifted to joint region and resulted in the severe joint damage. During the final stage of loading, at $\pm 5.88\%$ drift ratio, upheaving of concrete in the joint region and opening of joint is observed as shown in Fig. 4b.

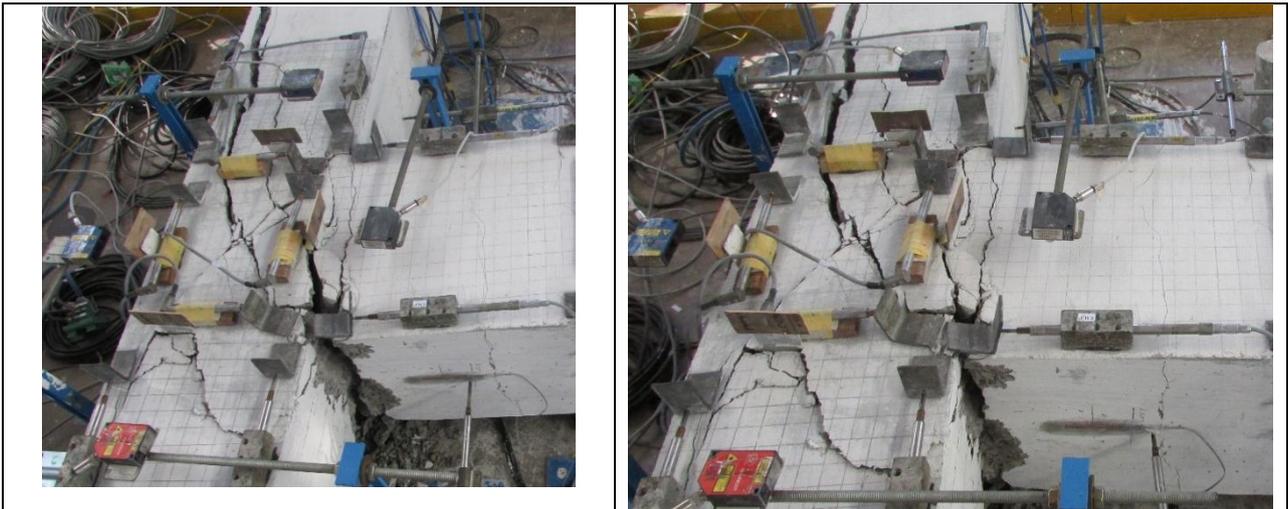
Fig 4b Crack pattern at +5.88%(left) and -5.88%(right) drift ratio –SP2

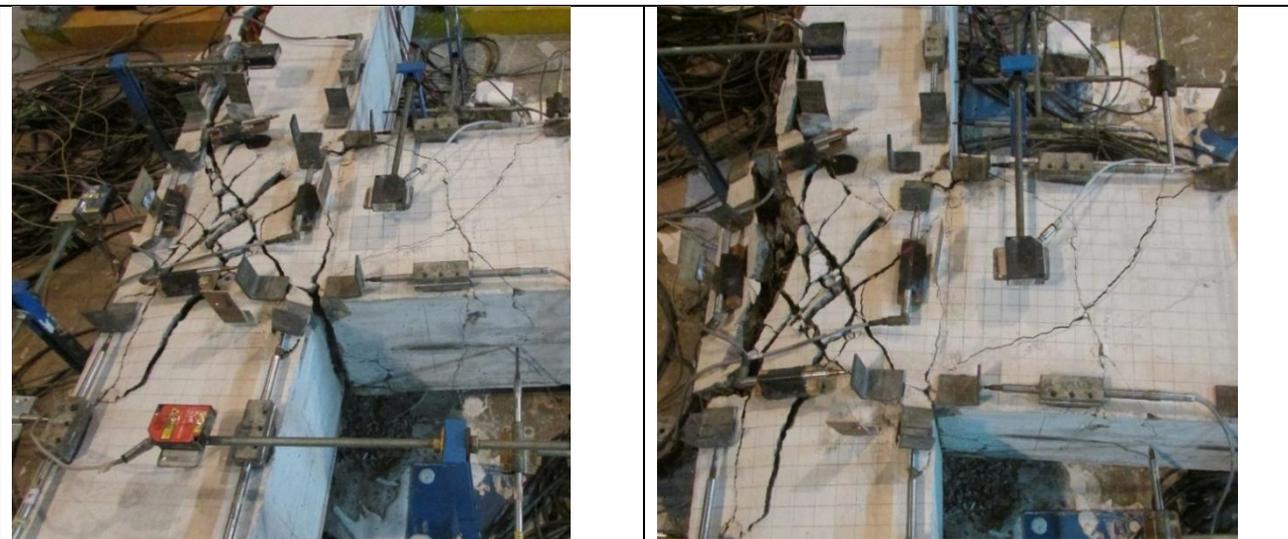
Fig 5 Crack pattern at +7.05%(left) and -7.05%(right) drift ratio –SP3

In specimen SP3, at drift ratio of 0.367%, first flexural cracks are appeared at the joint face at the beam bottom and but the first flexural crack on the beam top is appeared at the drift ratio of 0.735%. The flexural cracks spread throughout the length of beam with increment of drift. The first diagonal shear cracks are formed in the joint at the drift ratio of 1.47%. As the joint is provided with confinement in the form closely spaced ties and the presence of intermediate column bars enables mobilisation of shear resistance through compression strut, vertical and horizontal mechanism which is evident from the crack pattern observed. At the final stage of loading (at $\pm 7.05\%$ drift ratio) column cover concrete at the outer face of column spalled-off and upheaving of joint concrete is also observed as shown in Fig.5.

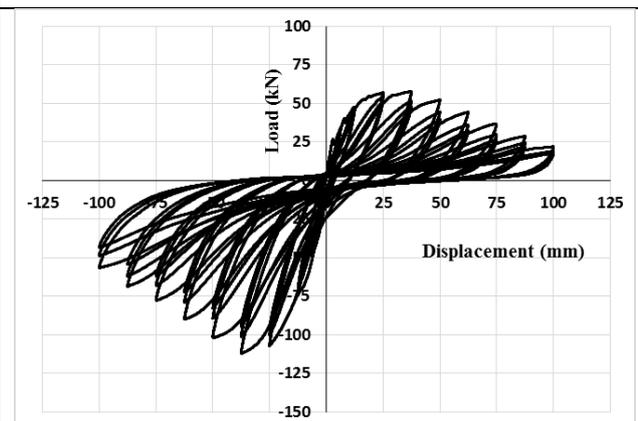
Fig. 6 Load Displacement hysteresis of SP2

The load versus displacement hystereses obtained from the experiments are presented in Figs 6 and 7. The maximum load carried by the SP2 and SP3 specimens in the positive cycle (i.e., tension on Beam bottom) are 58kN and 94kN

respectively. The higher load carried by ductile specimen is due to provision of positive steel at the joint face equal to at least 50% of negative steel at that face from ductility detailing consideration. In the negative cycle, maximum load carried by the SP2 and SP3 specimens are 112kN and 123kN respectively. Even though the non-ductile specimen has slightly higher reinforcement than the ductile specimen, the ductile specimen carried higher load than the non-ductile specimen. This may be due to the confinement effect provided by the ties in the joint region. In the negative cycle, both specimens exhibited almost similar hysteric behavior. Whereas in the positive cycle remarkable improvement in the hysteric behaviour is observed. The maximum load carried by SP3 in the positive and negative cycles is 39% and 9% higher than SP2 respectively. Even though the total area of steel (ie including main steel of beam, column and stirrups) provided in the both specimens are almost same ductile specimen showed remarkable performance. This signifies the importance of providing ductility detailing. Though the seismic performance of SP3 is superior to SP2, weak beam-strong column mode of failure is not observed in the both specimens.

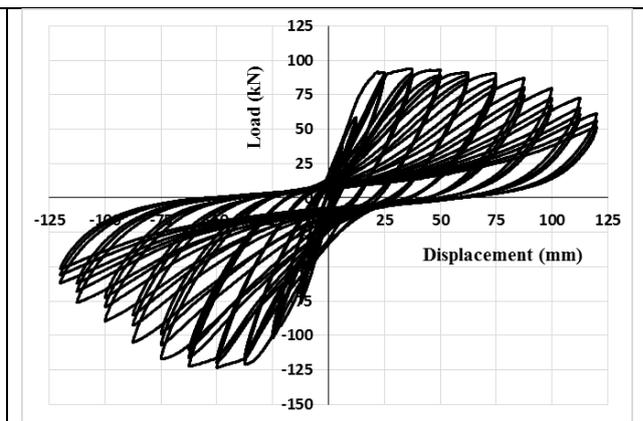
Fig. 7 Load Displacement hysteresis of SP3

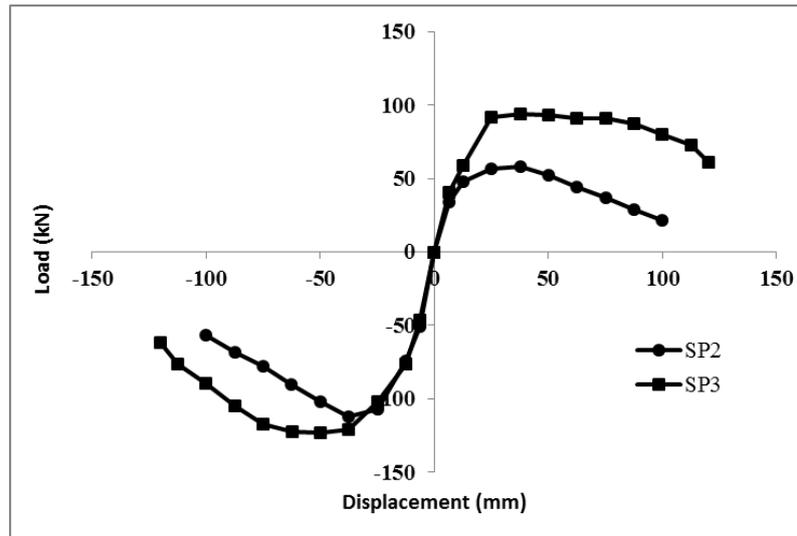
Fig. 8 Load Envelope of specimens SP2 and SP3

Load versus displacement envelopes obtained for both specimens are depicted in Figure 8. It could be observed that the ductile specimen carried much higher load for all the displacement levels in the positive cycle. In the negative cycle, both specimen carried almost same envelope load till 37.5mm displacement level (i.e., till the yielding of steel reinforcement) but ductile specimen carried much higher load beyond 37.5mm displacement cycles. The ductile specimen sustained maximum displacement of 120mm whereas the non-ductile specimen could sustain maximum displacement of 100mm at beam tip.

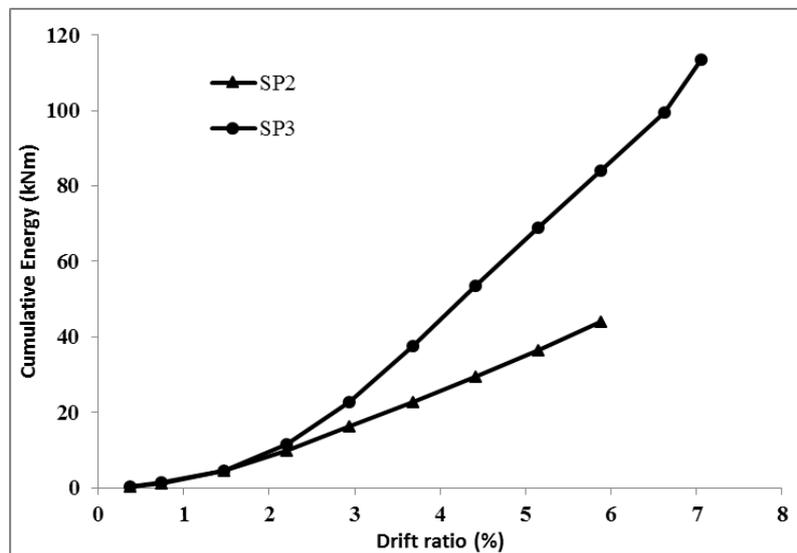
Fig. 9 Cumulative energy dissipation

The energy dissipation is the crucial performance parameter as the most of the seismic design principles rely on the inelastic deformation of the structure to withstand severe earthquakes. It is highly essential to ensure the required energy dissipation to prevent collapse of structures during severe earthquake. The cumulative energy dissipation capacity of specimen is shown in Fig 9. The cumulative energy dissipated by specimen SP2 and SP3 are almost same during the initial cycles up to the drift ratio of 2.2% (up to yielding of steel reinforcement). After the drift level of 2.2%, the cumulative energy dissipation of ductile specimen is much larger than that of SP2. The cumulative energy dissipation of SP3 is 2.5 times larger than that of SP2. Even though the maximum load carried by both specimens are nearly same, the energy dissipated by SP3 is enormous when compared to that of SP2. Thus energy dissipation depends on the ductility rather than on the strength of the specimen.

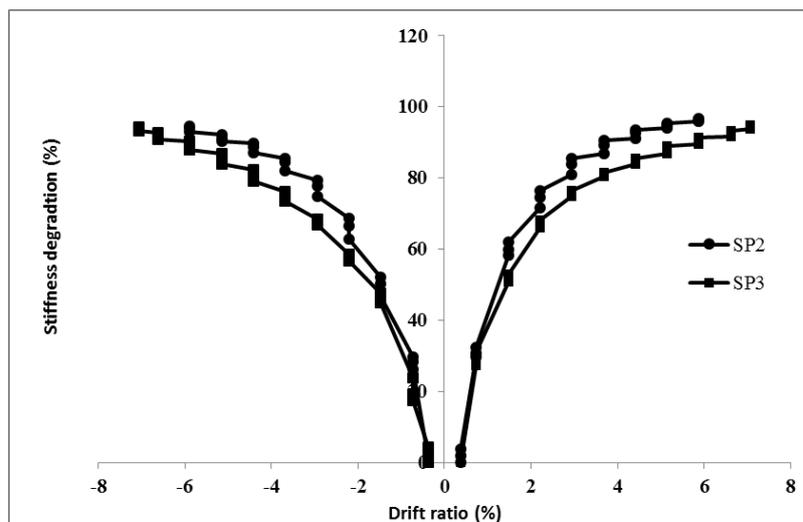
Figure 10 Stiffness Degradation of specimens

The stiffness degradation of the specimens is shown in Fig 10. Before failure all the specimens have undergone severe damage in the form of flexural cracks, shear cracks and up

heaving of concrete at the joint due to excessive shear deformation. This resulted in huge stiffness degradation of above 90% in both the specimens. Stiffness degradation of specimen SP3 is lower than SP2 in both positive and negative cycles for all the drift ratios. At drift ratio of 2.2%, stiffness degradation in first cycle of SP3 is 8% in positive cycle and in the corresponding negative cycle it is 11%, lower than SP2. It is observed that stiffness degradation in the positive cycles is more than the stiffness degradation in the negative cycle for both SP2 and SP3. At drift ratio of 2.2%, stiffness degradation of first positive cycle is 14% and 12% lower than corresponding negative cycle in SP3 and SP2 respectively.

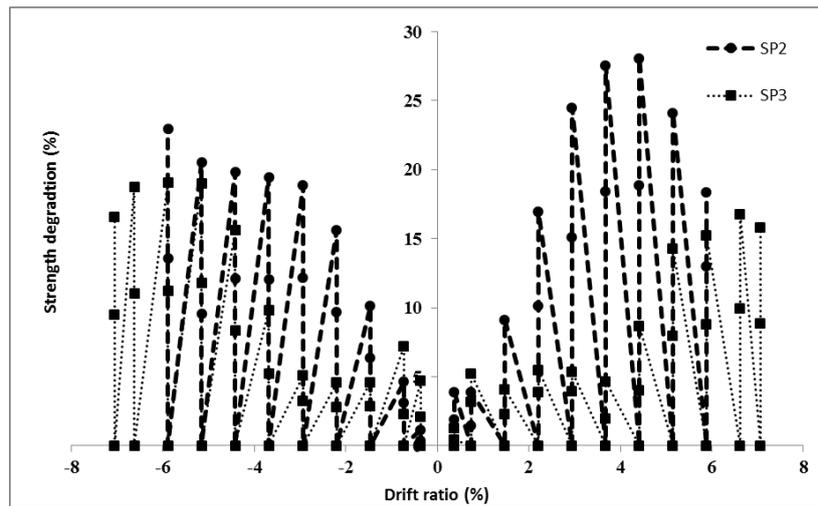
Figure 11 Strength Degradation of specimens

The strength degradation in second and third cycles with respect the first cycle at each drift ratio is shown in Fig 11. It is observed that the strength degradation in the positive cycles is larger than the negative cycle for SP2 whereas SP3 has undergone equal degradation in both positive and negative cycles. Even though SP2 is designed for higher seismic forces than SP3 the strength degradation of SP2 is much larger than SP3 in both positive and negative cycles. Strength degradation of SP3 is less than 10% till the drift ratio of 3.67% in both positive and negative cycles. The maximum strength degradation of SP3 and SP2 in positive cycles is 17% and 28% respectively and in negative cycles are 19% and 23% respectively. Specimen SP2 has larger beam top reinforcement than SP3 but still the strength degradation and maximum load carried by SP2 is larger than SP3. The confinement provided by the ties/stirrups improves the load carrying capacity and reduces further damage.

After the yielding of beam reinforcement, specimen SP2 showed global strength degradation i.e. degradation in strength with drift increment behavior in both positive and negative cycles. In specimen SP3, the negative cycles showed a global strength degrading behavior whereas in the positive cycles the load sustained from a drift ratio of 2.2% to 3.6% beyond which global strength degradation behavior was observed.
