# FULL SCALE FIELD TESTING FOR PERFORMANCE EVALUATION AND RETROFITTING OF OPEN WEB GIRDER TYPE ROAD CUM RAILWAY BRIDGE

In the present study, full scale field testing carried out on an Open Web Girder (OWG) type of rail cum road steel truss bridge towards obtaining the responses of a typical damaged and undamaged portals of the bridge under both vehicular loads on the roadway and passage of trains is discussed. Numerical modelling at both global and local level is carried out to simulate the responses obtained from the field testing. It is found that, the cross girders of the portal at intermediate expansion joint locations are subjected to excessive torsion due to improper seating of the stringer beams at the edge of the cross girder flange. By assessing the requirement and envisaging the practical suitability, a suitable rehabilitation scheme has been proposed.

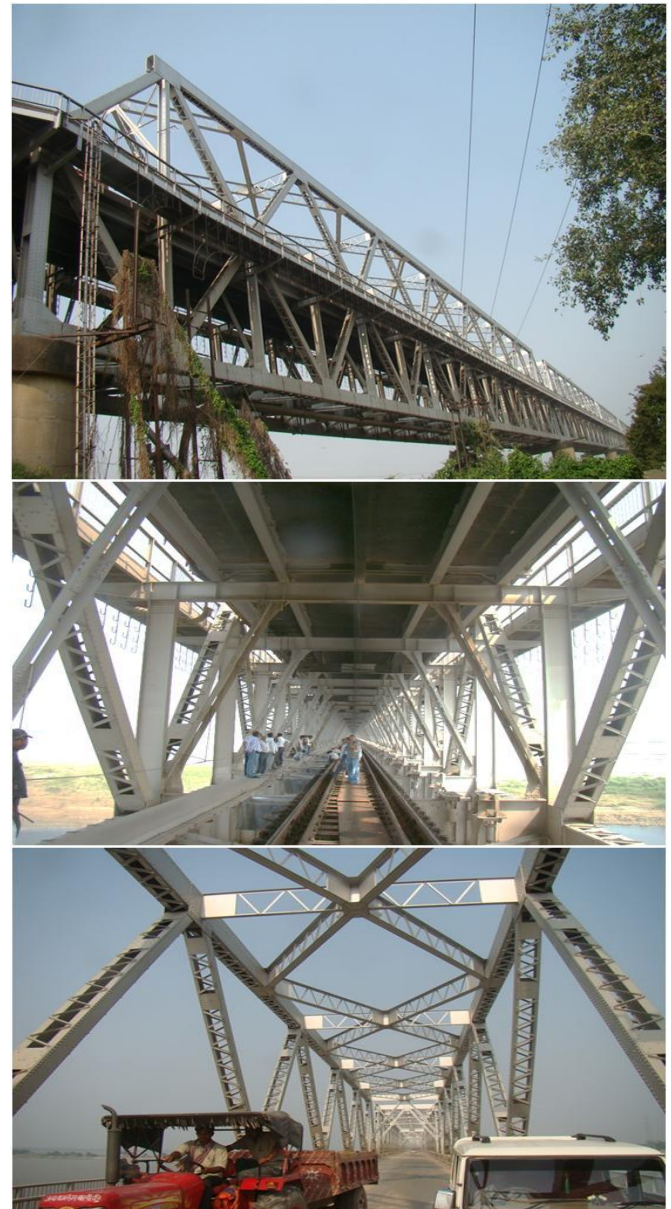
Fig.1 General view of the Open Web Girder Road cum Rail Bridge

The bridge under the present investigation is a rail cum road bridge over river Ganges on the East Central Railway (ECR) zone of Indian Railways. This bridge is the life line for North-Eastern states of India. The bridge was commissioned in the year 1959. This is an Open Web Girder (OWG) type of steel truss bridge consisting of two shore spans of 31.93m and 14 main spans of 121.047m. The lower deck of the bridge is through type which cater to single line rail track and upper deck cater to the national highways having carriageway of 7.5m. The loading standard adopted for the

design for railway track is Broad Gauge Main Line Loading (BGML) as per Indian Railway Standard<sup>15</sup> Bridge Rules, while road deck is designed for single lane Class – AA or double lane Class-A loading standard as per IRC-6<sup>16</sup>. The general view of the bridge is shown in Fig.1.

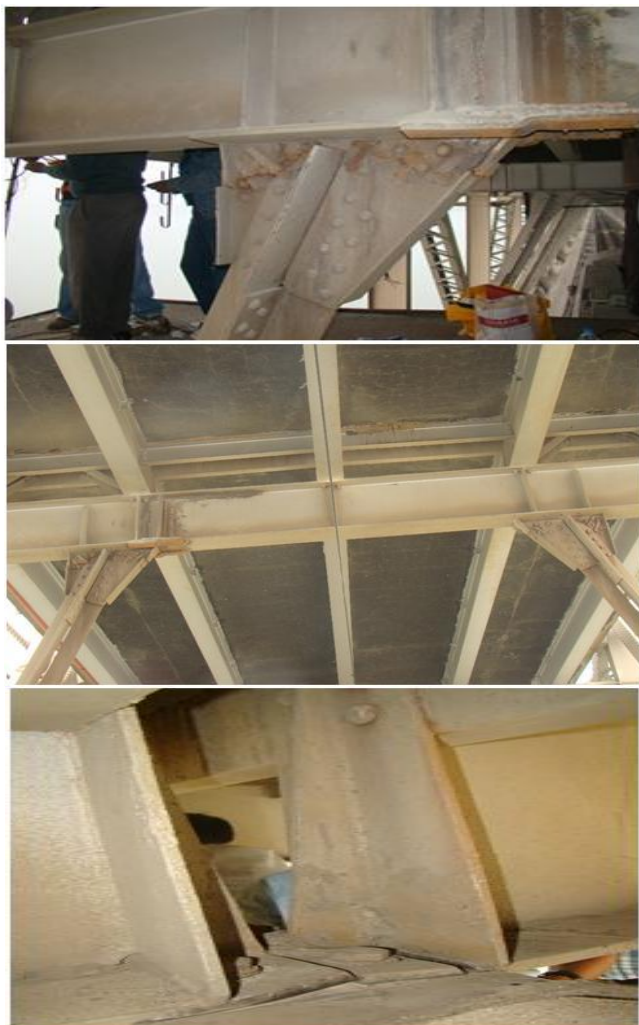
Fig.2 Damages observed in the structural members of the bridge

Cracking was observed in gusset plates connecting the road cross-girders and bracings at the location of intermediate expansion joint. Cracks are also observed in bottom flange of the road cross girders which are just below the intermediate expansion joints of the spans. The formation of cracks on cross girders, gussets etc, are identified and the bridge is observed to be experiencing vibration. Deterioration of seats in the intermediate expansion joints is noticed. Some typical damages observed on the structural members of the bridge is shown in Fig.2. The probable reasons for the failure is observed to be due to the passage of heavily loaded trucks which are more than the designed load and may be due to impact by the vehicles due to uneven road surfaces, expansion joints etc.

It is observed from the visual inspection and from the experimental measurements, that the load is being applied eccentrically at the tip of the flange of the cross girder at intermediate expansion joints causing additional stresses, moments and torsion in the member. To investigate and to further assess the cause for the additional stresses, 3D numerical modeling of the portal is carried out and the same loading which is obtained from the undamaged model of the portal that matches with the experimentally measured responses are applied eccentrically at the tip of the flange of the cross girder. Fig. 11 show the stress distributions (X direction, Y direction and von Mises) due to the eccentric

loads applied in the portal frame representing the one at intermediate expansion joints. It can be seen from the plots that the gusset plate is being stressed more due to eccentric loading. It is found from the numerical study also, that the eccentric loads on the cross girder causes additional stresses due to torsion which are not considered in the design for the same. The bending of the gusset further causes additional stress in the flange and web of the cross girder causing the stresses to cross the limit which is the main reason for the cracking in the gusset which propagates further into the web of the cross girder. Hence, it has been concluded that the cause for damage in gusset plate is eccentric loading on the cross girders at intermediate expansion joints.

It is observed from the measured strains from the instrumented portals of undamaged and damaged as well as from the numerical modeling of the same portal with concentric and eccentric loading representing the loading experienced at intermediate expansion joints that when the designed IRC loads are applied on the cross-girder, the portal members at intermediate expansion joint experiences the stresses which are above the permissible level giving rise to cracking of the members. This is found to be due to the torsional moments caused by the eccentric loading on the flange of the cross girder which is also correlated with the analytical calculations. Hence, in order to minimize the torsional effect on the cross girder due to eccentric loading, a suitable modification of the cross girder has been formulated as a retrofitting scheme to cater for the additional stresses due to torsion. In order to reduce the stress in the gusset plate, the cross girders have to be designed to take up the eccentric load. Hence box shaped cross girders are being suggested. The present I-section cross girder at the intermediate expansion joints can be modified to a box section with more width than the existing flange of the I-section so as to have more bearing area for the stringers positioned on the cross girder.

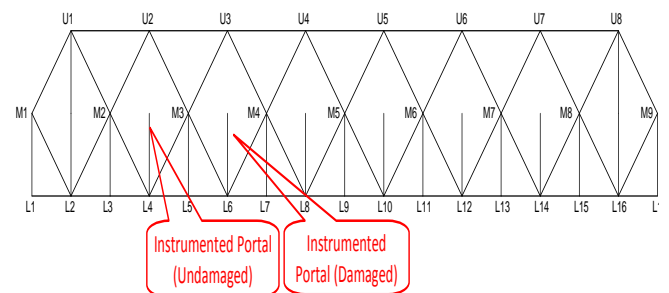
(a) Instrumented portals for strain measurement

span and local modelling of the affected portal frame, critical locations are identified on the cross-girders, vertical members and bracings of the damaged and undamaged portals. Detailed instrumentation strategy is formulated based on the preliminary investigations at site and on numerical models to measure the responses at bridge site. Instrumentation has been carried out on two portal frames, one is damaged and the other is adjacent similar portal in undamaged condition. The adopted instrumentation scheme consists of strain gages at the identified critical locations on the cross girder, vertical members, bracings and on the gussets of the portal to measure the strain responses under the vehicular load passing on the bridge.

**Fig.3** Instrumentation Details adopted for field investigation  
The identified portals are shown in Fig. 3(a) and 6(c). The instrumentation scheme adopted on the portal is shown in Fig.3(d). The tower wagon provided by the railways for a limited block period is used for fixing of sensors and connection of cables to the sensors on the cross girders of the two portals. Instrumentation has also been carried out for measurement of vibration responses of the bridge span as shown in Fig.3(b). For this purpose, triaxial accelerometers have been fixed at all the node locations on the span of the bridge at three levels, viz., at rail level, road level and at top level of bracings. As the accelerometer sensors are limited, roving type of acceleration measurements are adopted by fixing two constant reference accelerometers for all test setups. Fixing of sensors on typical locations of the girder is shown in Fig.4.

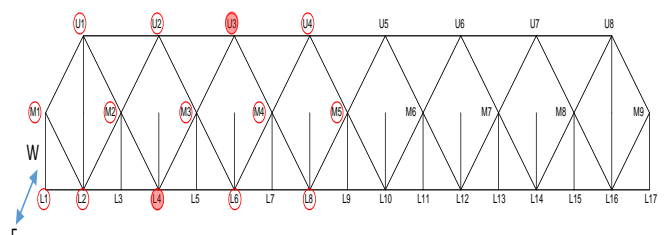
(b) Sensor locations for vibration measurement ( ● = fixed Reference, ○ = roving accelerometer)

Vibration measurements are acquired on the bridge span by the accelerometers fixed at the node locations at three levels. Acceleration measurements have been taken for all the three directions at all the nodes to observe the vibration behaviour and vibration amplitude in longitudinal, lateral and in vertical direction of the bridge span. Typical vibration responses in terms of acceleration are shown in Fig. 9.

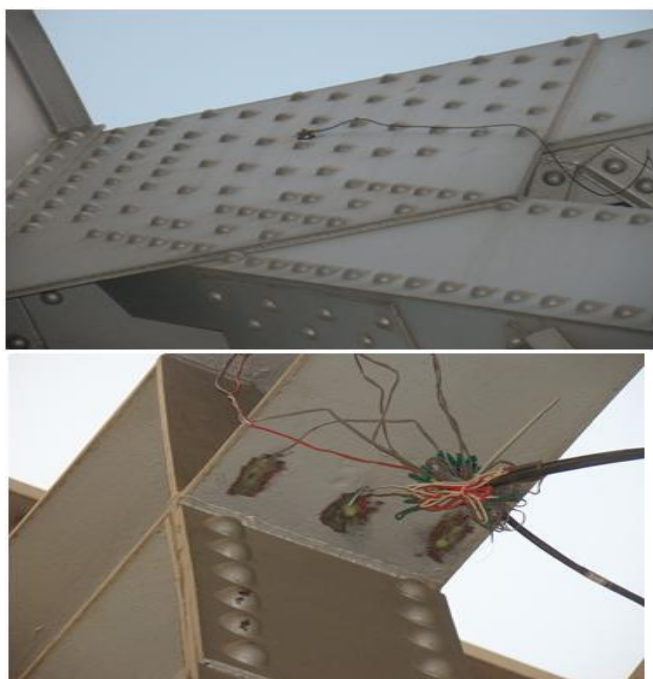
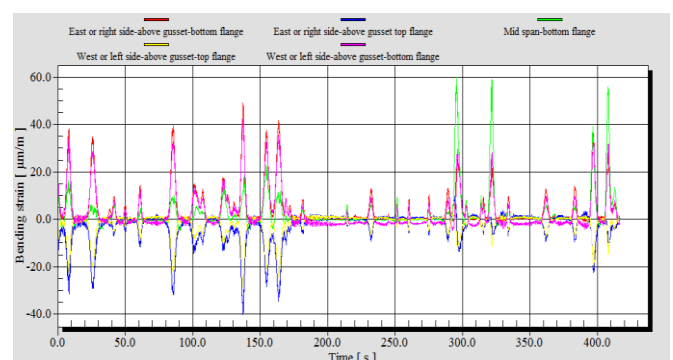
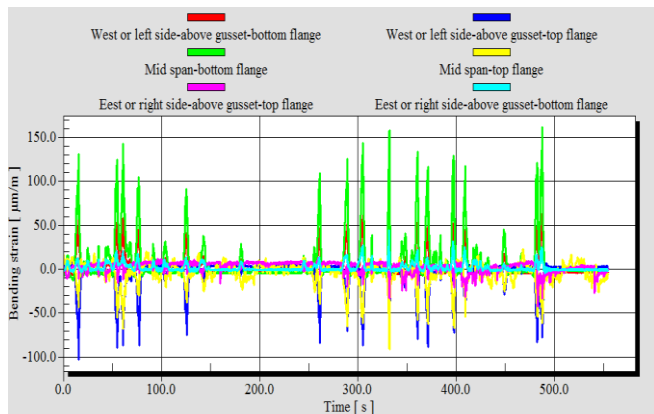
(b) Damaged  
**Fig. 5** Bending strain of cross girder

Similar instrumentation scheme is adopted for both the undamaged and damaged portal frames and the responses are measured simultaneously during the passage of vehicles on the bridge. The bending strain at top and bottom flange of the girder are measured at support, above gusset and at mid span. The strain is found to be maximum at mid span bottom flange and is around 72.71microstrain and 142microstrain for undamaged and damaged frames respectively as can be observed from Fig.5. Torsional strain at both ends of cross girder are shown in Fig 6. Strain on gusset and star angle has also been measured and the responses are shown in Figs.7 and 8 respectively.

From the responses of different sections of the cross girder, it is found that due to damage to the gusset, strain is not so high. Further, one of the gussets in star angles did not show any result due to no load transfer mechanism. It is important to mention here that the strain responses are obtained under the restricted traffic load on road, hence the magnitude is not very high. But the distribution of bending strains clearly reveals that there is considerable amount of torsion being produced due to the eccentric loading on the cross girder at intermediate expansion joints. In the case of

undamaged cross girder, torsional strain produced at ends of cross girder (shown in Fig. 6) is almost nil and the bending strain developed at different sections of the cross girder and the star angles are considerably lesser than that observed in damaged cross girder. It clearly emphasises that the undesirable force flow mechanism in the cross girder at intermediate expansion joint, which needs to be mitigated.

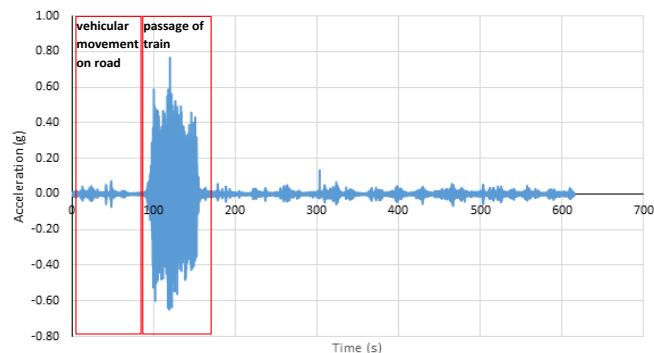
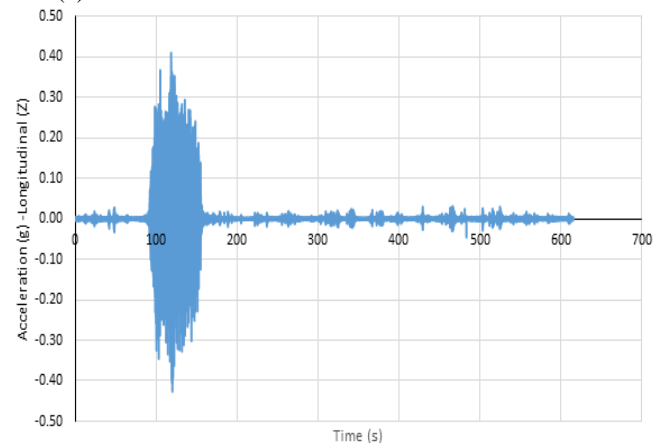
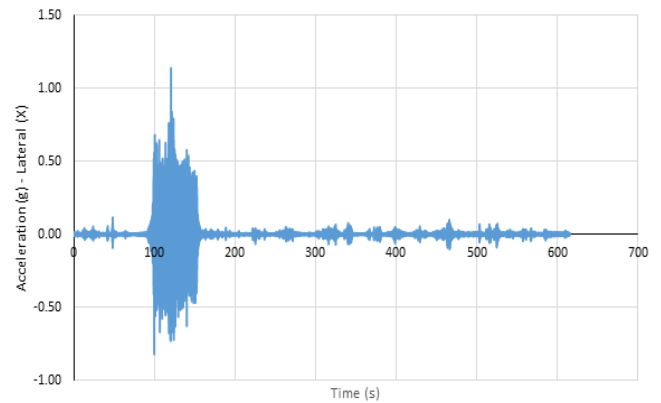
**Fig. 9** Typical vibration responses of the bridge span

It is observed that the bridge experiences tolerable vibration levels in the case of vehicular movement on the roadway at top. However, large vibrations are observed during the passage of train over the railway track of the bridge. Vibration levels of  $0.1\text{m/s}^2$  and  $0.8\text{m/s}^2$  are observed in the case of vehicular traffic and train movement respectively. The higher vibration levels may be mainly due to the impact of vehicles when moving over the intermediate joints which are damaged and due to undulated and damaged road surface. Based on frequency analysis of the measured vibration responses based on auto power spectra (Fig.10), it is observed that the first fundamental frequency of the bridge is around 2.686Hz and very closely spaced modes are observed.
