CONDITION ASSESSMENT AND FORMULATION OF STRATEGY FOR REHABILITATION OF INDUCED DRAUGHT COOLING TOWER (IDCT) WALLS

Bhaskar Sangoju¹, Saptarshi Sasmal¹, Srinivas V₃, Sivasubramanian. K⁴, Ramanjaneyulu. K⁵

¹Principal Scientist, CSIR-Structural Engineering Research Centre (SERC), Chennai, INDIA-600

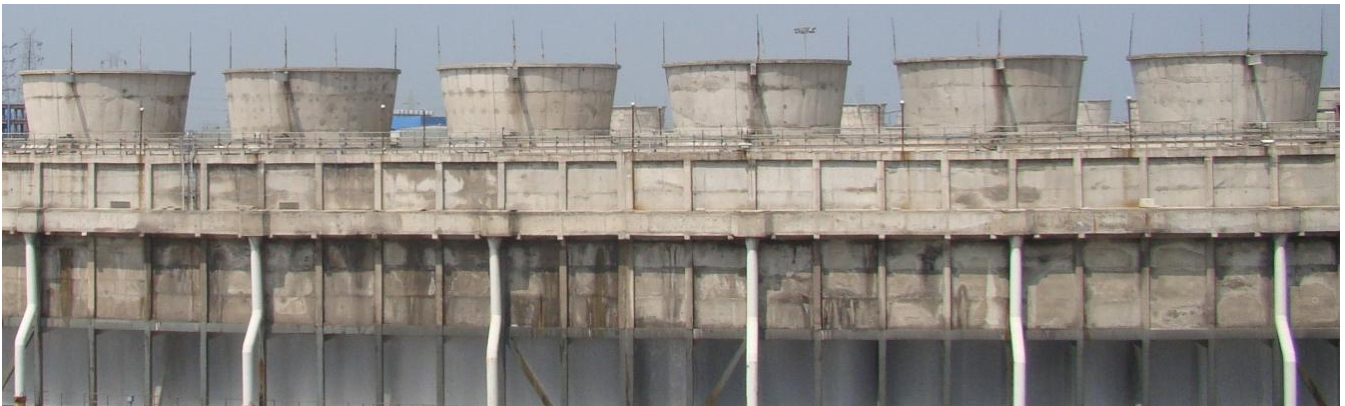
Fig.1 Typical view of IDCT

The IDCT is a nine cell reinforced concrete (RC) framed structure consisting of columns and beams. The main function of IDCT is to reduce the temperature of hot water stream by extracting heat from water and emitting it to the atmosphere⁵. The space between peripheral beams and columns is covered with RC walls of 130mm thickness and space between cells is covered with wall of 100mm

thickness. M30 grade concrete was proposed to be used for construction of IDCT walls. Fig. 1 shows the typical photograph of IDCT. Seawater is being used for condenser cooling.

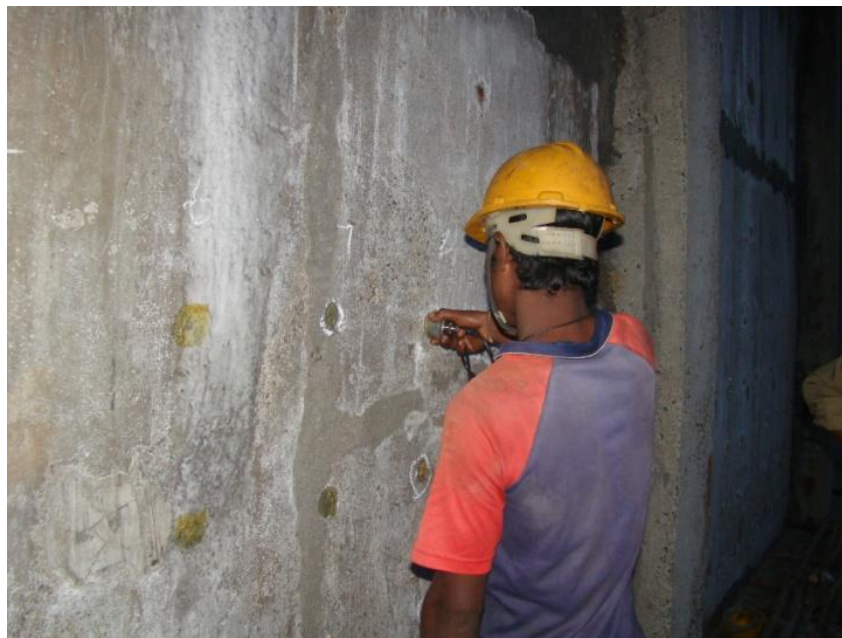
Fig. 2 UPV Test in Progress

UPV test is basically a wave propagation test and consists of transmitting ultrasonic pulses of 54 kHz frequency from transmitting transducer to the receiving transducer through concrete medium and measuring the transit time. The equipment used is known as PUNDIT LAB+. UPV test has been carried out on grid points of selected RC wall portion in a systematic way. Transmit time is measured at each grid point and the velocity is calculated by dividing the thickness of the member by the transit time. Fig. 2 shows the UPV test in progress. Generally, UPV varies with the denseness of concrete, the presence of voids, cavities, cracks, etc. which affect the wave propagation resulting in lower pulse velocities.

Based on UPV test results, the quality grading of concrete in terms of quality and integrity is assessed as per IS 13311 (Part 1)⁶. It is noted that nearly 50% of test locations (grid points) in the selected portion of RC wall recorded (i) unstable reading (USR) and (ii) the velocity less than 3.0km/sec; indicate poor quality concrete possessing excessive voids, honeycombs, flaw, local defect, etc. In remaining locations, the velocity is about 3.5km/sec and indicate that the concrete quality grading is good. However, the coefficient of variation is very high (more than 50%). The UPV results of the selected Column are in the range 4.23 to 4.44km/sec and indicates that the quality of concrete is good.

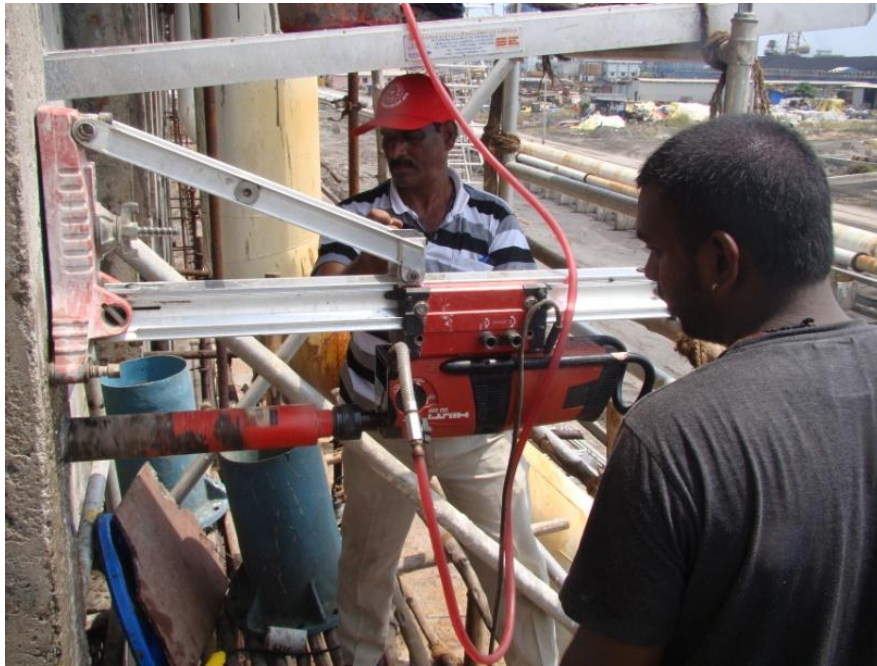
Fig. 3 Core extraction in progress

Concrete core samples are collected from different locations of the selected RC wall and Column using a portable core cutting machine. Fig. 3 shows the extraction of core from the RC wall. To determine the effect of carbonation, 1.0% phenolphthalein solution is sprayed on to the extracted core samples at site⁷. Later, the extracted core samples are dressed in the laboratory using the concrete cutting machine.

After dressing, water absorption and the compressive strength of the cores are determined in the laboratory. The core compressive strength is corrected for its height to diameter ratio. The equivalent cube strength is obtained by multiplying with the value 1.25.

The carbonation depth obtained from extracted core samples at different locations of RC wall and Column is not significant and found to be in the range of 10-12mm. It is observed that the equivalent cube compressive strength of concrete is in the range of 7.0 MPa to 28.6 MPa indicating large variation in strengths. As per Clause 17.4.3 of IS 456:2000, concrete in the member represented by a core test shall be considered as acceptable if the average equivalent cube strength of the cores is equal to at least 85 percent of the cube strength of the grade of concrete ($0.85 \times 30 = 25.5$ MPa; M30 is the design grade of concrete) and no individual core shall have a strength less than 75 percent ($0.75 \times 30 = 22.5$ MPa; M30 is the design grade of concrete)⁸⁻¹⁰. The water absorption levels in the core samples observed are higher than the normal values (4%) for concretes made of granite/basalt aggregates⁷.

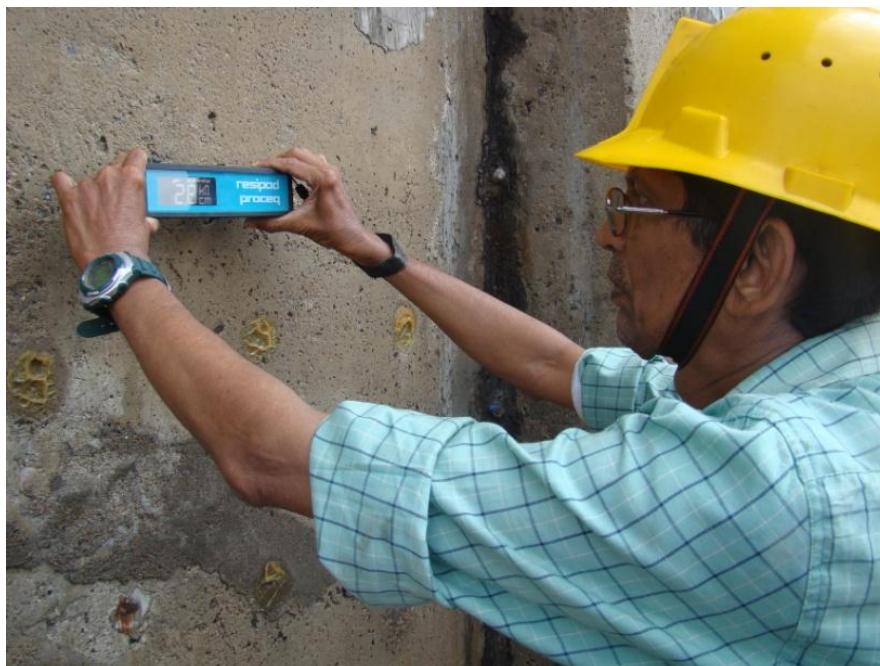
Fig. 4 Typical resistivity measurement

Corrosion is basically an electrochemical phenomenon, measurements of electrochemical parameters such as half-cell potential and resistivity of concrete are helpful to identify the proneness of corrosion of rebars^{3,11}. In this investigation, half-cell potentials with reference to copper-copper sulphate electrode are measured for selected members. Also, concrete resistivity measurements are made with Wenner four probe resistivity meter and typical resistivity measurement is shown in Fig. 4. The powder samples are also collected from different locations and the chloride content present in the concrete is determined in the laboratory.

The half-cell potentials observed are in the range of -330 to -870mV in the selected Column and -299 to -508 in RC wall. At most of the locations of the Column, the potentials are more negative than -500mV near to GL and in the range of -330 to -530mV at Level 1 (top tier beams). The more negative values at GL portion could be due to nearby storage water. The observed half-cell potentials indicate that the probability of corrosion is more than 90% or certain¹². The resistivity of concrete is in the range of 3 to 6 kΩcm in RC wall and 7 to 40 kΩcm in the Column indicating early chance of corrosion initiation. At many locations, the chloride content present at the rebar position is more than the threshold limit (0.4% by weight of cement), indicating probability of occurrence of corrosion risk due to chloride ions¹³.
