STUDY ON STRENGTHENING BY REHABILITATION OF CRACKED RC SLABS USING DIFFERENT FRP SHEETS UNDER IMPACT LOADING

Abstract

Keywords:- Rehabilitation, Wrapping Fibers, Impact Loading

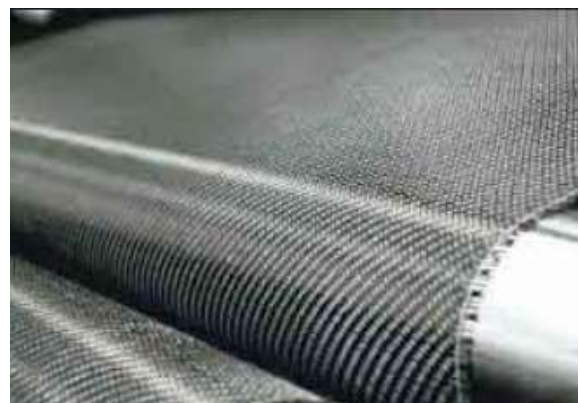
Fig 1: Carbon Fibre Reinforced Polymer

CFRP is a fabric which is mainly made of Carbon fibres. It can be unidirectional, bidirectional or random. In the present study, unidirectional CFRP of thickness 200 GSM was used. CFRP fabric is very costly and is used in the places where high strength to weight ratio and rigidity are required. The properties of CFRP are given in the table.

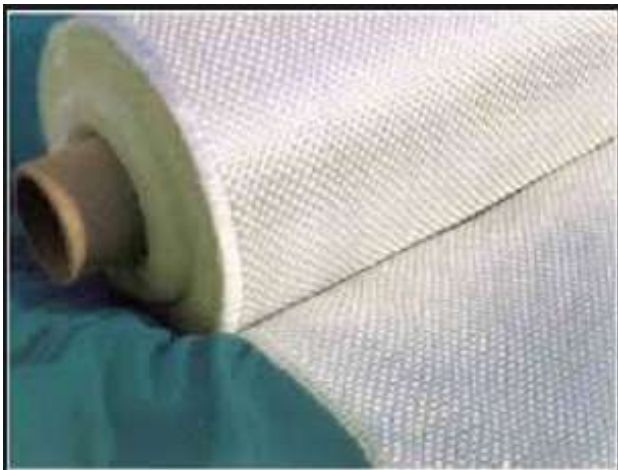
Fig. 2: Glass Fibre Reinforced Polymer

GFRP is a fabric which is mainly made up of glass fiber. The glass fiber may be randomly oriented, may be unidirectional or bidirectional. In the present study, bidirectional GFRP of thickness 900gsm was used. GFRP is light in weight and strong. The properties are given in table

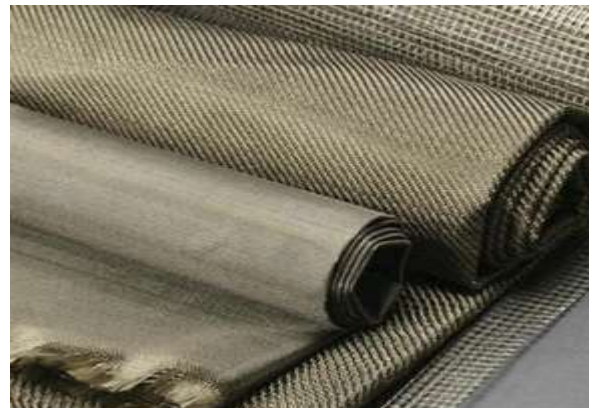
Fig 3: Basalt Fiber Reinforced Polymer

Basalt fiber are made from fine fibers of basalt. It has better physical and mechanical properties than fiberglass. It is cheaper than carbon fiber. BFRP used in this study, was bidirectional with thickness 200gsm. It has high tensile strength and exhibits excellent resistance to acid and alkali, along with the non-magnetic and non-conductive characteristics. Basalt is also non-combustible and offers good thermal protection making it suitable for many insulation and high temperature applications. Now –a- days, BFRP is economical and is used extensively for strengthening purpose because of its high temperature and abrasion resistance .The properties are given below.

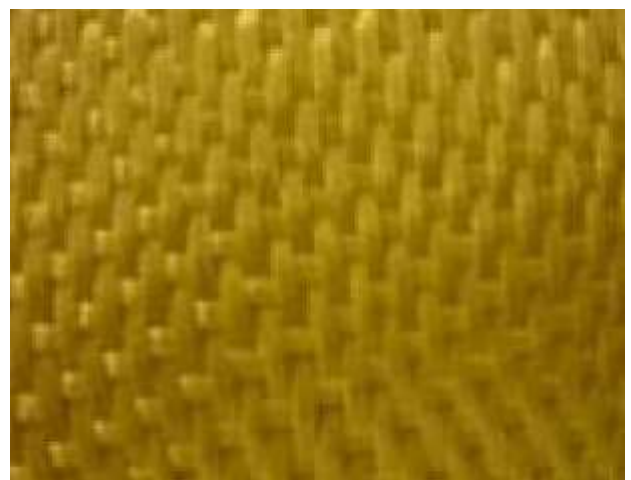
Fig 4: Aramid Fiber Reinforced Polymer

AFRP is a fabric made of strong synthetic aramid fibres. The word aramid has arrived from two words "aromatic" and "polyamide". 85% is of amide linkages (-CONH-) attached directly to two aromatic rings, in our study Bidirectional aramid fabric is made use of. It has high heat resistance property. It is light weight fabric, hence it is used where weight reduction is necessary .Its properties are given in table.

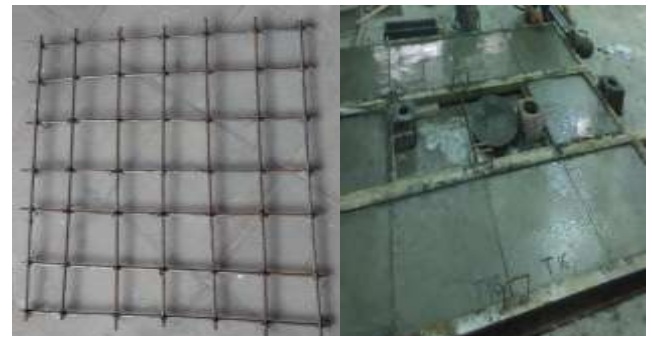
Fig 5: Reinforcement details and slab casting

Ten slab specimens of dimension 600 mm x 600 mm x 60 mm were cast with reinforcement of 6 mm diameter bars of Fe 500 @ 95 mm c/c spacing on both sides. Preparation of form work, bar bending, casting of slabs was done.

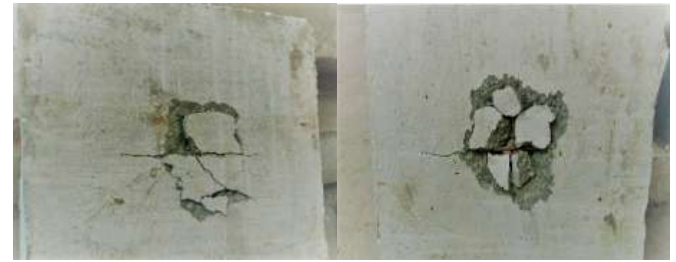
Fig. 7: Failure pattern of control slabs

A very sharp sound was observed for first impact blow which gradually decreased for further blows. This indicated the appearance of first crack. On further impact blows widening of cracks occurred at the bottom surface. With continued impact blows caused deformation of reinforcing bars and spalling of concrete. This stage was considered as the final ultimate failure .Test results are tabulated in Table .The failure pattern of the control slabs is shown below.

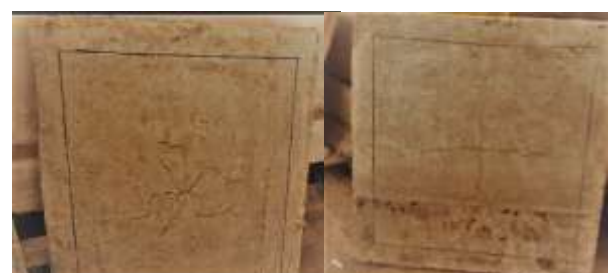
Fig 8: Appearance of First crack.

- **Initial impact loading on test specimen**
The first crack generally appeared for third or fourth blow .Crack appeared at the center portion of the slab as shown in the figure below. The cracks emerged at the center and radiated outwards. The cracks at the central region were clearly visible when compared to the cracks at the outer region of the slab. The cracks radiated in the outer region disappeared after some time of the testing. This indicated that it was still in the elastic zone.

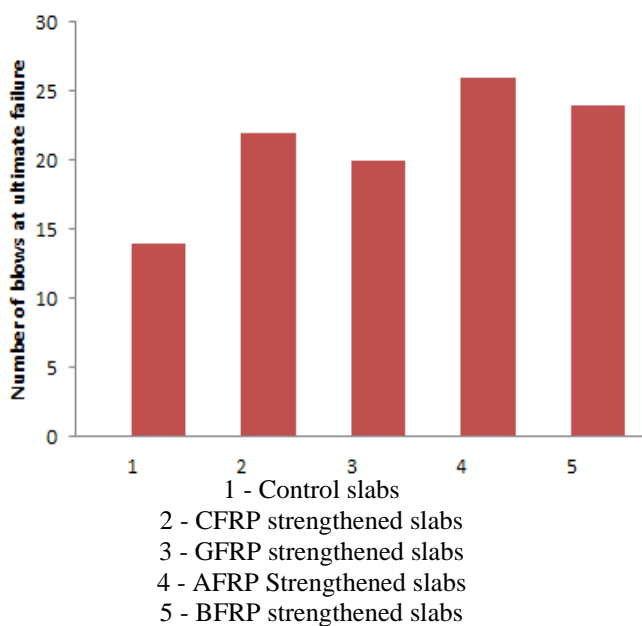
From the figure, observation was made that the AFRP strengthened slabs took more number of blows compared to other slabs

Material used for wrapping	Trial 1 No. of blows at ultimate failure	Trial 2 No. of blows at ultimate failure	Remarks
CFRP	22	22	TEARING OF FRP
GFRP	20	19	BULGING OF FRP
AFRP	26	26	BULGING OF FRP
BFRP	24	24	BULGING OF FRP

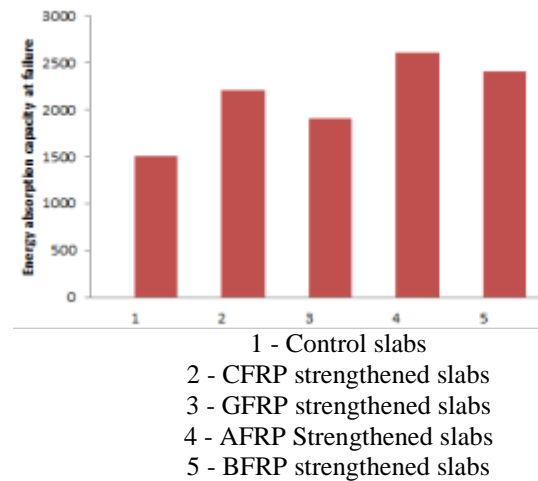
Graph 2: Variation of Energy absorption capacity at failure for control and rehabilitated slabs

From the figure it is observed that AFRP strengthened slab absorbed more energy and showed greater increase in impact resistance than other slabs. The least increase in the impact resistance was shown by GFRP strengthened slabs.

Wrapping material	Energy absorption of control slab(J)	Energy absorption of Rehabilitated slab(J)	% increase in the Energy absorption (%)
CFRP	1500	2201.364	46.75
GFRP		1901.178	26.74
AFRP		2601.612	73.44
BFRP		2401.488	60.09

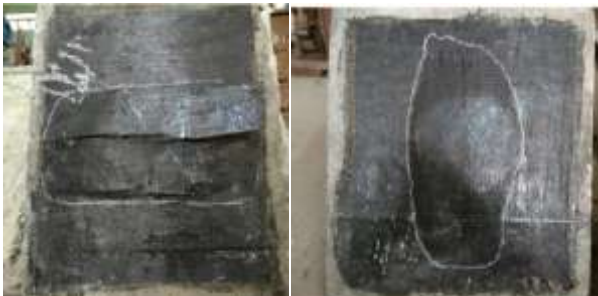
Fig 9: Failure pattern of CFRP wrapped rehabilitated slab.

Two damaged slabs were strengthened by wrapping it with unidirectional Carbon fiber reinforced polymer fabric of 200 GSM Thickness. These strengthened slabs were subjected to Impact blows. The CFRP rehabilitated slabs offered good Resistance to the impact blows compared to the control slabs as seen in the above graph. There was emergence of

sharp sound for the first few blows, which gradually reduced for increased blows. At this stage bulging of CFRP was seen. There was a noticeable sound difference between the portion which was bulged and flat portion when tapped on the surface. Further increase in the Impact blows caused the CFRP sheet to tear. Since the CFRP sheet was unidirectional, tearing of the fabric occurred. The energy absorption capacity of CFRP rehabilitated slabs was 2201.364 J. There was 46.75 % increase in the Energy Absorption capacity of rehabilitated slabs compared to control slabs.

Bulging of the wrapping material at the bottom was observed in all type of fabrics except CFRP which de-bonded on number of blows due to its unidirectional nature.

Though the energy absorption capacity remained somewhat same the area of bulging varied for different fabrics. Large bulged area was noticed in GFRP strengthened slabs. Next to GFRP was the BFRP, AFRP and least bulged fabric. But tearing of fabric was observed only in CFRP as it was unidirectional fabric. Thus this proves that Bidirectional fabric performance was better than unidirectional fabric under the Impact loading.

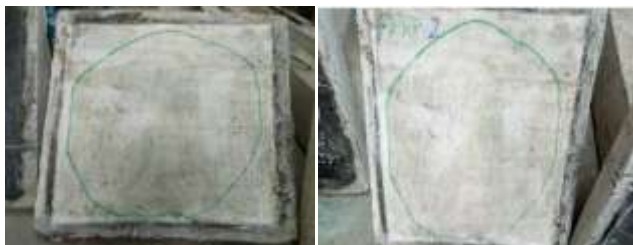
Fig 10: Failure pattern of GFRP wrapped rehabilitated slab

Other two slabs were strengthened by wrapping with bidirectional glass fiber reinforced polymer fabric of 900gsm thickness. The GFRP strengthened slabs showed increased resistance to impact blows compared to control slabs. After certain Impact blows GFRP at the bottom started bulging. On further increase in the blows, expansion in the bulging area was observed. Since GFRP used was bidirectional, tearing of the fabric was not seen as in case of CFRP. Furthermore blows on the rehabilitated slabs caused peeling or de-bonding of the fabric. This was considered as the ultimate failure. The failure pattern is as shown in the figure below. Analysis of damaged pattern showed that GFRP strengthened slabs has largest damage area than other fabrics. There was just 26.74 % increase in the Energy absorption capacity of rehabilitated slabs compared to control slabs.

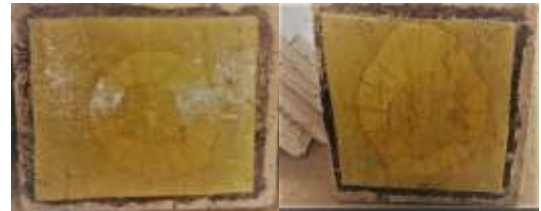
Fig 11: Failure pattern of AFRP wrapped rehabilitated slab.

Other two slabs were strengthened by wrapping with Aramid fiber Reinforced Polymer. Aramid fiber used in the

study was 200gsm and bidirectional. There was considerable increase in the energy absorption capacity compared to control slabs. Behavior of bidirectional AFRP fabric was very much better than unidirectional fabric. The response of AFRP was comparatively better than CFRP, GFRP and BFRP. Increase in the impact blows neither caused tearing of the fabric nor, peeling. There was just initiation of bulging and the bulged area expanded as the number of blow increased. The area of bulging was least compared to other fabrics since the aramid fiber absorbed and dispersed the impact energy that is transmitted from the blows very efficiently. This was considered as the ultimate failure point. The failure pattern is as shown in the picture below. There was 73.44 % enhancement in the energy absorption capacity of rehabilitated slabs compared to control slabs.

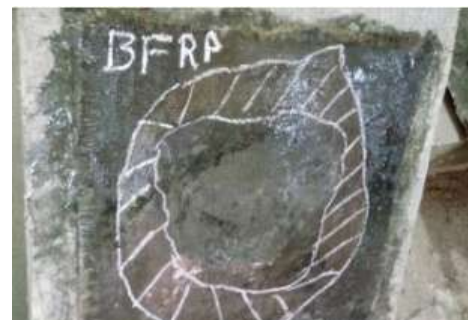
Fig 12: Failure pattern of BFRP wrapped rehabilitated slab

Remaining two slabs were strengthened with Basalt fiber reinforced polymer. BFRP used was Bidirectional with 200 gsm as thickness. BFRP wrapped slabs showed improved impact resistance compared to the control slabs. There was emergence of sharp sound for the first few blows, then as Impact blow increased, the sharp sound started fading indicating the failure of the slab. At the bottom initiation of bulging was seen. The bulging area expanded for further more blows. Since BFRP was also bidirectional there was no tearing or peeling of fabric. The behavior of the BFRP wrapped slab was better than slabs wrapped by GFRP and unidirectional CFRP. The failure pattern is as shown in the figure.. There was 60.09 % enhancement in the energy absorption capacity of rehabilitated slabs compared to control slabs.
